**Reference: Pescadito Environmental Resource Center – Webb County
Municipal Solid Waste (MSW) – Proposed Permit No. 2374
Supplemental Response to Parts I and II Application
CN603835489/RN106119639**

Attachment A
Site Visit Summary of Findings and
Recommendations

Subject: **Site Visit Summary of Findings and Recommendations — Rancho Viejo, Webb County, Texas Proposed Landfill**

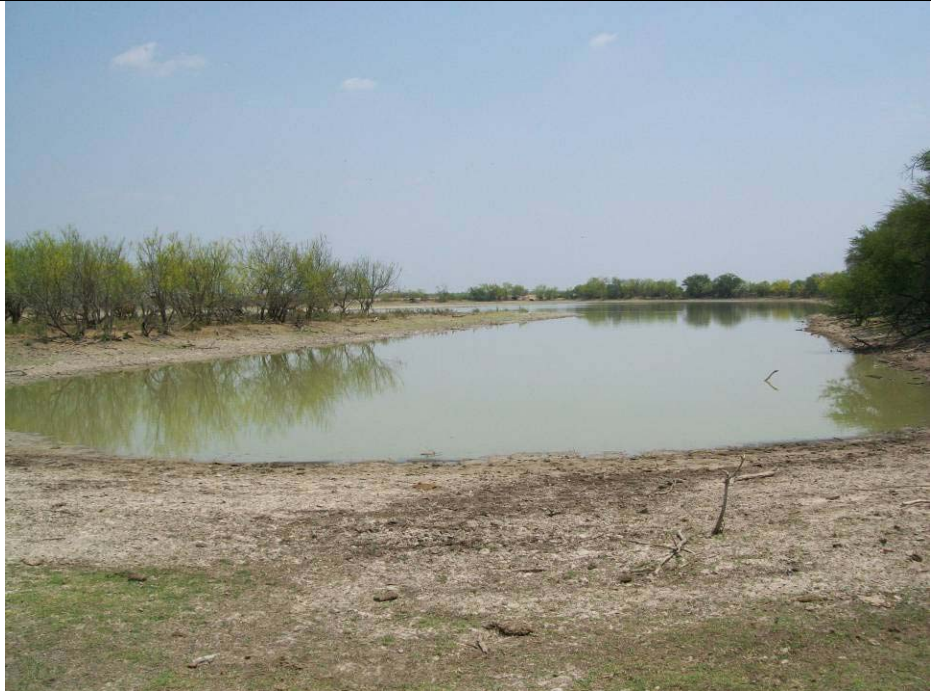
Client: Rancho Viejo Waste Management, LLC		Project Number: 182277
Project Name: Pescadito Environmental Resource Center		County, State: Webb County, Texas
Photograph ID: 5

Feature: Stock Tank WB104 and Wetland W133		
Date: 4/19/2011		
Comments: Stock tank SB104 and wetland W133 (left of photo). Facing south.		
Photograph ID: 6

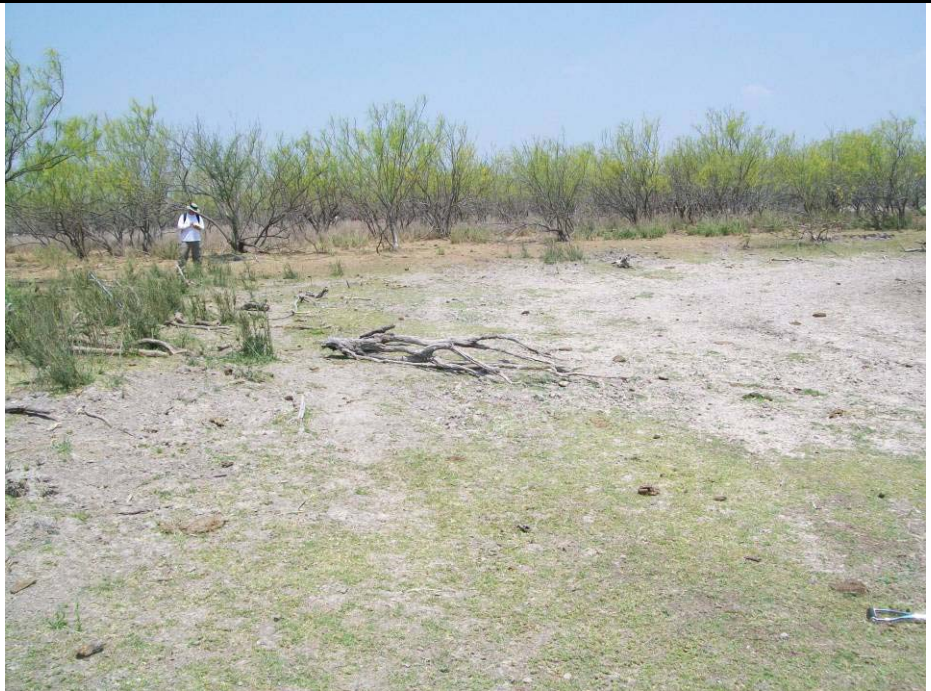
Feature: Wetland W133 and Stock Tank W1B104		
Date: 4/21/2011		
Comments: Wetland W133 (background) at the edge of stock tank WB104 (foreground). Facing north.

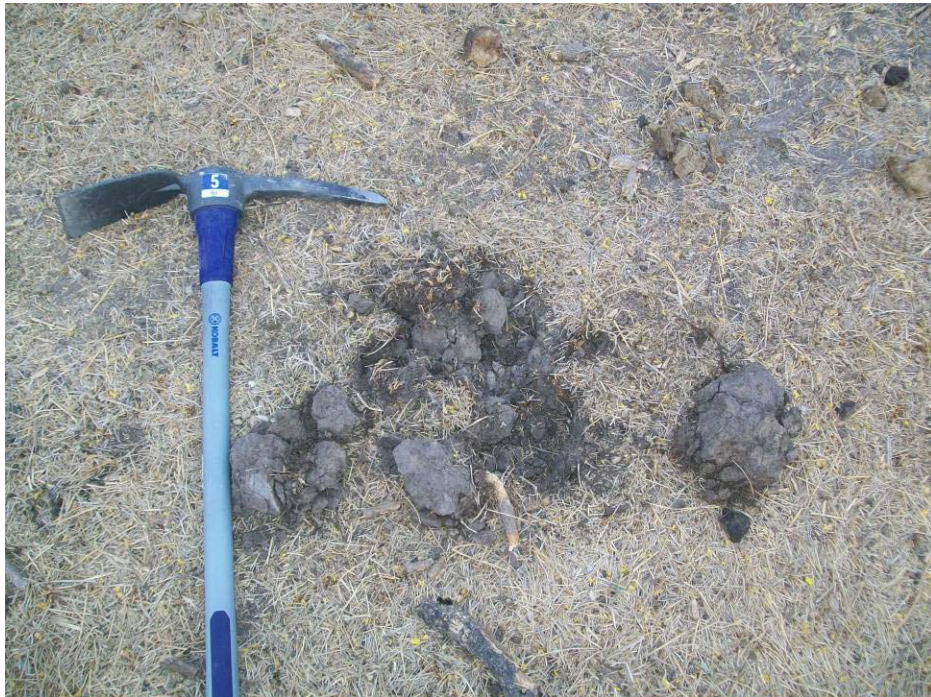
Feature: Soil at W133-WDP			
Date: 4/19/2011			
Comments: Soil at W133-WDP wetland data point.

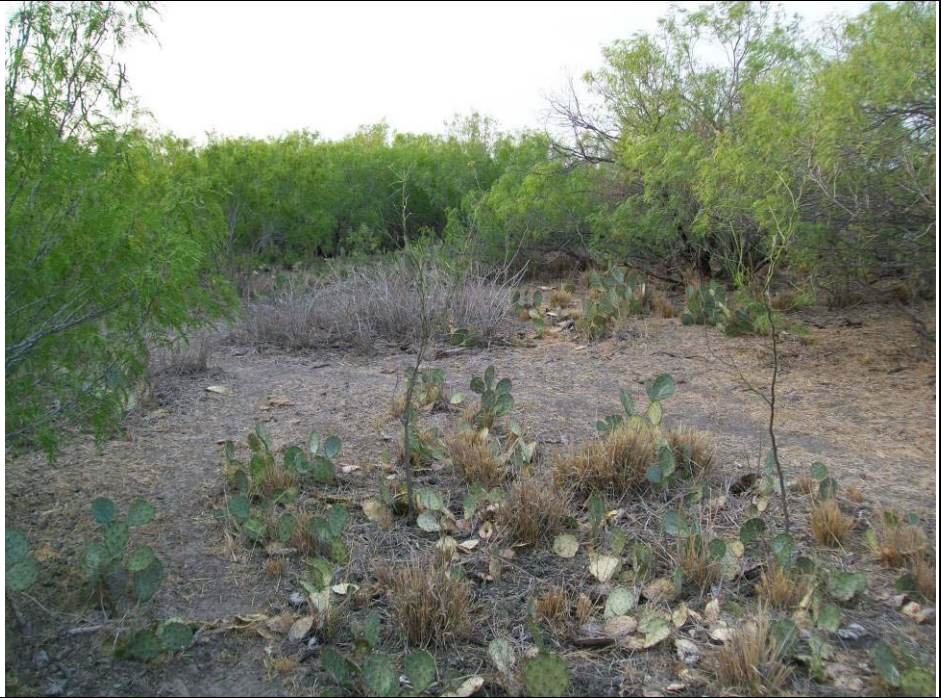
Client: Rancho Viejo Waste Management, LLC		Project Number: 182277	
Project Name: Pescadito Environmental Resource Center		County, State: Webb County, Texas	
Photograph ID: 9

Feature: Upland Habitat at W133-UDP			
Date: 4/19/2011			
Comments: Upland habitat at W133-UDP upland data point. Facing north.			
Photograph ID: 10

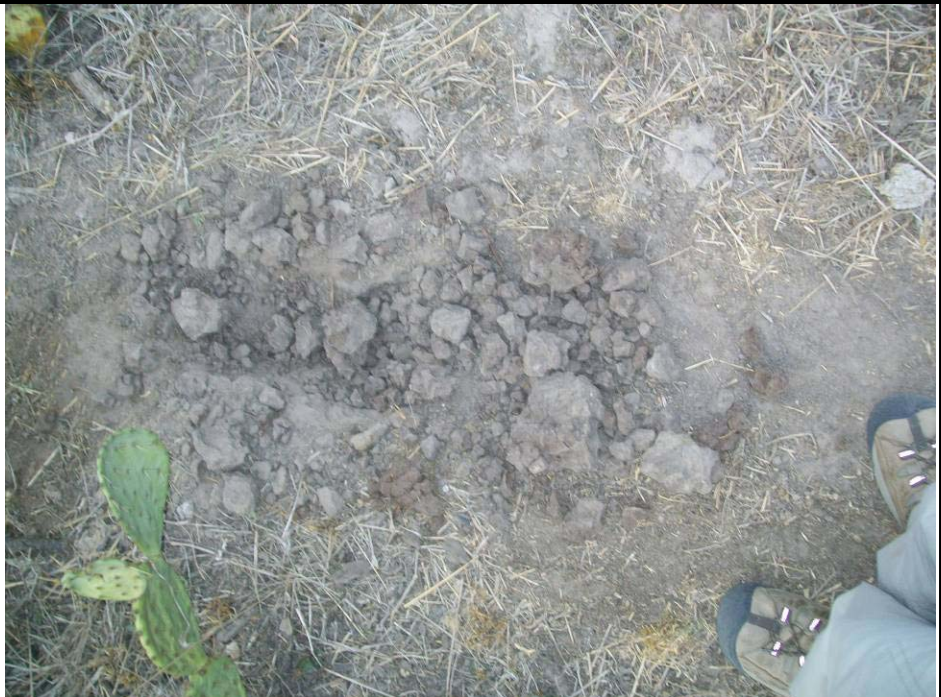
Feature: Soil at W133-UDP			
Date: 4/20/2011			
Comments: Soil at W133-UDP upland data point.

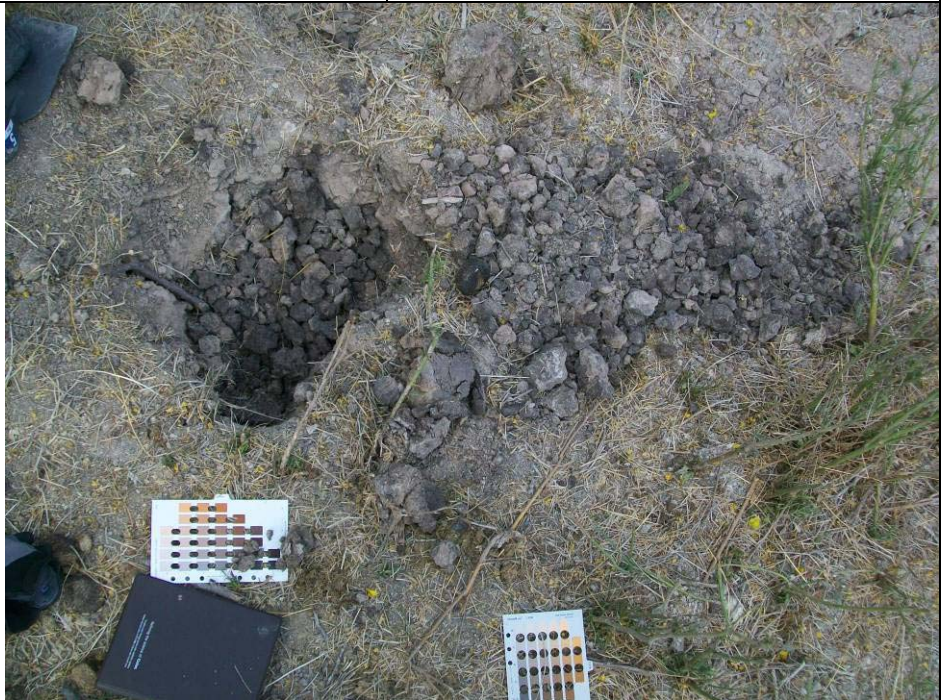
Client: Rancho Viejo Waste Management, LLC		Project Number: 182277	
Project Name: Pescadito Environmental Resource Center		County, State: Webb County, Texas	
Photograph ID: 13

Feature: Soil at W109-WDP			
Date: 4/20/2011			
Comments: Soil profile at W109-WDP wetland data point.			
Photograph ID: 14		 	
Feature: Upland habitat at W109-UDP			
Date: 4/20/2011			
Comments: Upland habitat at W109-UDP upland data point. Facing north.

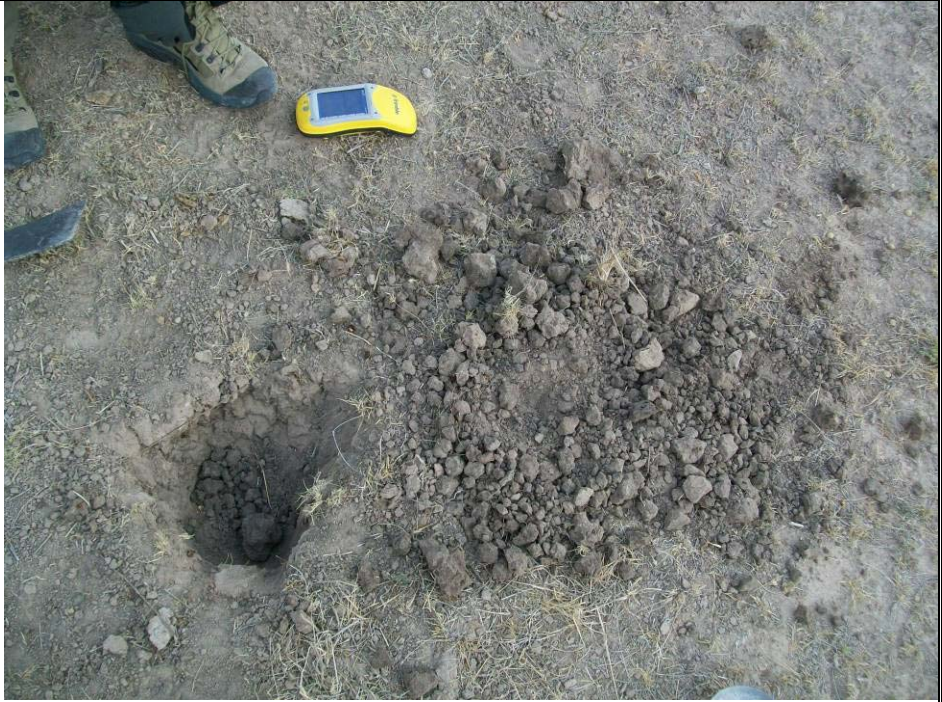
Client: Rancho Viejo Waste Management, LLC		Project Number: 182277
Project Name: Pescadito Environmental Resource Center		County, State: Webb County, Texas
Photograph ID: 15

Feature: Soil at W109-UDP		
Date: 4/20/2011		
Comments: Soil profile at W109-UDP upland data point.		
Photograph ID: 16

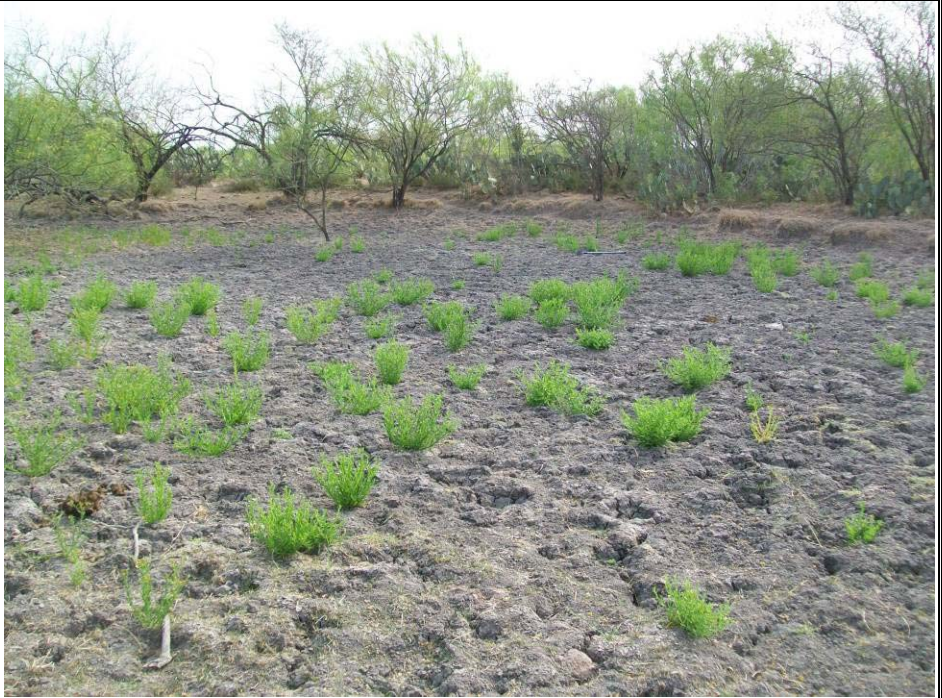
Feature: Stock Tank WB110		
Date: 4/20/2011		
Comments: Stock tank WB110. Facing north.

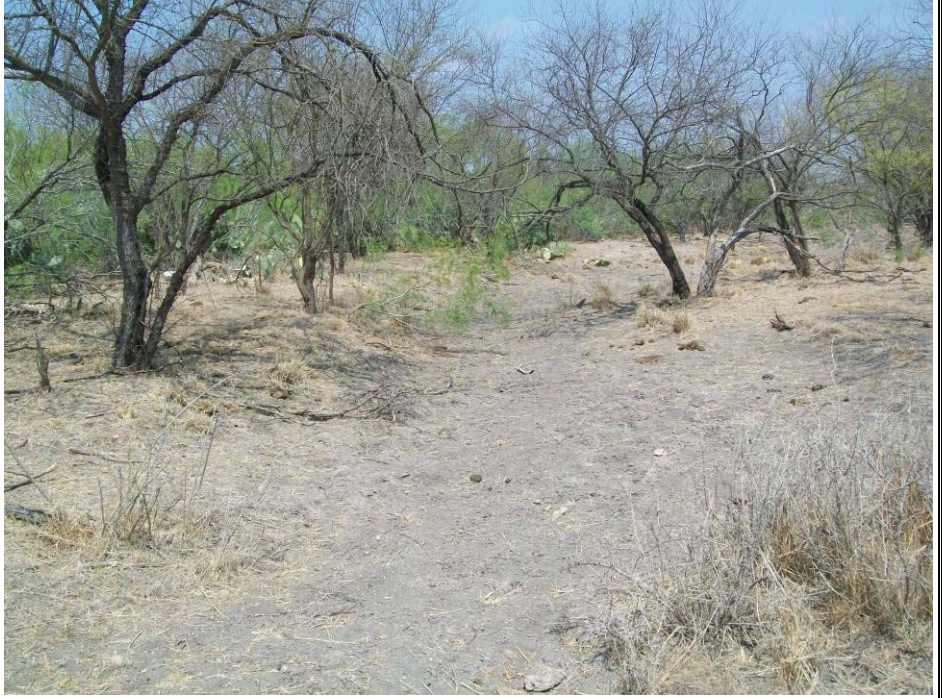
Client: Rancho Viejo Waste Management, LLC		Project Number: 182277
Project Name: Pescadito Environmental Resource Center		County, State: Webb County, Texas
Photograph ID: 25

Feature: Wetland W118		
Date: 4/20/2011		
Comments: Wetland W118, located within an abandoned drainage channel created by stock tank construction. Facing north.		
Photograph ID: 26	 	
Feature: Stream S116		
Date: 4/20/2011		
Comments: Ephemeral stream S116. Facing north (upstream).

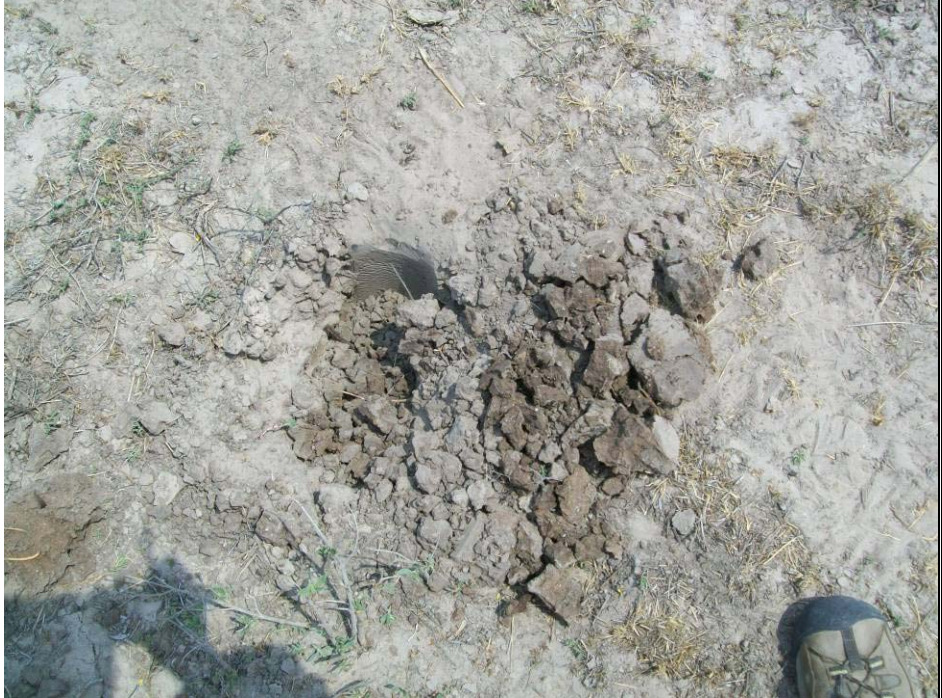
Client: Rancho Viejo Waste Management, LLC		Project Number: 182277
Project Name: Pescadito Environmental Resource Center		County, State: Webb County, Texas
Photograph ID: 35

Feature: Soil at W126-UDP		
Date: 4/21/2011		
Comments: Soil at W126-UDP upland data point.		
Photograph ID: 36	 	
Feature: Wetland W127 at W127-WDP1		
Date: 4/21/2011		
Comments: Wetland W127 at W127-WDP1. Facing south.

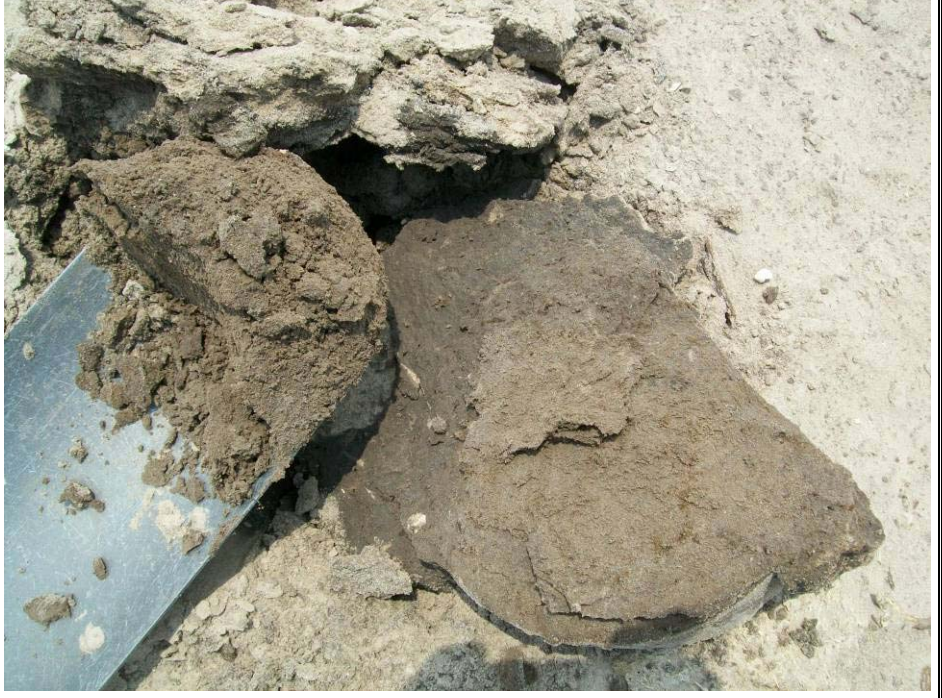
Client: Rancho Viejo Waste Management, LLC		Project Number: 182277
Project Name: Pescadito Environmental Resource Center		County, State: Webb County, Texas
Photograph ID: 39

Feature: Soil at W127		
Date: 4/21/2011		
Comments: Hydric soil at sparsely vegetated area of W127.		
Photograph ID: 40	 	
Feature: Upland habitat at W127-UDP1		
Date: 4/21/2011		
Comments: Upland habitat at W127-UDP1 upland data point. Facing north.

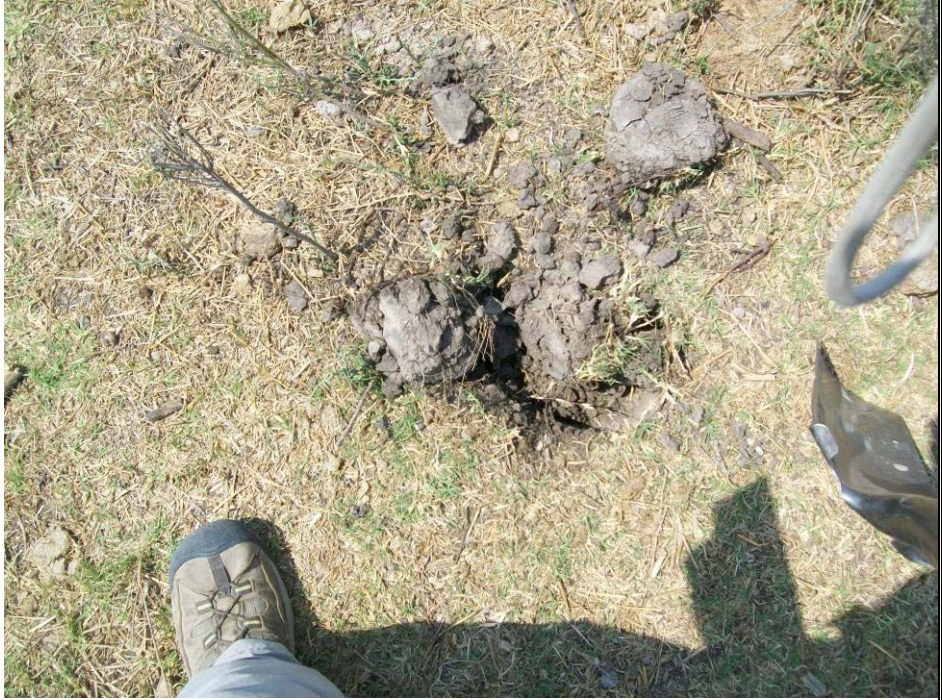
Client: Rancho Viejo Waste Management, LLC		Project Number: 182277
Project Name: Pescadito Environmental Resource Center		County, State: Webb County, Texas
Photograph ID: 43

Feature: Soil at W127-WDP2		
Date: 4/21/2011		
Comments: Soil at W127-WDP2 wetland data point.		
Photograph ID: 44

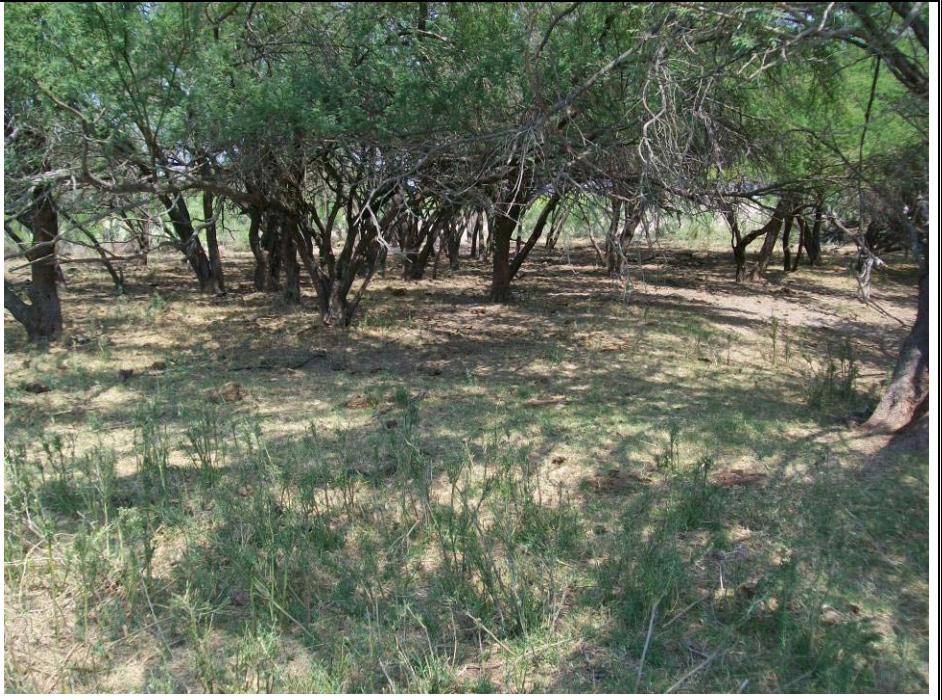
Feature: Upland habitat at W127-UDP2		
Date: 4/21/2011		
Comments: Upland habitat at W127-UDP2 upland data point. Facing southeast.

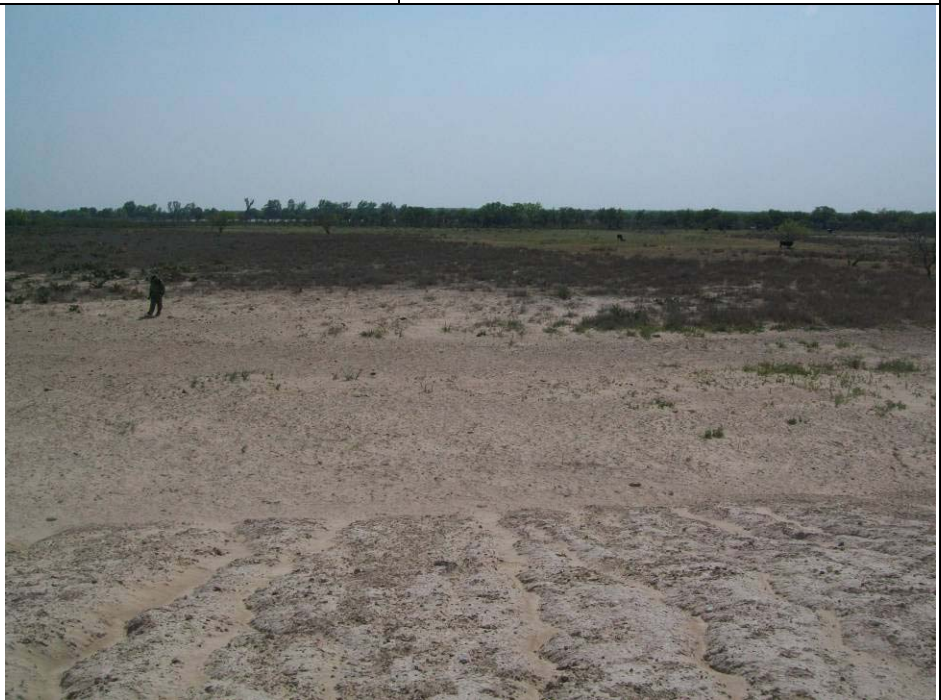
Client: Rancho Viejo Waste Management, LLC		Project Number: 182277	
Project Name: Pescadito Environmental Resource Center		County, State: Webb County, Texas	
Photograph ID: 47

Feature: Wetland W127 at W104 Impoundment			
Date: 4/21/2011			
Comments: Wetland W127 (background) at W104 impoundment (foreground). Facing south.			
Photograph ID: 48

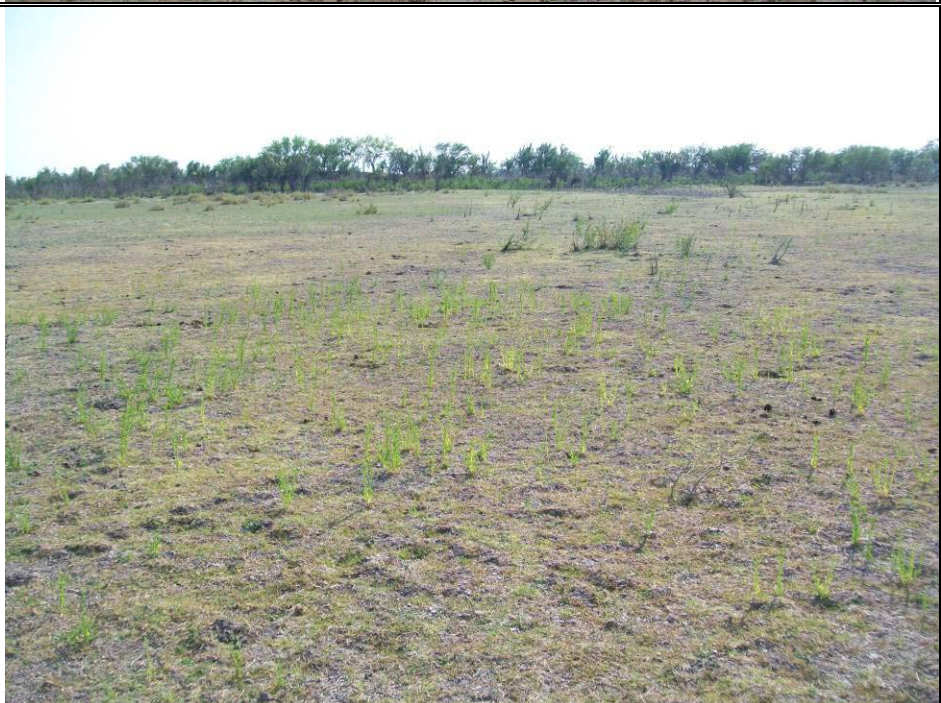
Feature: Wetland W130			
Date: 4/21/2011			
Comments: Wetland W130. Facing south.

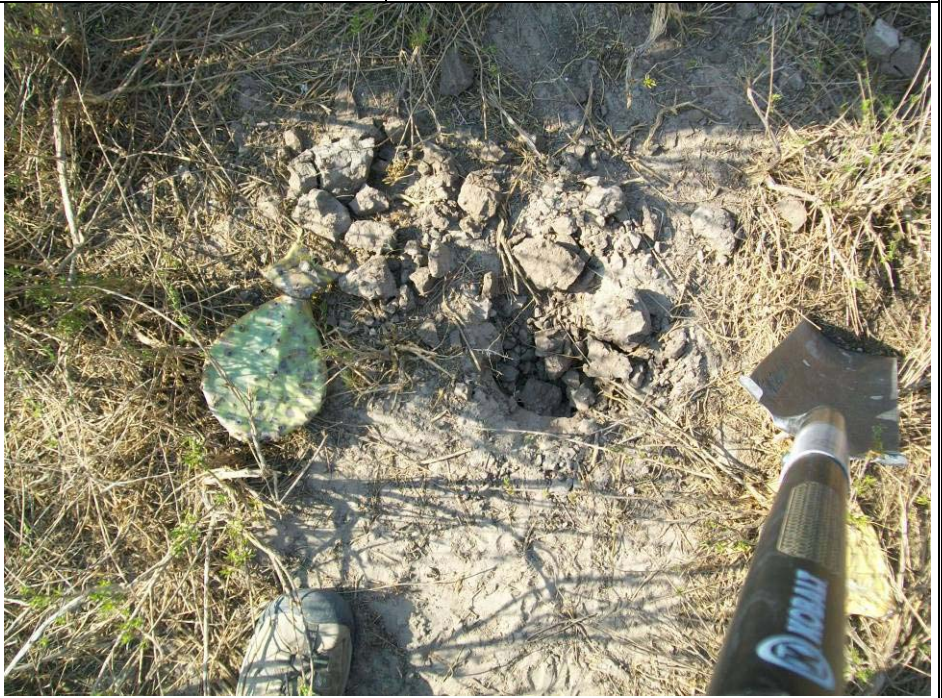
Client: Rancho Viejo Waste Management, LLC		Project Number: 182277
Project Name: Pescadito Environmental Resource Center		County, State: Webb County, Texas
Photograph ID: 51

Feature: Soil at W12/W130-UDP		
Date: 4/21/2011		
Comments: Soil at W127/W130- UDP upland data point.		
Photograph ID: 52

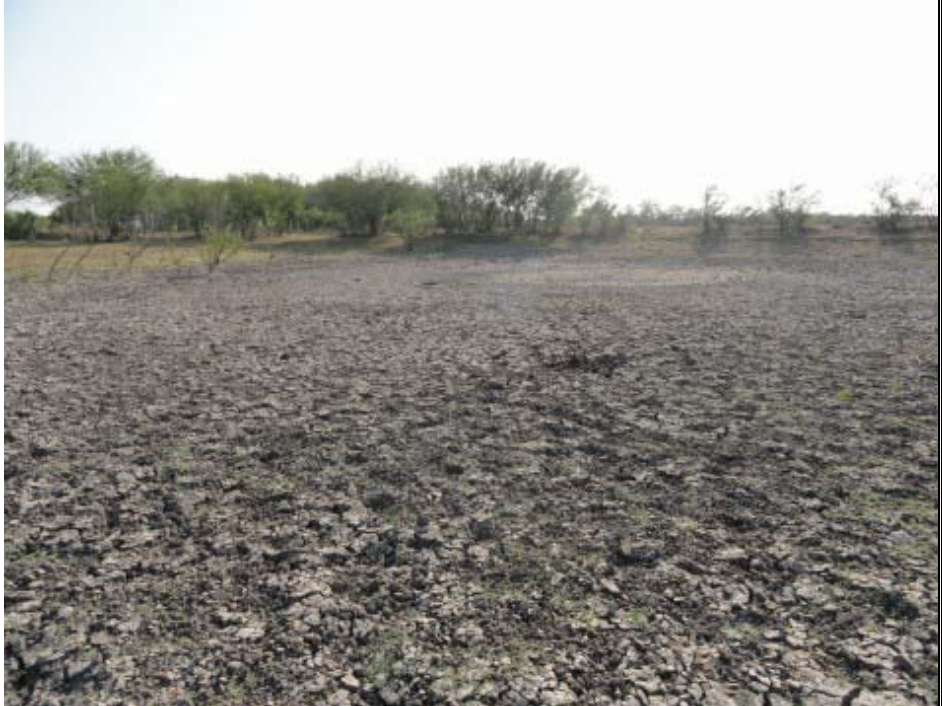
Feature: Stock Tank WB131		
Date: 4/21/2011		
Comments: Stock tank WB131. Facing west.

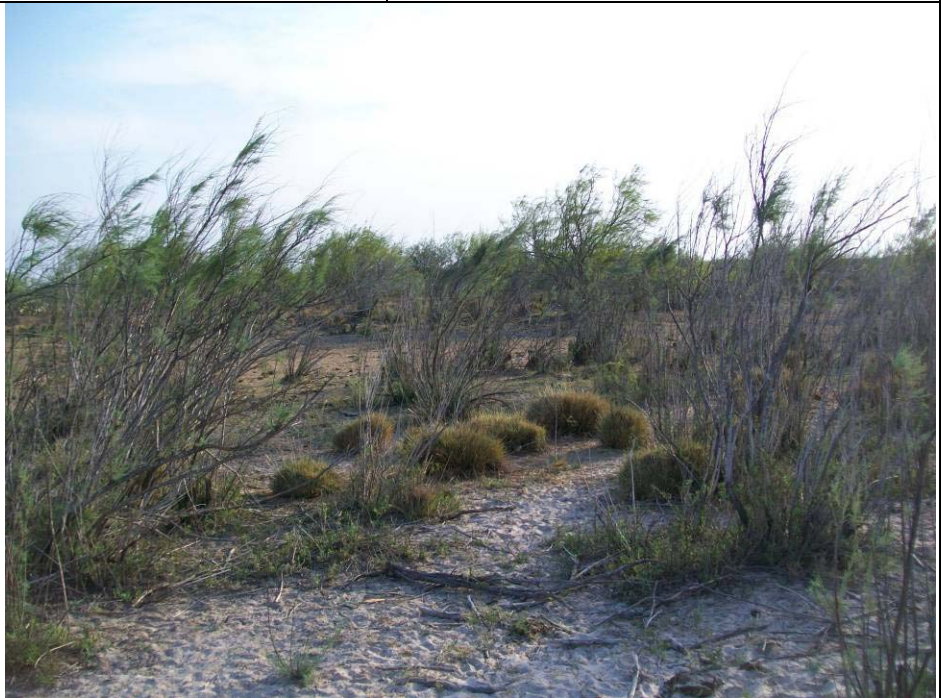
Client: Rancho Viejo Waste Management, LLC		Project Number: 182277	
Project Name: Pescadito Environmental Resource Center		County, State: Webb County, Texas	
Photograph ID: 53

Feature: Wetland W132			
Date: 4/21/2011			
Comments: Wetland W132. Facing southeast.			
Photograph ID: 54

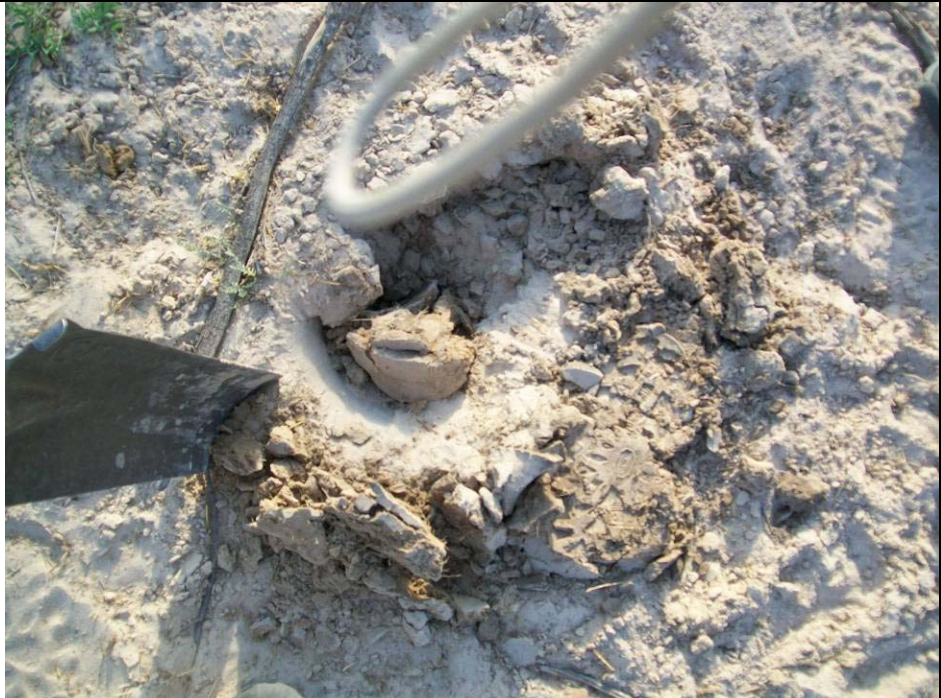
Feature: Soil at W132-WDP			
Date: 4/21/2011			
Comments: Soil at W132-WDP wetland data point.

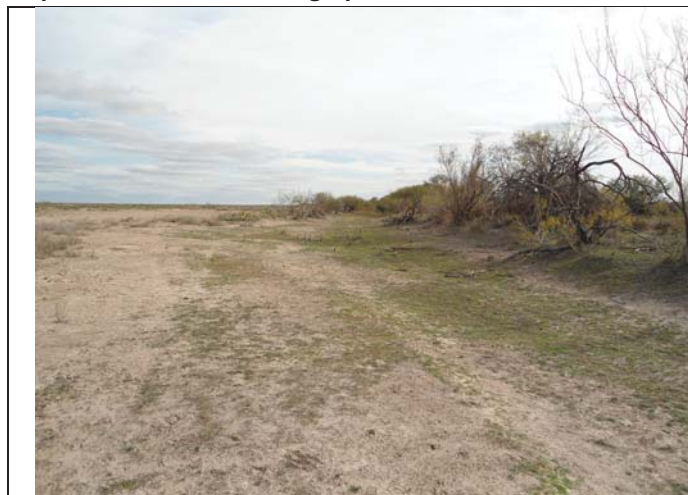
Sum of overall TXRAM stream score and additional points = total overall TXRAM stream score				25.83

S125 SAR 1 facing southeast (downstream)

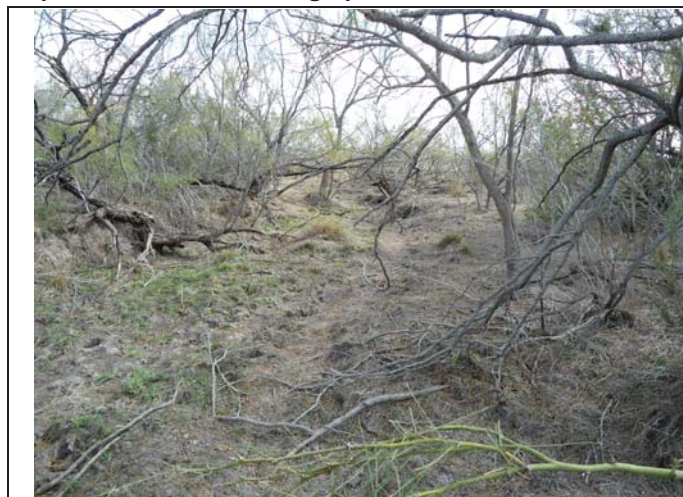
Sum of overall TXRAM stream score and additional points = total overall TXRAM stream score				15.83

S121 SAR 4 facing south (downstream)

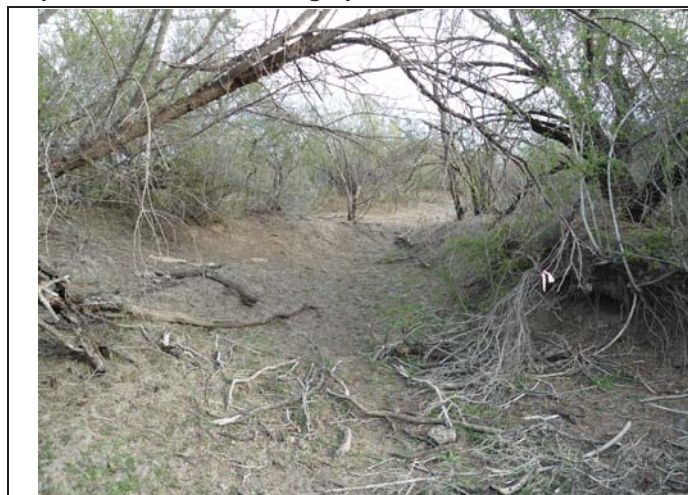
Sum of overall TXRAM stream score and additional points = total overall TXRAM stream score				15.83

S121 SAR 3 facing south (downstream)

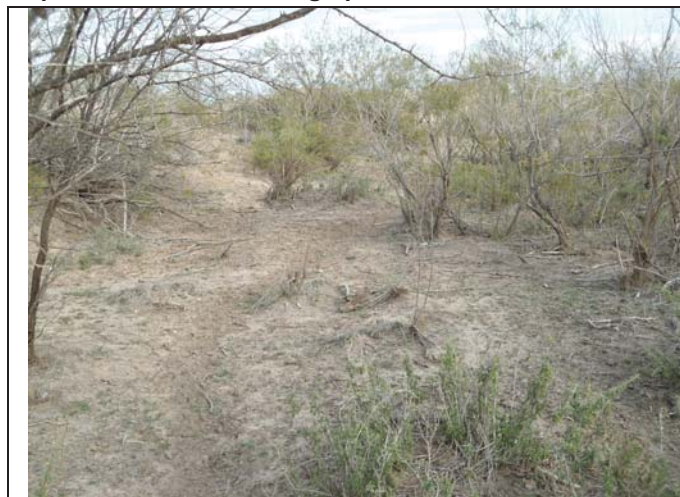
Project/Site Name/No.: Pescadito Environmental Resource Center Project Type: ☒ Fill/Impact (☐ Linear ☒ Non-linear) ☐ Mitigation/Conservation
 Stream ID/Name: S121 SAR No.: 2 Size (LF): 1088 Date: 1/31/2012 Evaluator(s): B.Clark/T.Schnakenberg
 Stream Type: Ephemeral Ecoregion: South Texas Plains Delineation Performed: ☒ Previously ☐ Currently
 8-Digit HUC: 13080003 Watershed Condition (developed, pasture, etc.): Rangeland Watershed Size: ~200 ac
 Aerial Photo Date and Source: 2008 NC from NAIP (TNRIS) Site Photos: 21 Representative: ☒ Yes ☐ No
 Stressor(s): Overgrazing Are normal climatic/hydrologic conditions present? ☒ Yes ☐ No (If no, explain in Notes)

Sum of overall TXRAM stream score and additional points = total overall TXRAM stream score				20.83

S121 SAR 1 facing south (downstream)

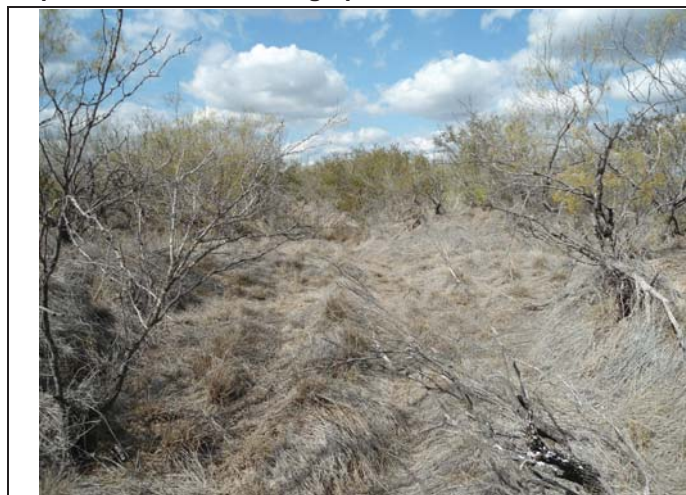
Sum of overall TXRAM stream score and additional points = total overall TXRAM stream score				17.50

S120 SAR 3 facing southeast (downstream)

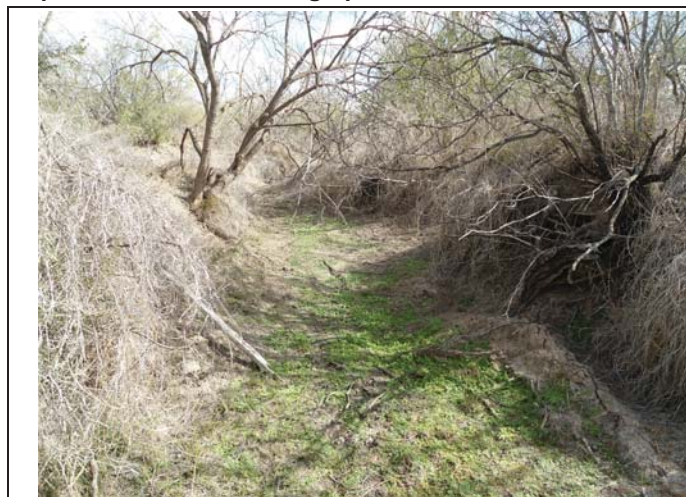
Project/Site Name/No.: Pescadito Environmental Resource Center Project Type: ☒ Fill/Impact (☐ Linear ☒ Non-linear) ☐ Mitigation/Conservation
 Stream ID/Name: S120 SAR No.: 2 Size (LF): 695 Date: 2/1/2012 Evaluator(s): B.Clark/T. Schnakenberg
 Stream Type: Ephemeral Ecoregion: South Texas Plains Delineation Performed: ☐ Previously ☒ Currently
 8-Digit HUC: 13080003 Watershed Condition (developed, pasture, etc.): Rangeland Watershed Size: ~200 ac
 Aerial Photo Date and Source: 2008 NC from NAIP (TNRIS) Site Photos: 28 Representative: ☒ Yes ☐ No
 Stressor(s): Overgrazing Are normal climatic/hydrologic conditions present? ☒ Yes ☐ No (If no, explain in Notes)
 Notes: Region is under severe drought conditions

Sum of overall TXRAM stream score and additional points = total overall TXRAM stream score				15.83

S120 SAR 2 (photo 28) facing south (downstream).

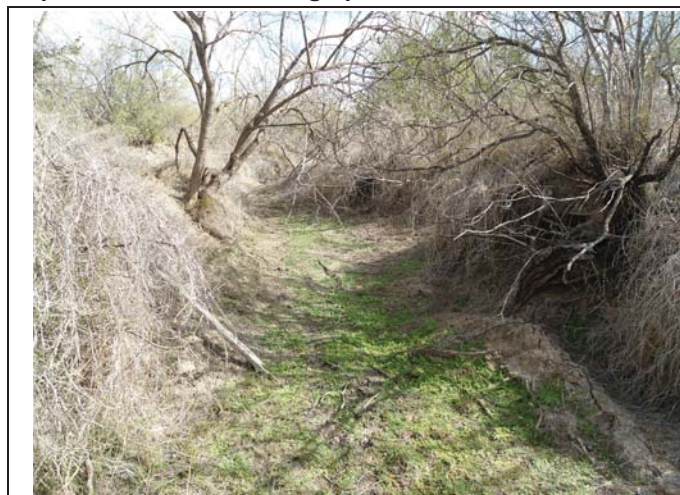
Project/Site Name/No.: Pescadito Environmental Resource Center Project Type: ☒ Fill/Impact (☐ Linear ☒ Non-linear) ☐ Mitigation/Conservation
 Stream ID/Name: S120 SAR No.: 1 Size (LF): 1406 Date: 1/31/2012 Evaluator(s): B.Clark/T. Schnakenberg
 Stream Type: Ephemeral Ecoregion: South Texas Plains Delineation Performed: ☒ Previously ☐ Currently
 8-Digit HUC: 13080003 Watershed Condition (developed, pasture, etc.): Rangeland Watershed Size: ~200 ac
 Aerial Photo Date and Source: 2008 NC from NAIP (TNRIS) Site Photos: 28 Representative: ☒ Yes ☐ No
 Stressor(s): Overgrazing Are normal climatic/hydrologic conditions present? ☒ Yes ☐ No (If no, explain in Notes)
 Notes: Leveed ephemeral stream.

Sum of overall TXRAM stream score and additional points = total overall TXRAM stream score				15.83

S120 SAR 1 facing south (downstream)

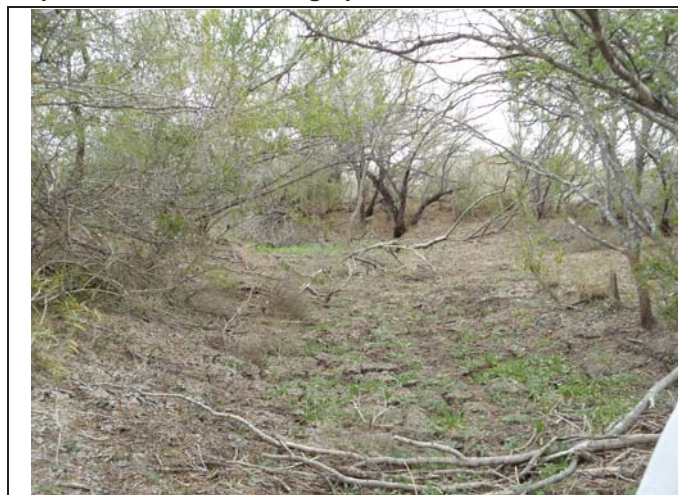
Sum of overall TXRAM stream score and additional points = total overall TXRAM stream score				27.50

S119 SAR 1 facing south (downstream)

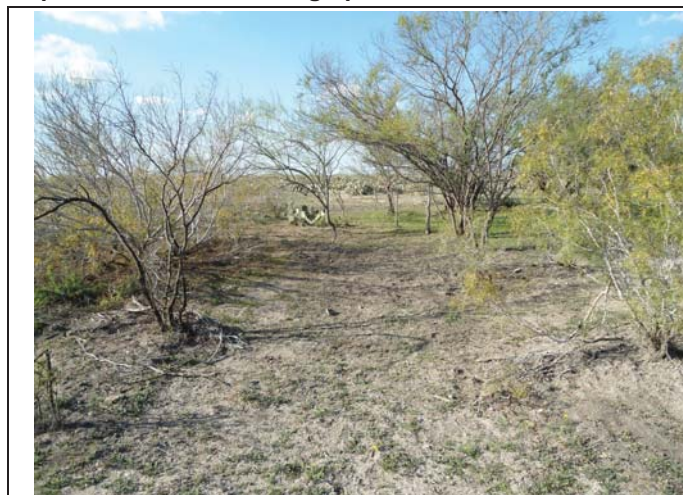
Project/Site Name/No.: Pescadito Environmental Resource Center Project Type: ☒ Fill/Impact (☐ Linear ☒ Non-linear) ☐ Mitigation/Conservation
 Stream ID/Name: S108 SAR No.: 3 Size (LF): 1332 Date: 1/31/2012 Evaluator(s): B.Clark/T. Schnakenberg
 Stream Type: Ephemeral Ecoregion: South Texas Plains Delineation Performed: ☐ Previously ☒ Currently
 8-Digit HUC: 13080003 Watershed Condition (developed, pasture, etc.): Rangeland Watershed Size: ~200 ac
 Aerial Photo Date and Source: 2008 NC from NAIP (TNRIS) Site Photos: 33/34/35 Representative: ☒ Yes ☐ No
 Stressor(s): Overgrazing Are normal climatic/hydrologic conditions present? ☐ Yes ☒ No (If no, explain in Notes)
 Notes: Sedimentation from vegetation growth within stream (sediment trapping)

Sum of overall TXRAM stream score and additional points = total overall TXRAM stream score				25.83

S108x SAR 1x facing west (upstream)(photo 33)

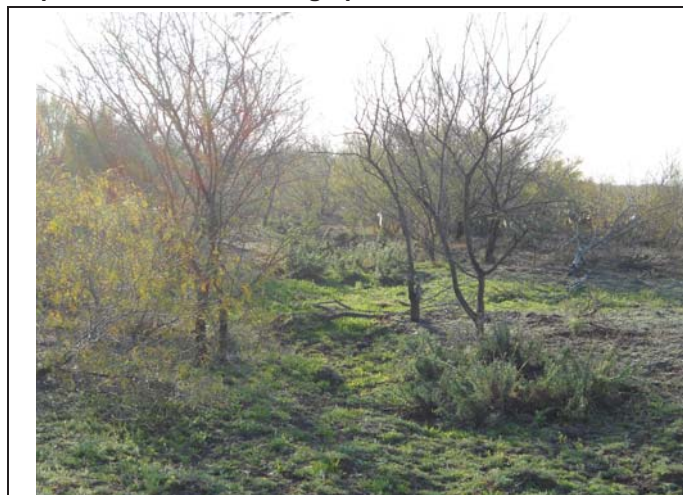
Sum of overall TXRAM stream score and additional points = total overall TXRAM stream score				27.50

SAR 2 facing southwest (downstream)

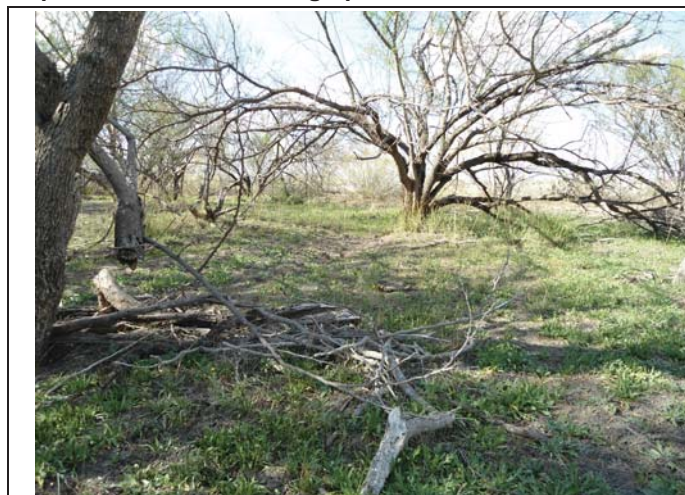
Sum of overall TXRAM stream score and additional points = total overall TXRAM stream score				27.50

S108 SAR 1 facing southwest (downstream)

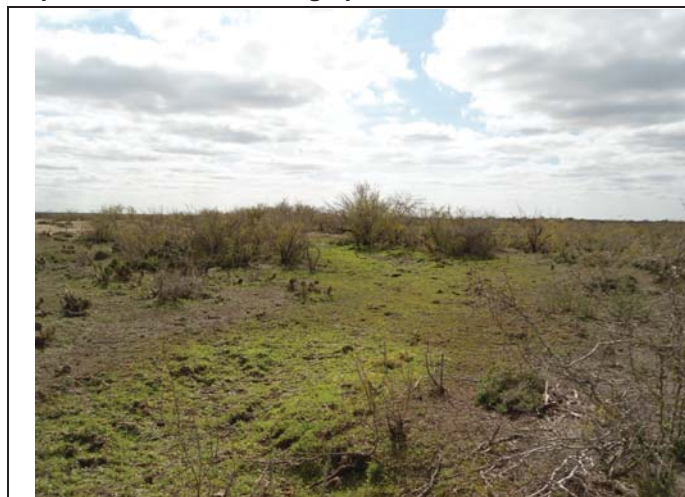
Sum of overall TXRAM stream score and additional points = total overall TXRAM stream score				27.50

S107 SAR 1 facing southwest (downstream)

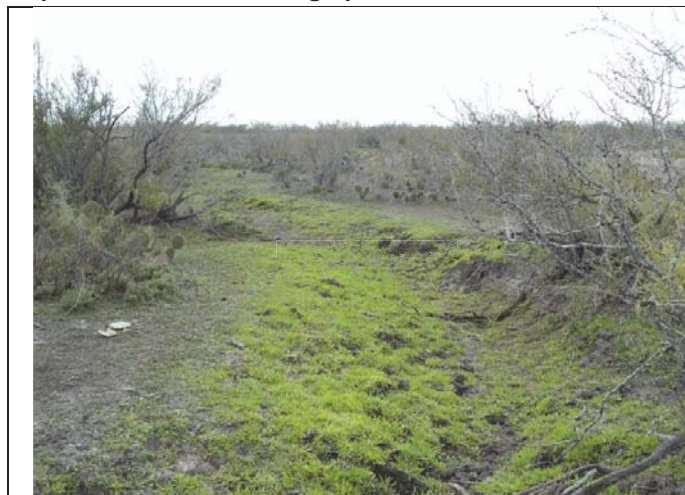
Sum of overall TXRAM stream score and additional points = total overall TXRAM stream score				25.83

S103 SAR 1 facing southwest (downstream)

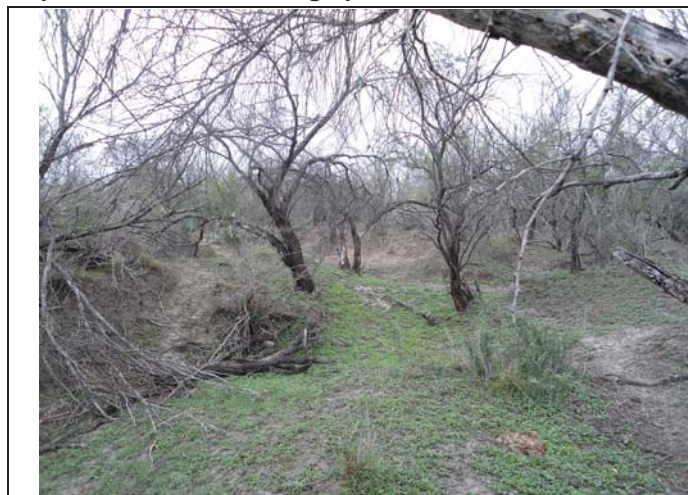
Sum of overall TXRAM stream score and additional points = total overall TXRAM stream score				9.17

S207 SAR 9 facing northeast (upstream).

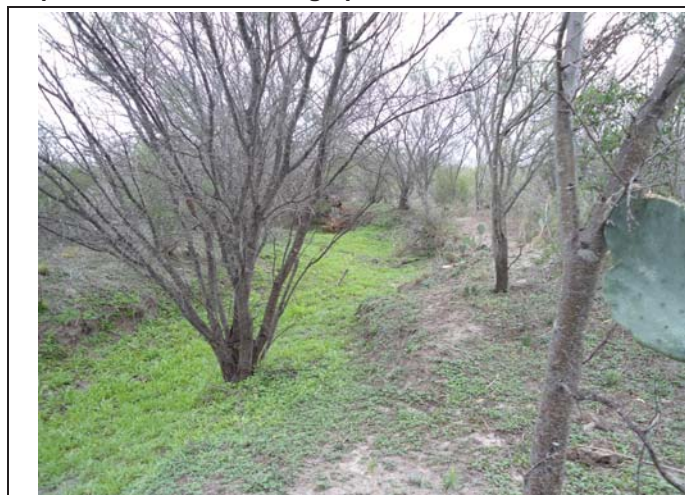
Sum of overall TXRAM stream score and additional points = total overall TXRAM stream score				9.17

S207 SAR 8 facing northeast (upstream).

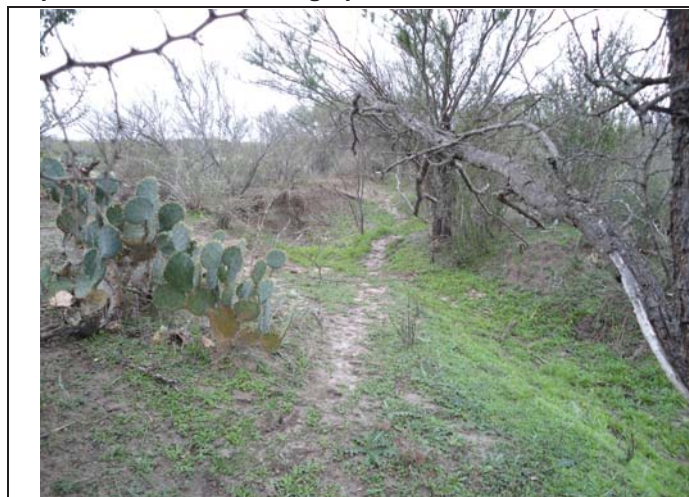
Sum of overall TXRAM stream score and additional points = total overall TXRAM stream score				9.17

S207 SAR 7 facing northeast (upstream).

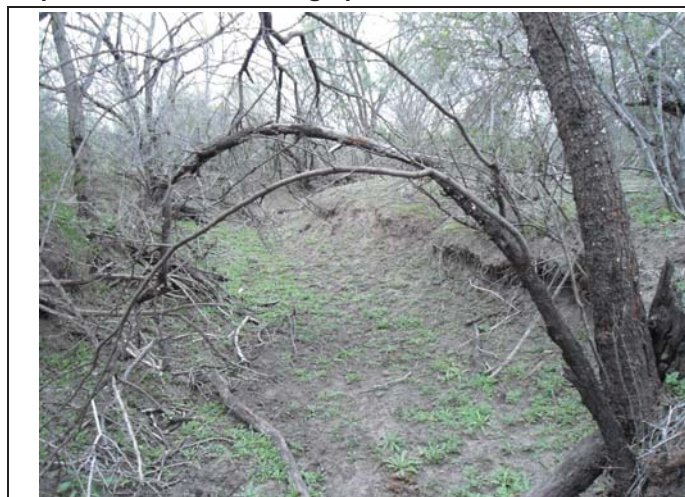
Sum of overall TXRAM stream score and additional points = total overall TXRAM stream score				9.17

S207 SAR 6 facing northeast (upstream).

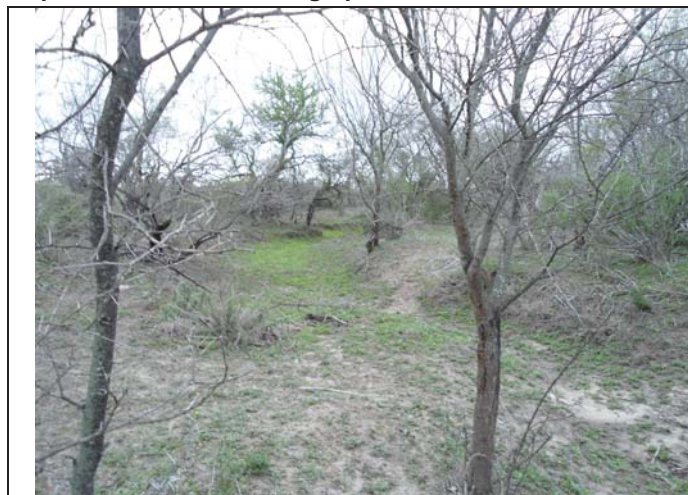
Sum of overall TXRAM stream score and additional points = total overall TXRAM stream score				9.17

S207 SAR 5 facing southwest (downstream).

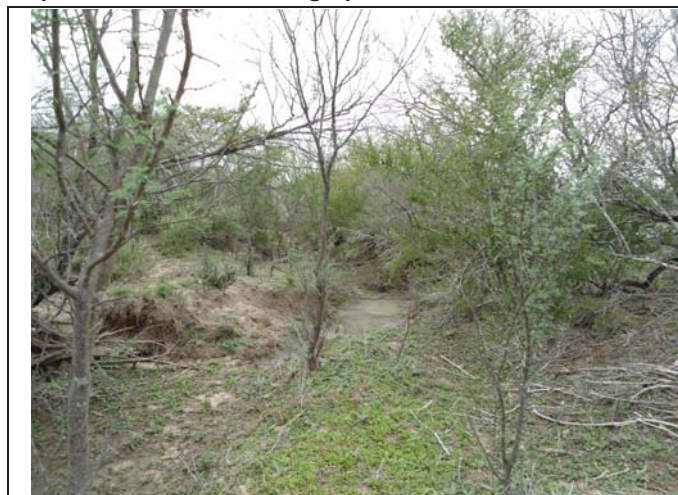
Sum of overall TXRAM stream score and additional points = total overall TXRAM stream score				9.17

S207 SAR 4 facing northeast (upstream).

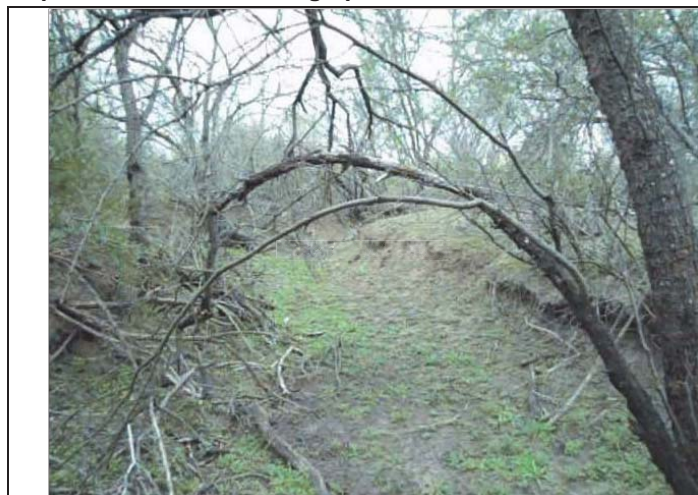
Sum of overall TXRAM stream score and additional points = total overall TXRAM stream score				9.17

S207 SAR 3 facing north (upstream).

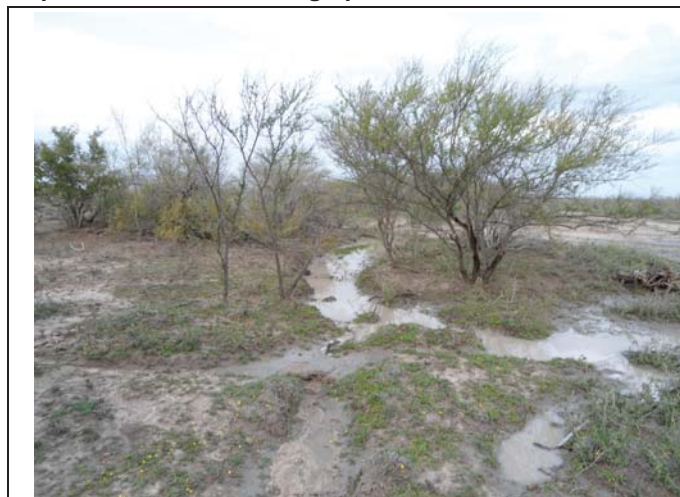
Sum of overall TXRAM stream score and additional points = total overall TXRAM stream score				9.17

S206 SAR 1 facing northeast (upstream).

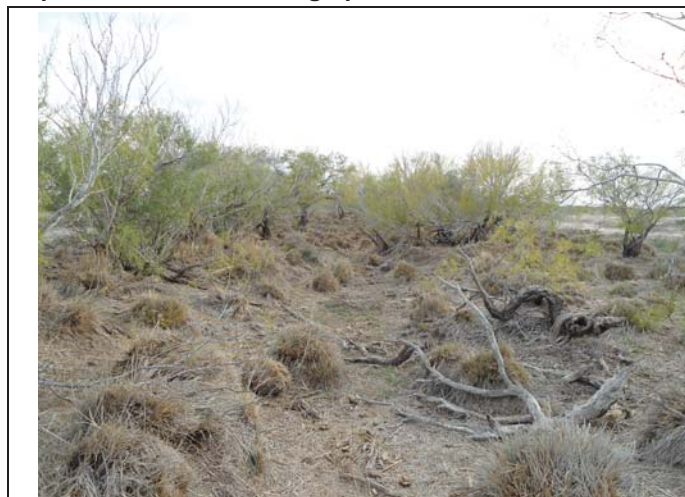
Sum of overall TXRAM stream score and additional points = total overall TXRAM stream score				15.83

S205 SAR 1 facing north (upstream).
