**Reference: Pescadito Environmental Resource Center – Webb County
Municipal Solid Waste (MSW) – Proposed Permit No. 2374
Supplemental Response to Parts I and II Application
CN603835489/RN106119639**

Attachment A
Site Visit Summary of Findings and
Recommendations

Subject: **Site Visit Summary of Findings and Recommendations — Rancho Viejo, Webb County, Texas Proposed Landfill**

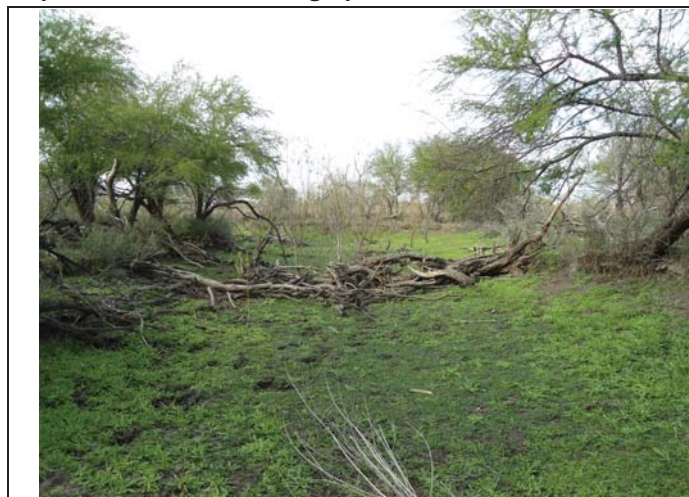
Sum of overall TXRAM stream score and additional points = total overall TXRAM stream score				7.50

S203 SAR 7 facing northwest (upstream).

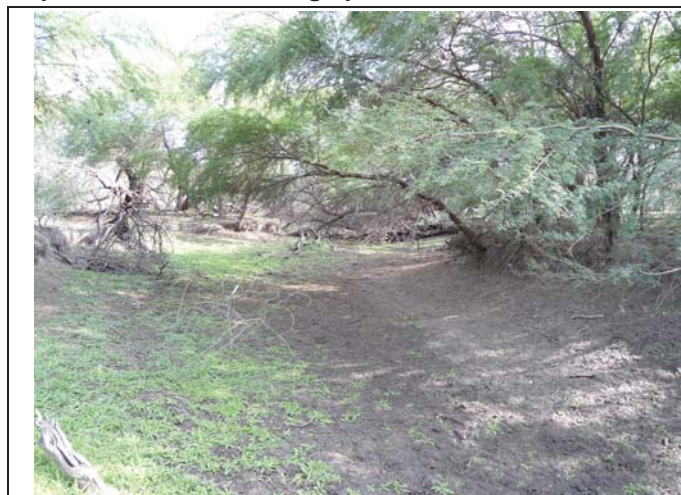
Sum of overall TXRAM stream score and additional points = total overall TXRAM stream score				7.50

S203 SAR 6 facing southwest (downstream).

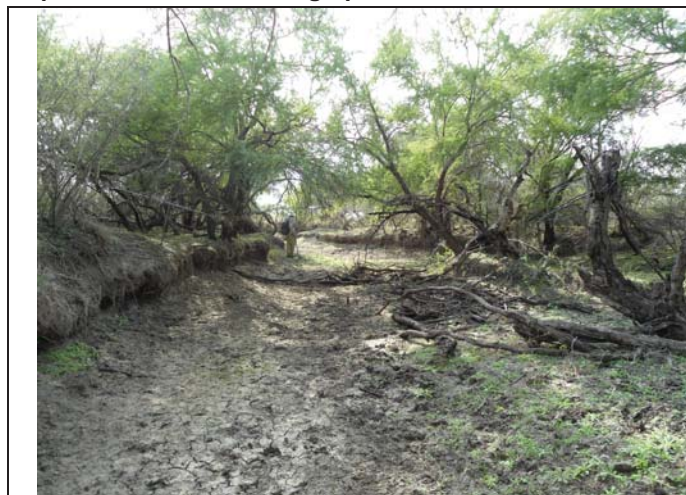
Sum of overall TXRAM stream score and additional points = total overall TXRAM stream score				7.50

S203 SAR 5 (photo 65) facing northeast (upstream).

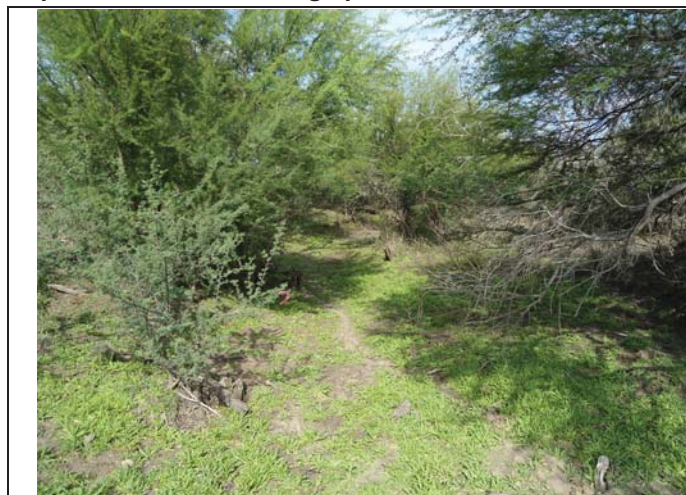
Sum of overall TXRAM stream score and additional points = total overall TXRAM stream score				9.17

S203 SAR 4 facing northwest (upstream).

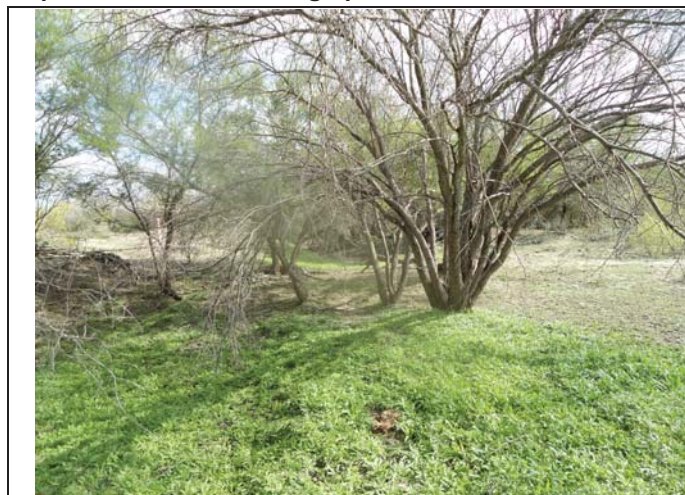
Sum of overall TXRAM stream score and additional points = total overall TXRAM stream score				9.17

S203 SAR 3 facing northwest (upstream).

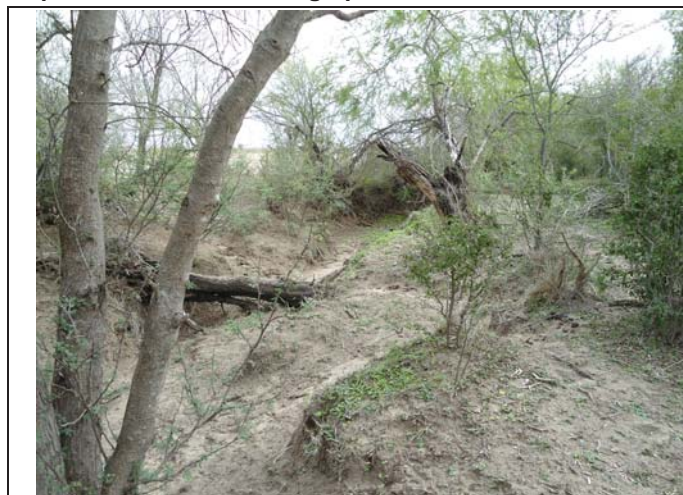
Sum of overall TXRAM stream score and additional points = total overall TXRAM stream score				7.50

S203 SAR 2 facing northwest (upstream).

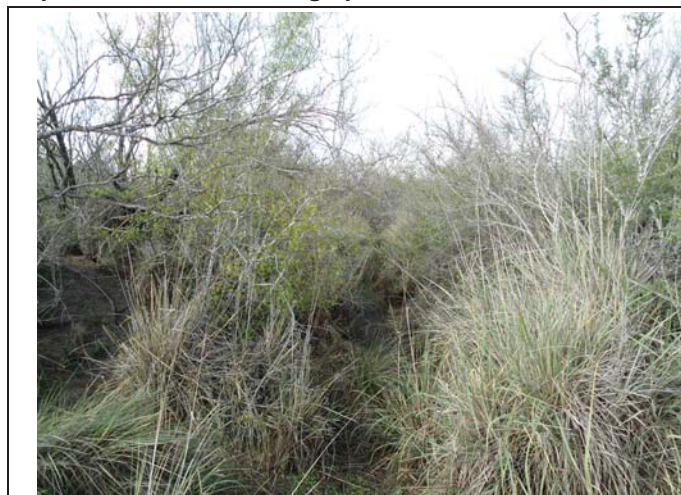
Sum of overall TXRAM stream score and additional points = total overall TXRAM stream score				22.50

S202 SAR 2 facing north (upstream). Note the dense Spartina growth within the streambed.

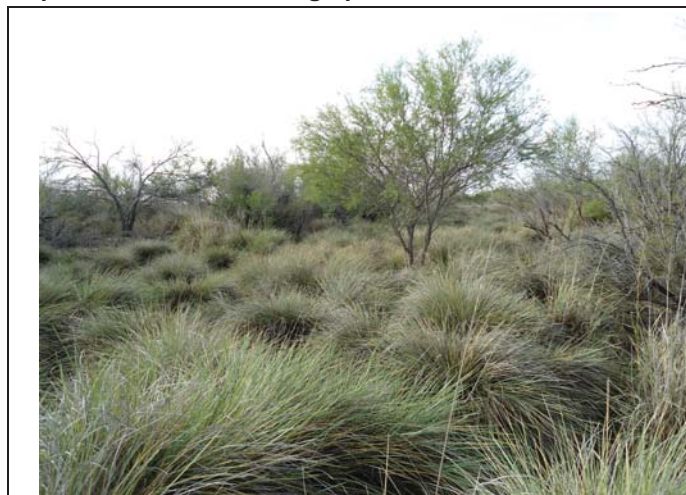
S202 SAR 1 facing north (upstream). Note the dense Spartina growth within the streambed.

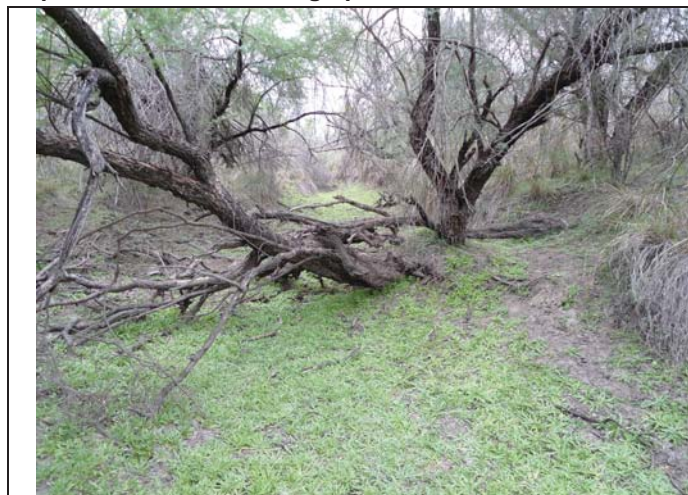
S201 SAR 14 facing north (upstream).

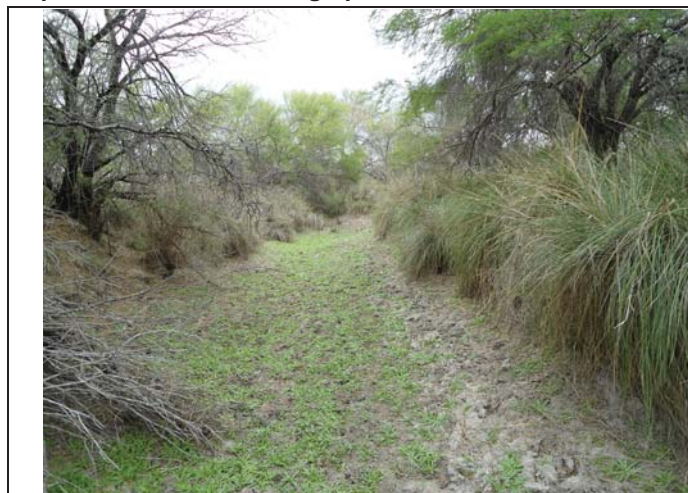
S201 SAR 13 facing south (downstream). Note the dense Spartina growth along the banks.

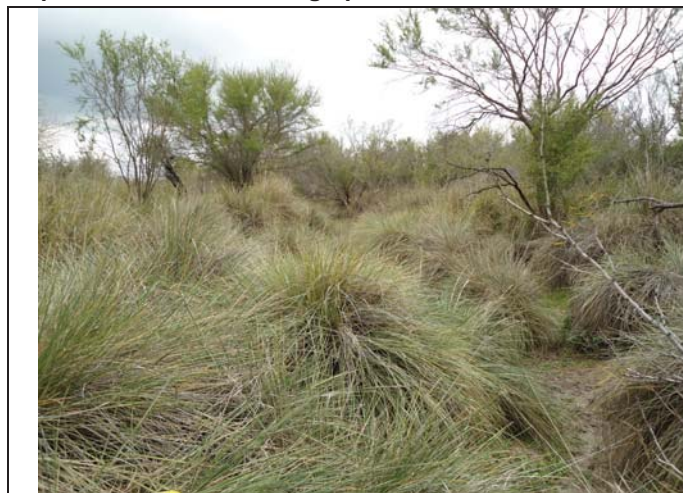
S201 SAR 12 facing north (upstream). Note the dense Spartina spp. growth within the streambed.

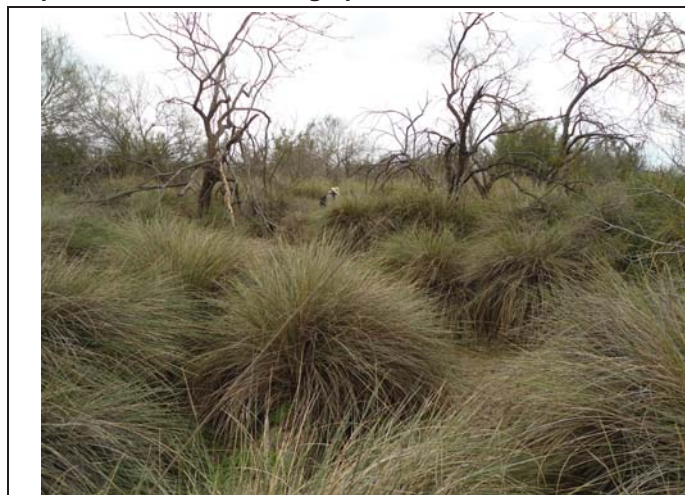
S201 SAR 11 facing north (upstream). Note the dense *Spartina* spp. growth

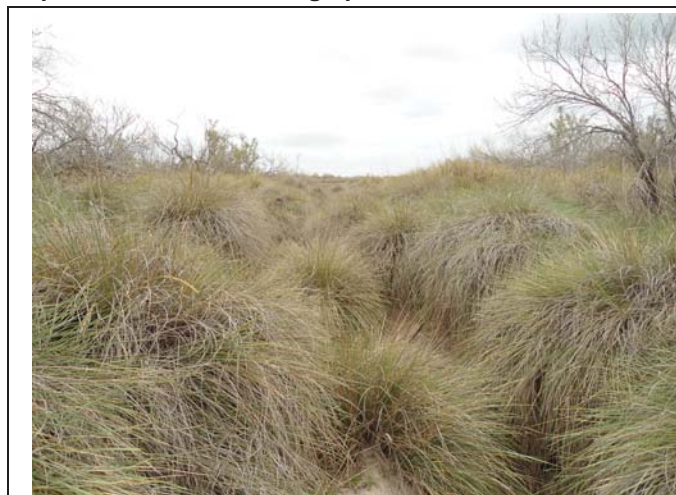
S201 SAR 10 facing north (upstream). Note the dense *Spartina* spp. growth within the stream bed.

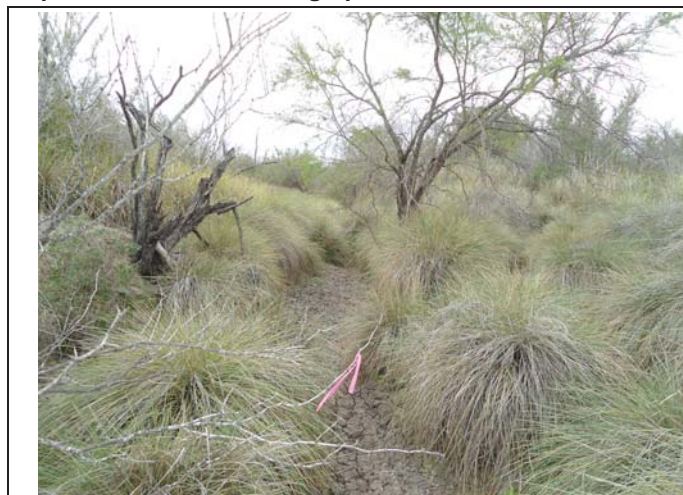
S201 SAR 9 facing north (upstream). Note the dense *Spartina* spp. growth in the streambed.

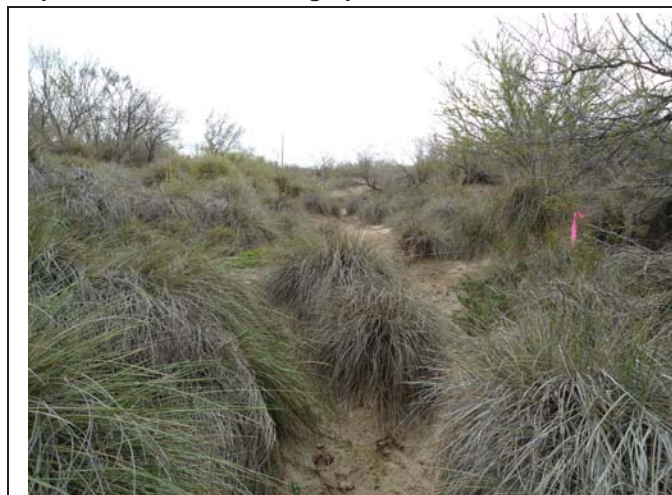
S201 SAR 8 facing south (downstream). Note the heavy *Spartina* spp. growth in throughout the SAR.

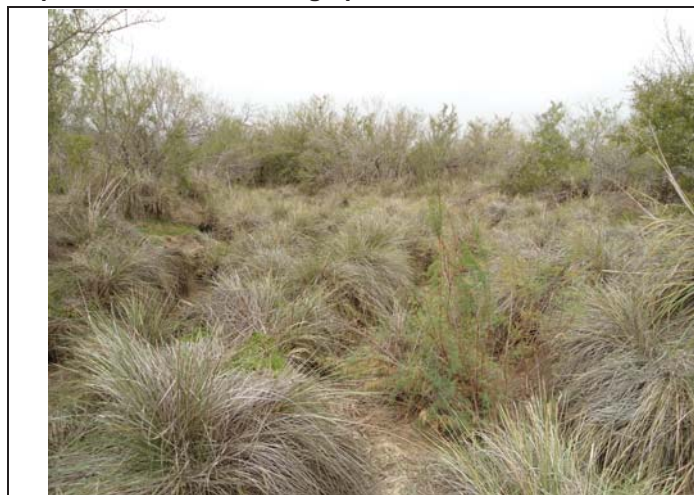
S201 SAR 6 facing north (upstream). Note the dense *Spartina* spp. growth in the stream channel and the braided OHWM.

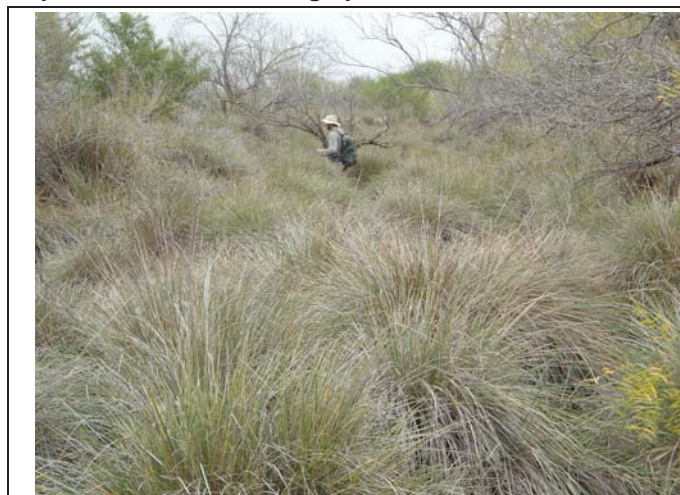
S201 SAR 5 facing north (upstream). Note the dense vegetation in the stream bed.

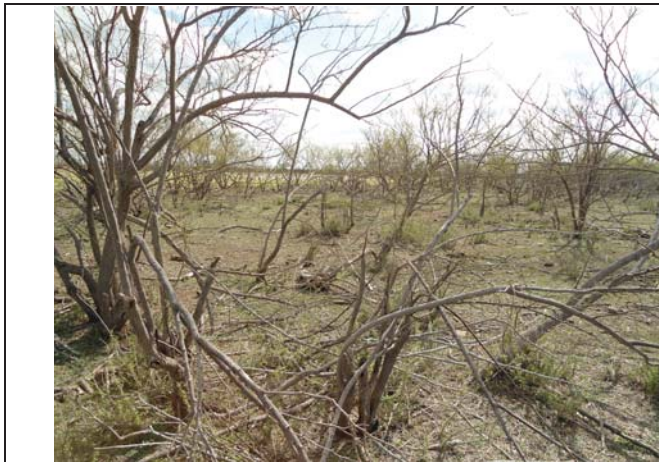
W133 (WAA 7) with brush piles and debris. Facing south

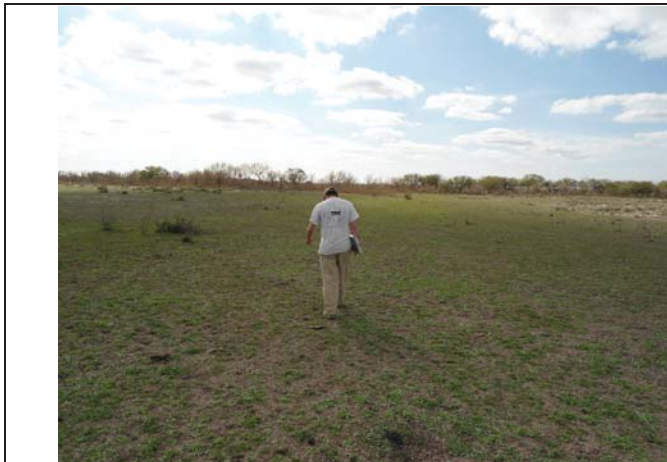
W130 (WAA 5) with S121 levee in far background.
Facing west.

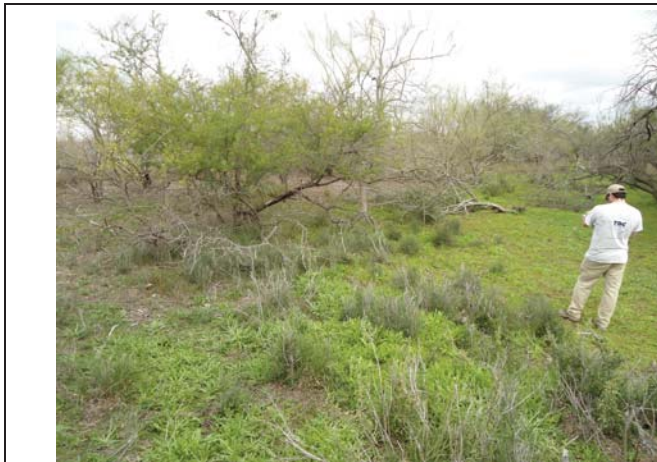
W115 (WAA 2) located left of photo.
Stream S114 located right of photo.
Facing northeast

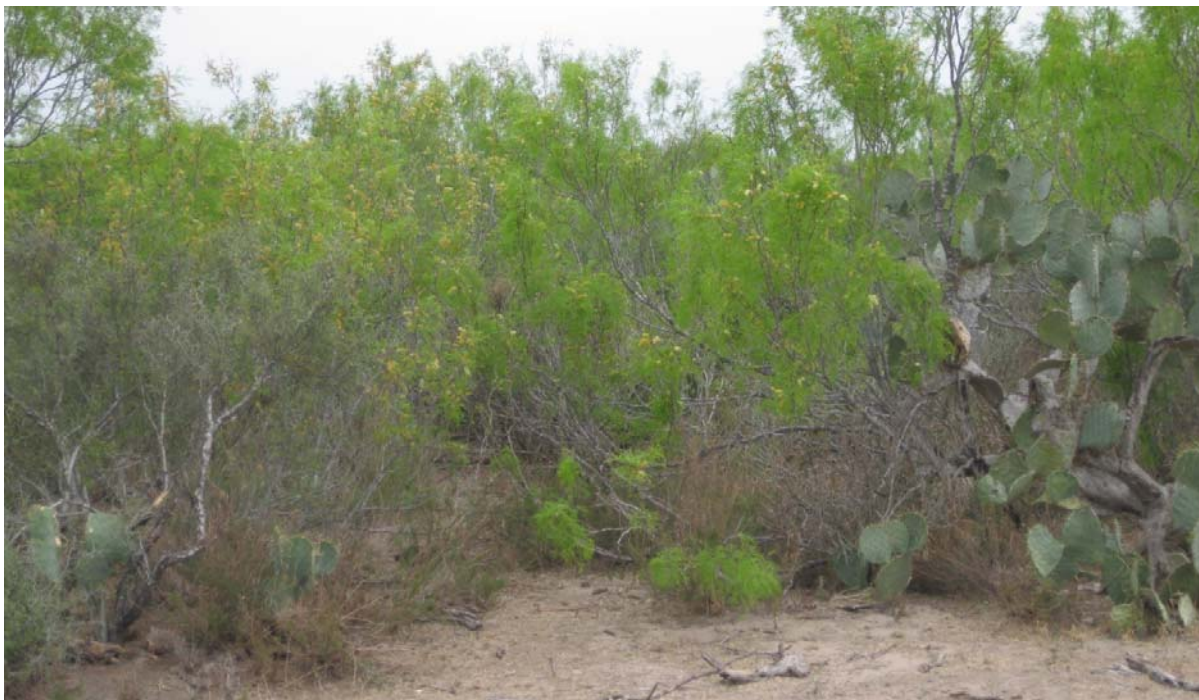
Photo 1. Typical Aguilares fine sandy loam vegetation. Dominant species included honey mesquite and Texas prickly pear.

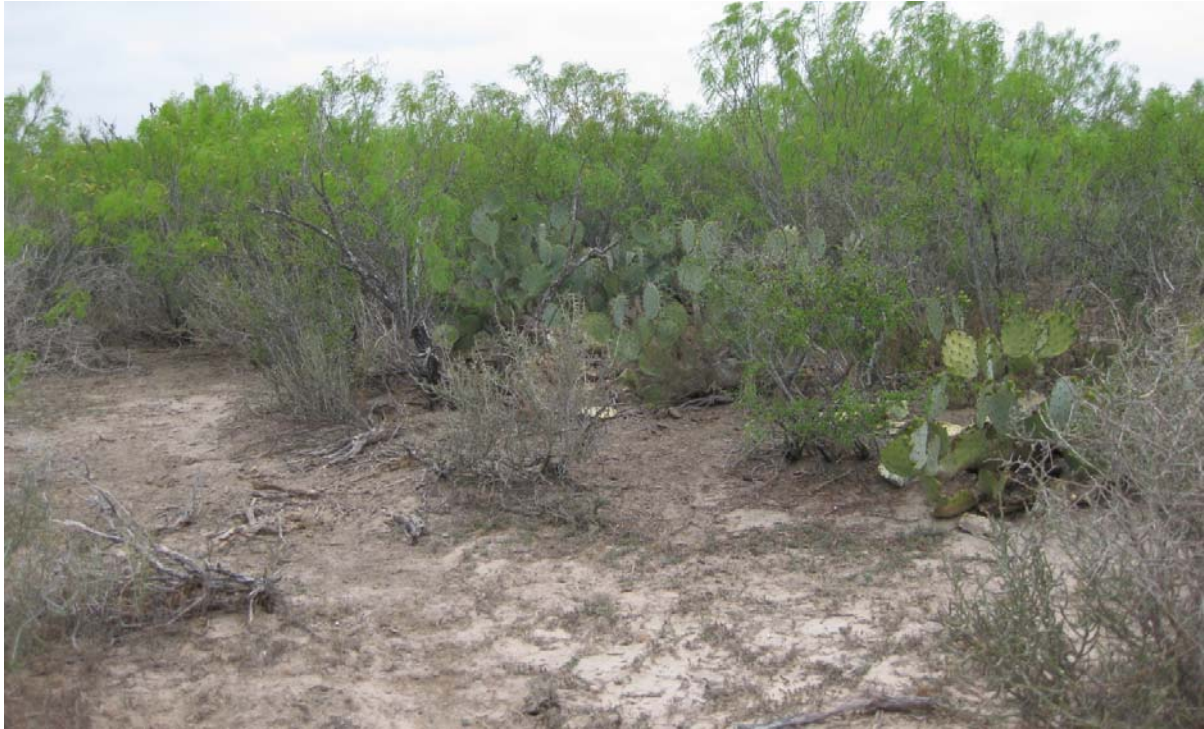
Photo 2. Typical Aguilares fine sandy loam vegetation. A mosaic of bare ground was present throughout this soil map unit.

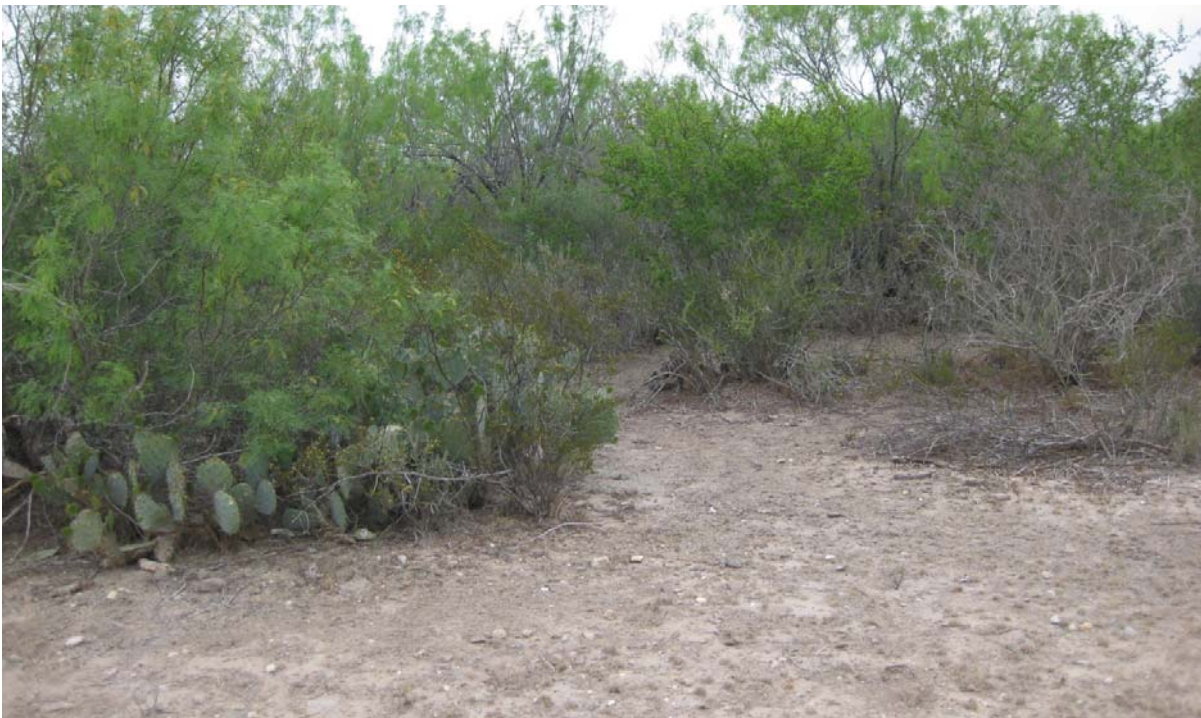
Photo 3. Typical Aguilares fine sandy loam vegetation. Dense vegetation was present in many areas.

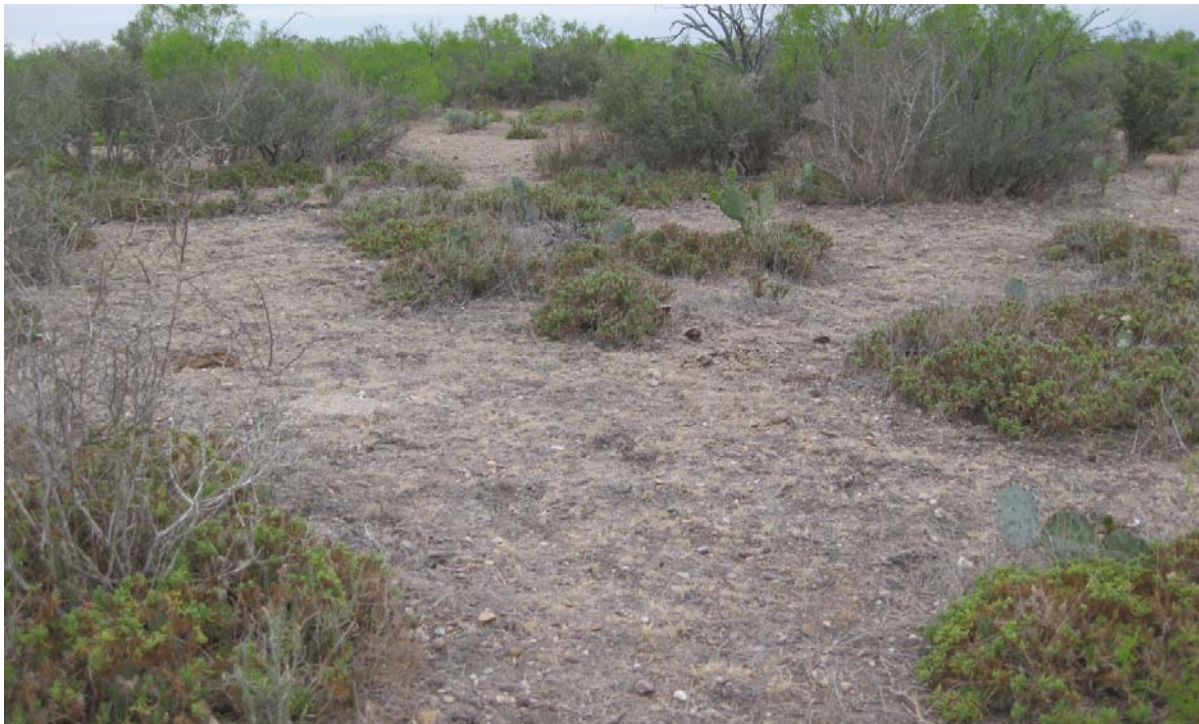
Photo 4. Typical Montell clay vegetation. Many areas consisted of a mosaic of saladillo and Texas prickly pear clusters, bare ground, and clusters of other woody species.

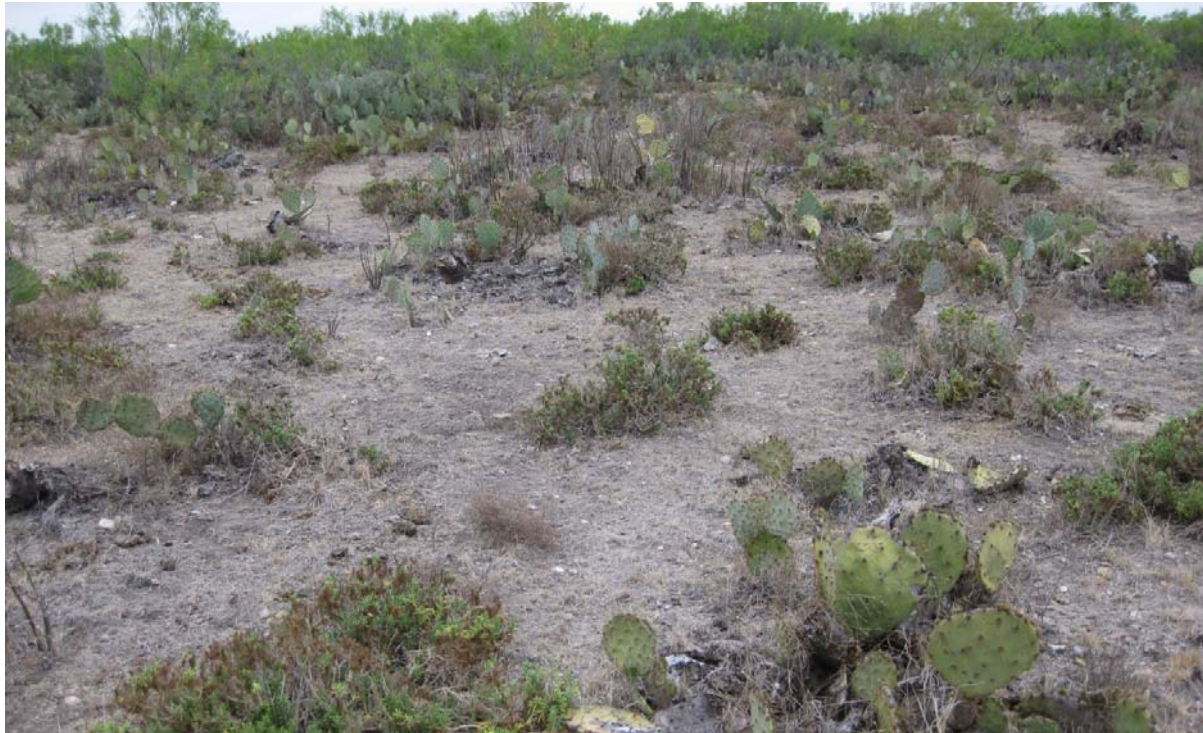
Photo 5. Typical Montell clay vegetation. Some areas exhibited increased vegetation density(background).

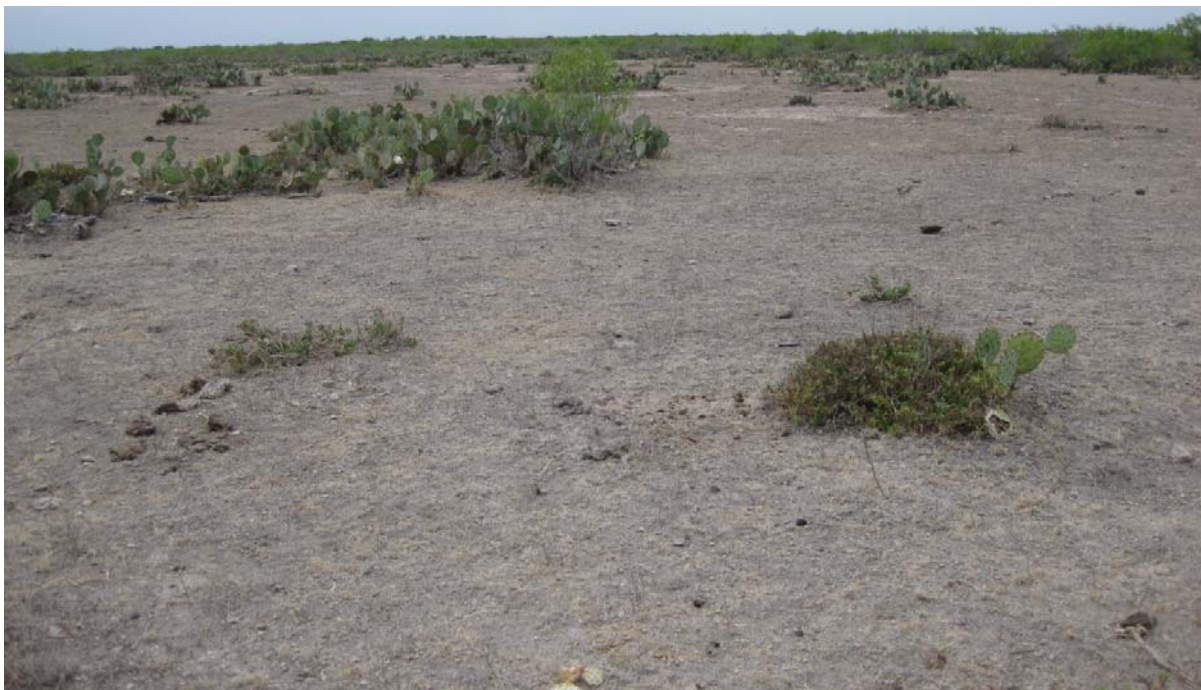
Photo 6. Typical Montell clay vegetation. In many areas, bare ground was the dominant landscape feature.

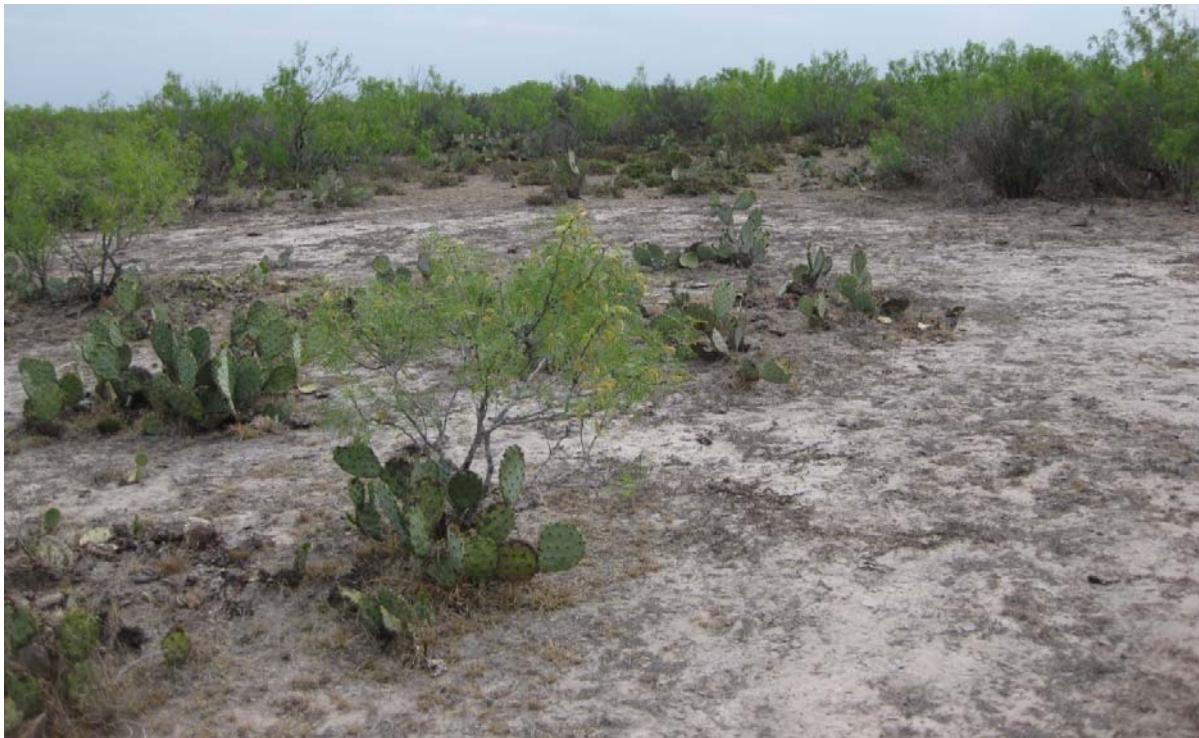
Photo 7. Typical Catarina clay vegetation. In some areas, bare ground was the dominant landscape feature.

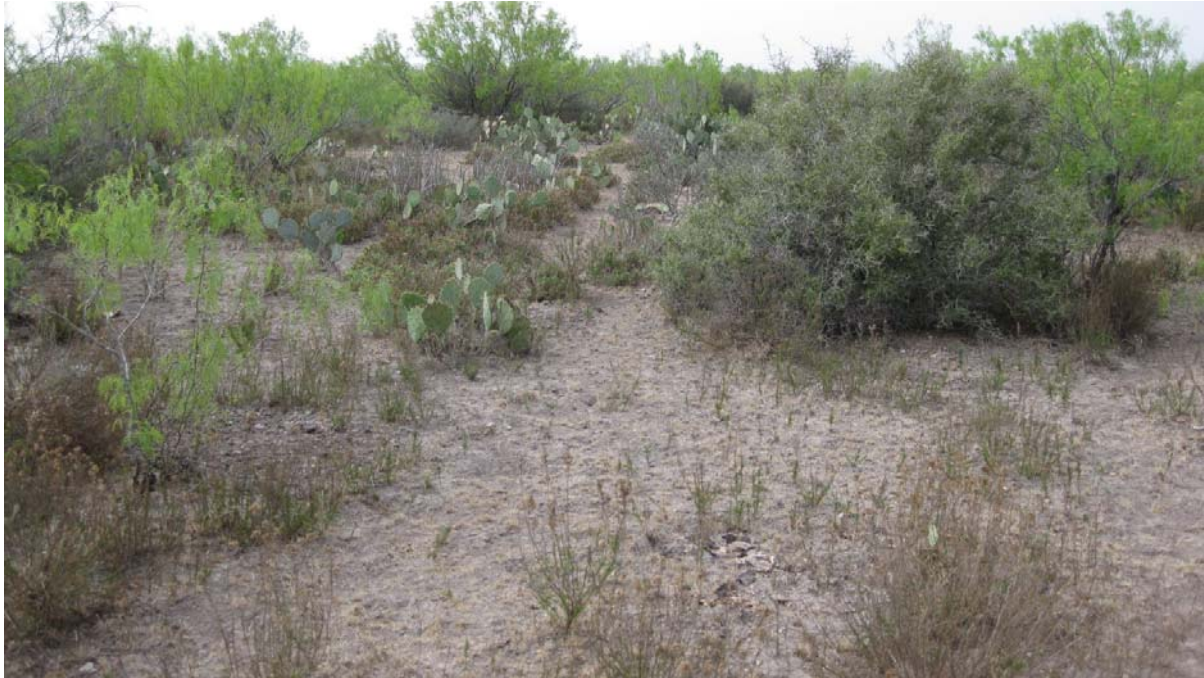
Photo 8. Typical Catarina clay vegetation. Severe overgrazing was evident throughout the Project area.

Vegetation throughout the Project survey area has been affected by the presence of cattle. Severe overgrazing was observed throughout nearly all of the Project survey area, making identification of some vegetation (e.g., herbaceous species) impossible. Soil compaction, likely a result of the presence of cattle, was also observed in many areas, particularly around stock tanks WB104, WB128 and the wetlands associated with those systems. Subsequently, identification of wetland indicators was difficult in some areas.

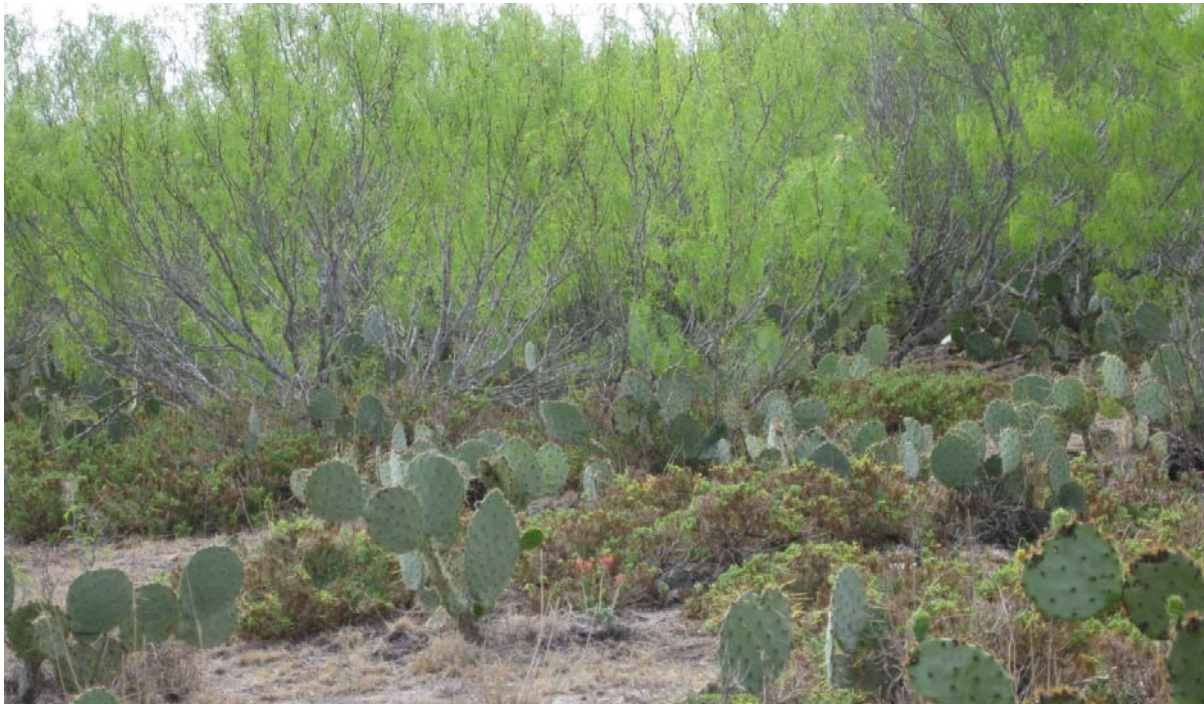
Photo 9. Typical Catarina clay vegetation. Increased vegetation density was located in the southeastern Catarina clay soil map unit.

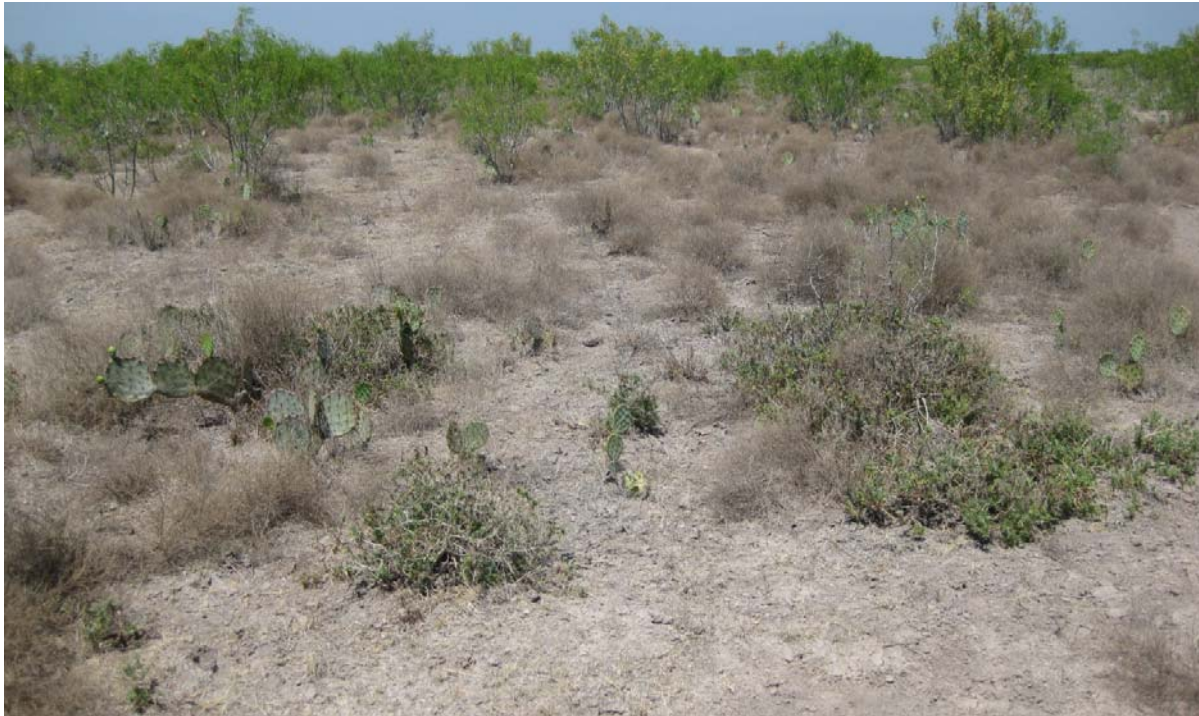
Photo 10. Typical Catarina clay vegetation. Within the western Catarina clay soil map unit, broomweed was an additional dominant species.

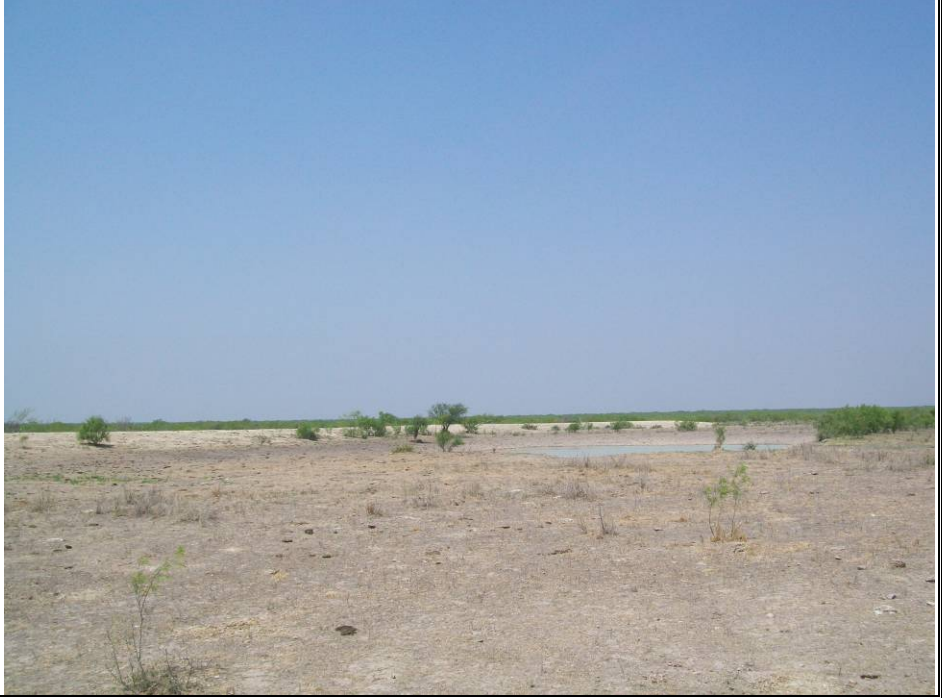
Client: Rancho Viejo Waste Management, LLC		Project Number: 182277
Project Name: Pescadito Environmental Resource Center		County, State: Webb County, Texas
Photograph ID: 1

Feature: Stock Tank WB101		
Date: 4/19/2011		
Comments: Stock tank WB101 in northeastern portion of project area. Facing north.		
Photograph ID: 2

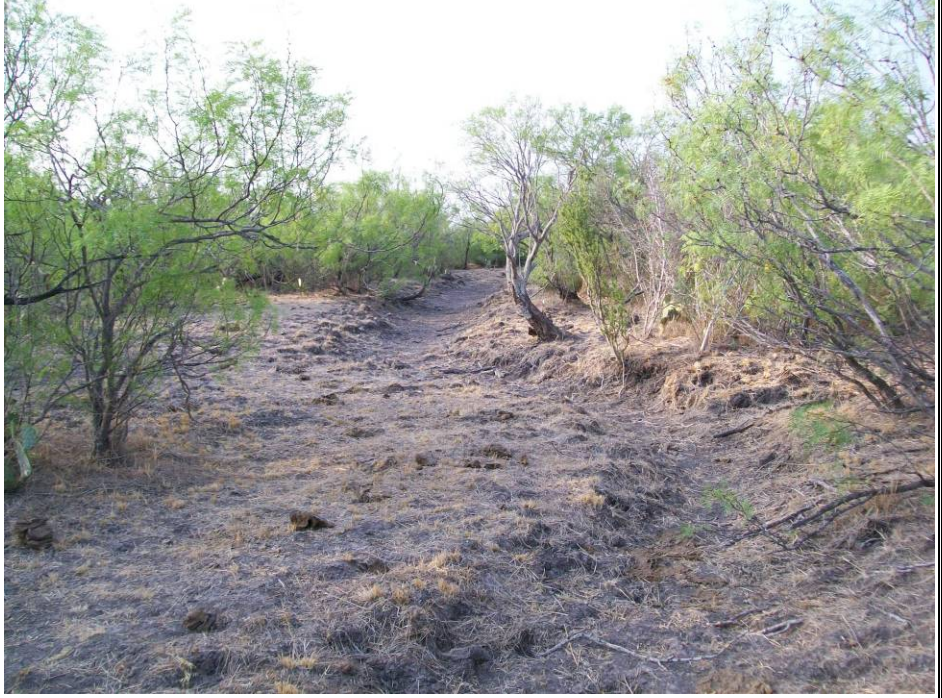
Feature: Stream S123		
Date: 4/21/2011		
Comments: Ephemeral stream S123 in northwestern portion of project area. Facing downstream (south).

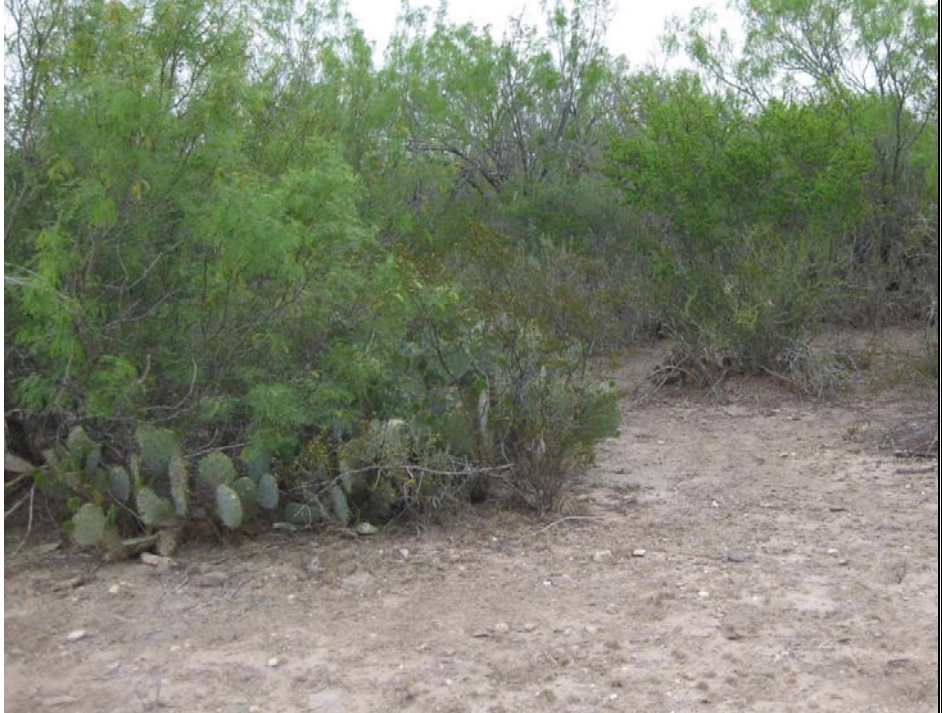
Client: Rancho Viejo Waste Management, LLC		Project Number: 182277
Project Name: Pescadito Environmental Resource Center		County, State: Webb County, Texas
Photograph ID: 3

Feature: Northwestern portion of project area		
Date: March 2011		
Comments: Typical Aguilares fine sandy loam vegetation. Moderately dense vegetation was present in many areas with a mosaic of bare ground present throughout this soil map unit.		
Photograph ID: 4

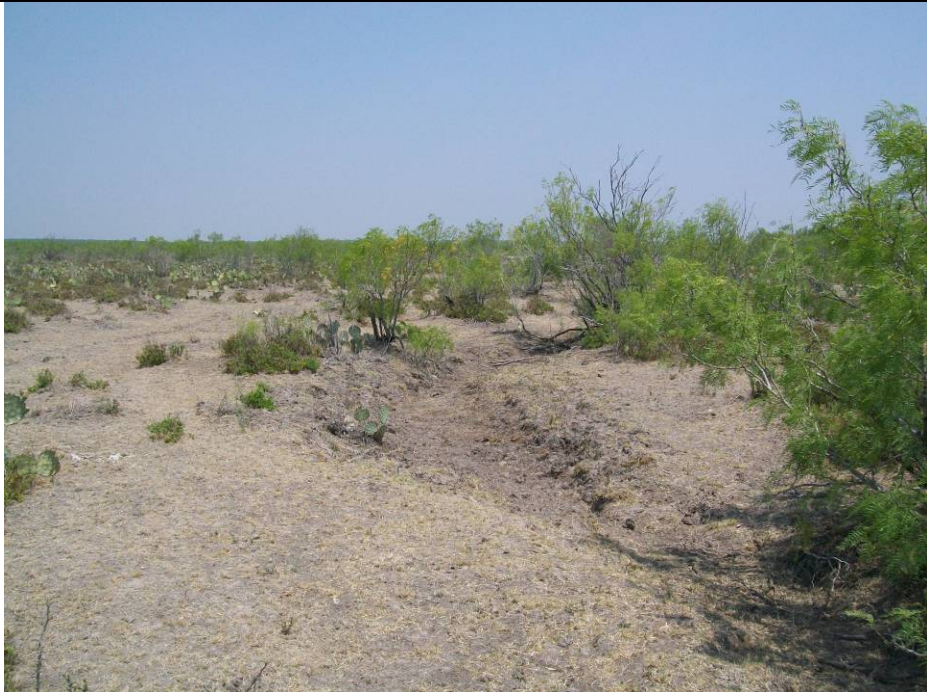
Feature: Stream S103			
Date: 4/19/2011			
Comments: Ephemeral stream S103 in central portion of the project area. Facing north (upstream).			
Photograph ID: 6

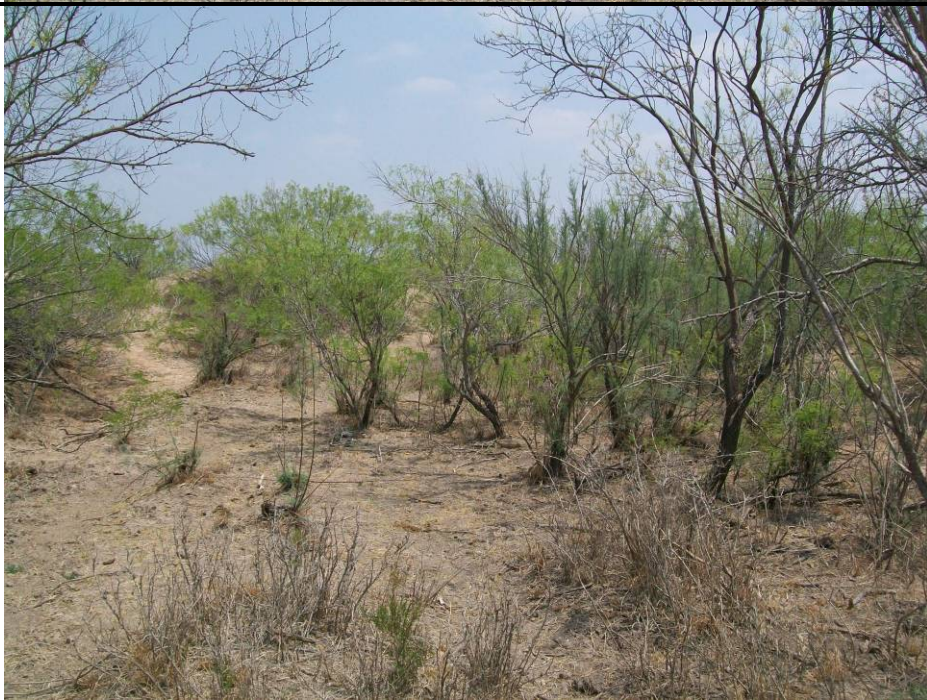
Feature: Stream S120			
Date: 4/20/2011			
Comments: Ephemeral stream S120 (left of photo) in west-central portion of project area. Facing east (downstream).

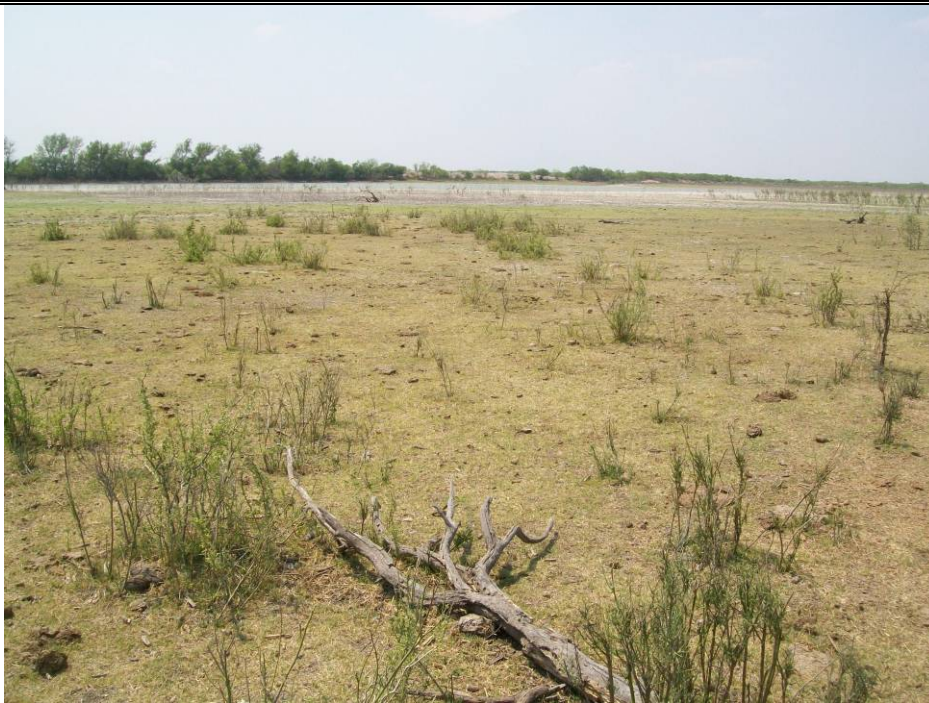
Feature: Wetland and Stock Tank WB128		
Date: 4/21/2011		
Comments: Fringe area of wetland W127 near large stock tank in southern portion of project area. Stock tank in background. Facing southwest.

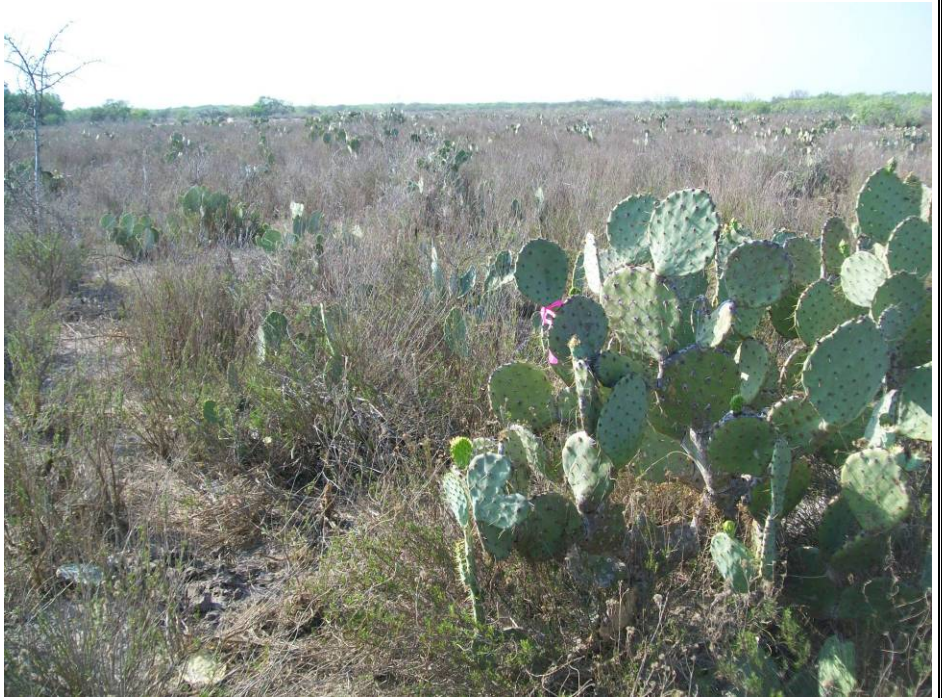
Client: Rancho Viejo Waste Management, LLC		Project Number: 182277
Project Name: Pescadito Environmental Resource Center		County, State: Webb County, Texas
Photograph ID: 9

Feature: Upland habitat; southern portion of site		
Date: 4/21/2011		
Comments: Upland habitat near large stock tank in southern portion of the project area. Facing northwest.		
Photograph ID: 10

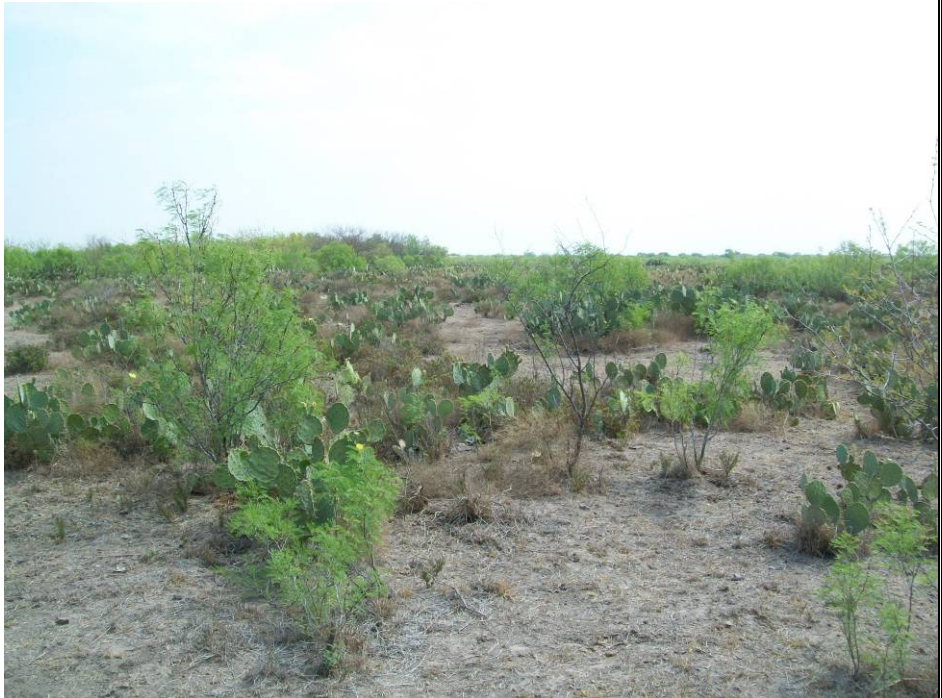
Feature: Upland Habitat; southwest portion of site		
Date: 4/20/2011		
Comments: Upland habitat at in southwestern portion of project area. Facing east.

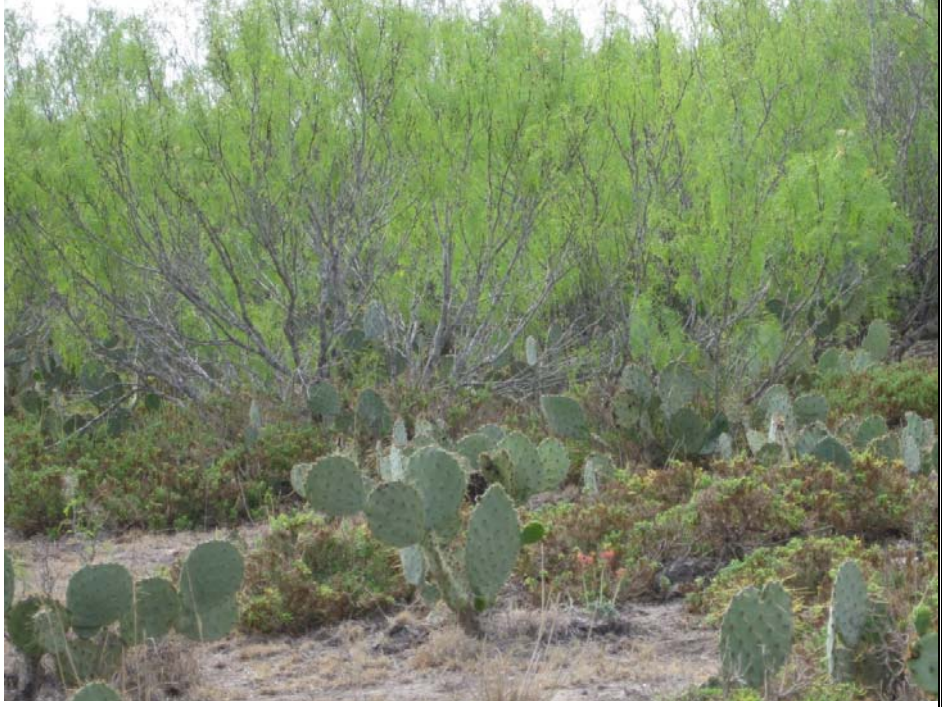
Client: Rancho Viejo Waste Management, LLC		Project Number: 182277
Project Name: Pescadito Environmental Resource Center		County, State: Webb County, Texas
Photograph ID: 11

Feature: Typical Habitat; southeastern portion of site		
Date: March 2011		
Comments: Typical habitat in the southeastern portion of the project area.
