**Reference: Pescadito Environmental Resource Center – Webb County
Municipal Solid Waste (MSW) – Proposed Permit No. 2374
Supplemental Response to Parts I and II Application
CN603835489/RN106119639**

Attachment A
Site Visit Summary of Findings and
Recommendations

Subject: **Site Visit Summary of Findings and Recommendations — Rancho Viejo, Webb County, Texas Proposed Landfill**

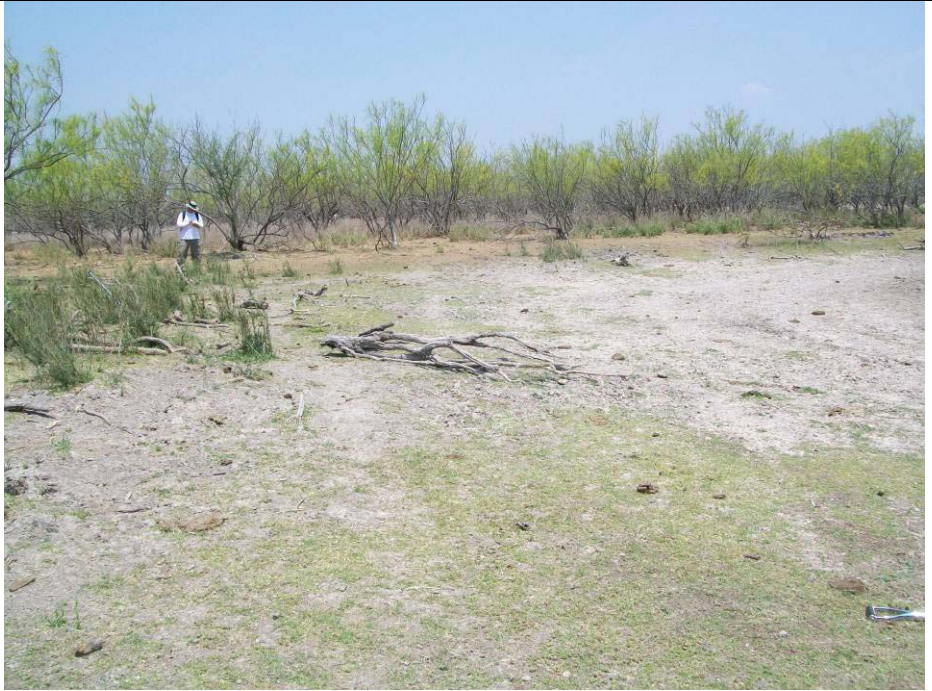
Feature: Wetland W133 and Stock Tank W1B104		
Date: 4/21/2011		
Comments: Wetland W133 (background) at the edge of stock tank WB104 (foreground). Facing north.

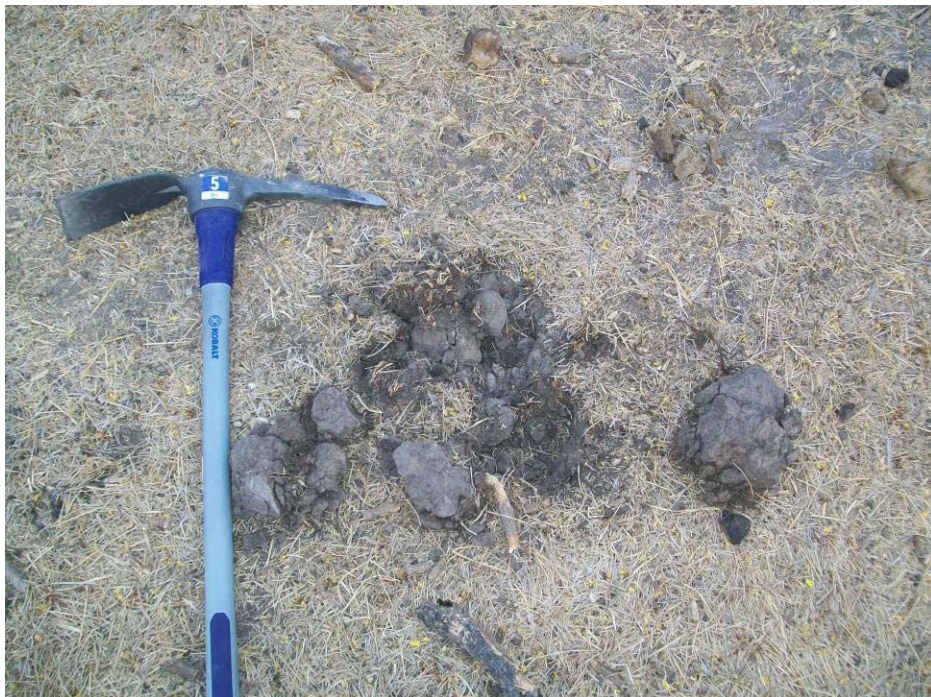
Feature: Soil at W133-WDP			
Date: 4/19/2011			
Comments: Soil at W133-WDP wetland data point.

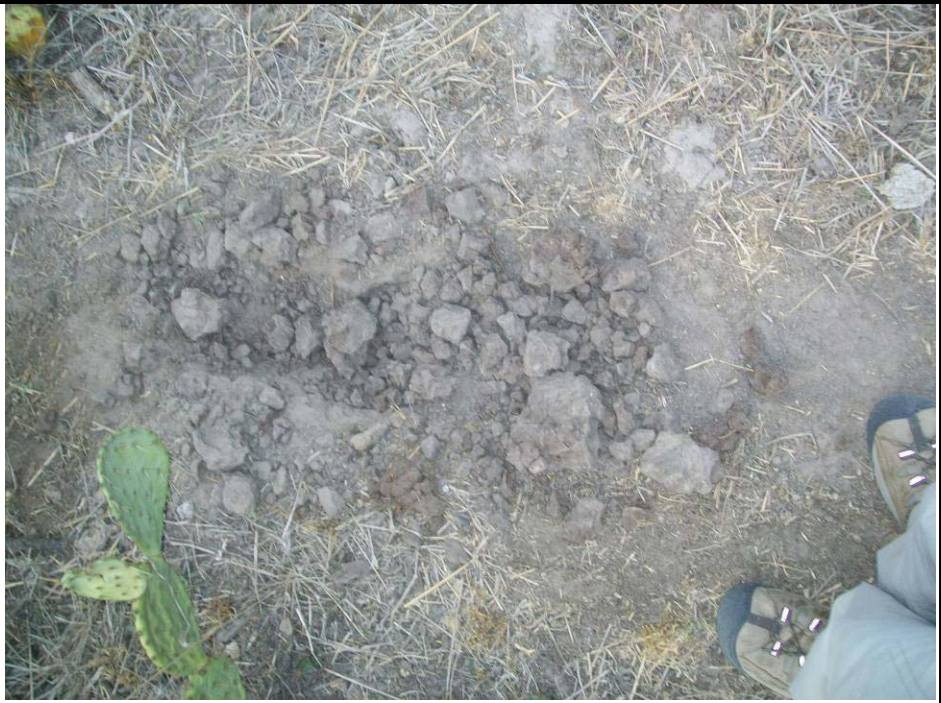
Feature: Soil at W133-UDP			
Date: 4/20/2011			
Comments: Soil at W133-UDP upland data point.

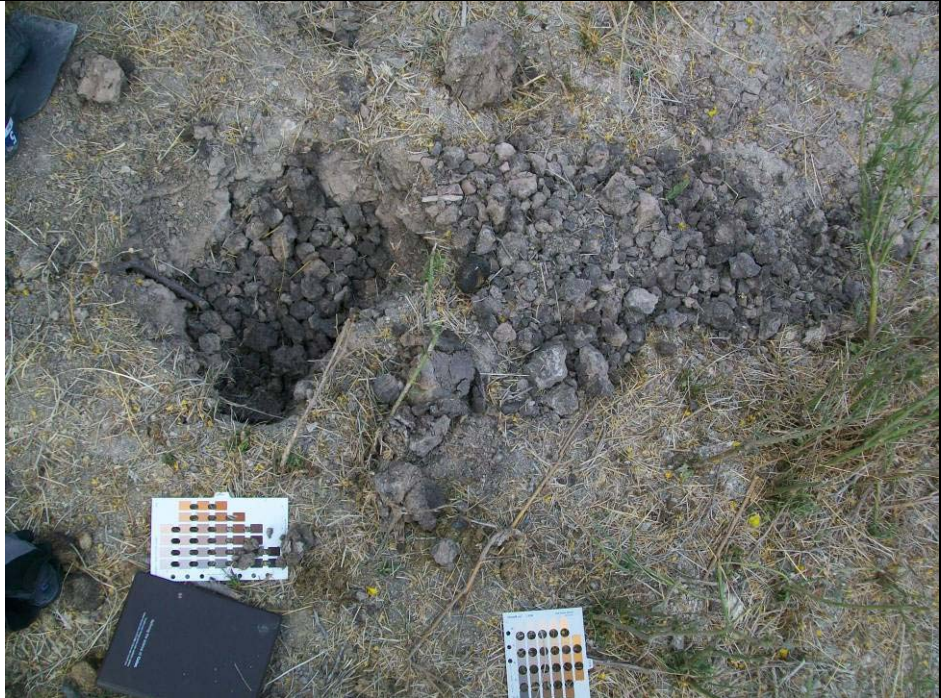
Feature: Soil at W109-WDP			
Date: 4/20/2011			
Comments: Soil profile at W109-WDP wetland data point.			
Photograph ID: 14		 	
Feature: Upland habitat at W109-UDP			
Date: 4/20/2011			
Comments: Upland habitat at W109-UDP upland data point. Facing north.

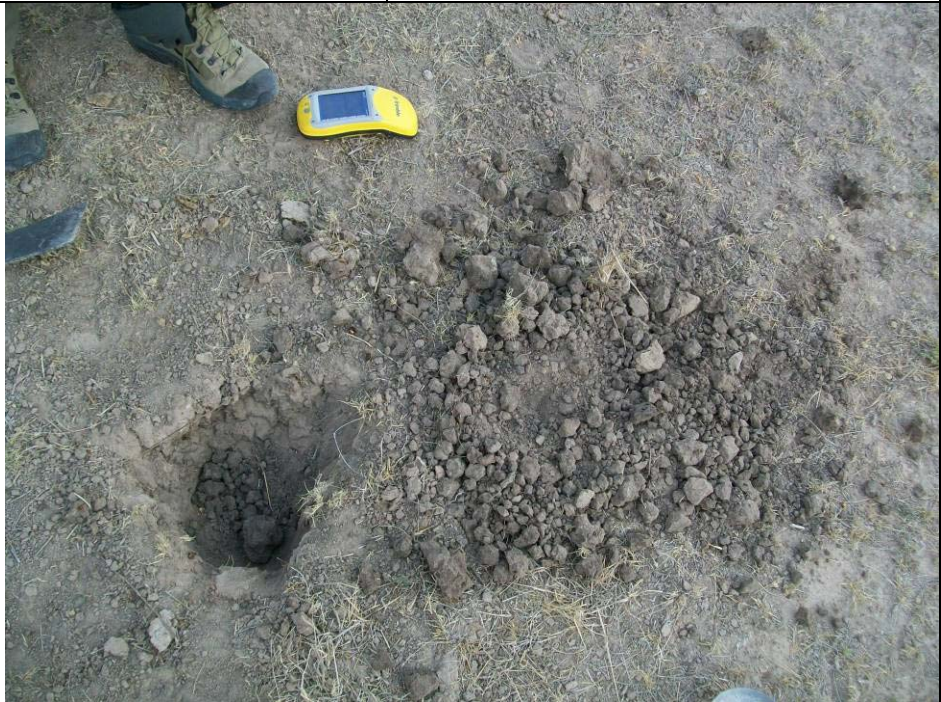
Client: Rancho Viejo Waste Management, LLC		Project Number: 182277	
Project Name: Pescadito Environmental Resource Center		County, State: Webb County, Texas	
Photograph ID: 15

Feature: Soil at W109-UDP			
Date: 4/20/2011			
Comments: Soil profile at W109-UDP upland data point.			
Photograph ID: 16

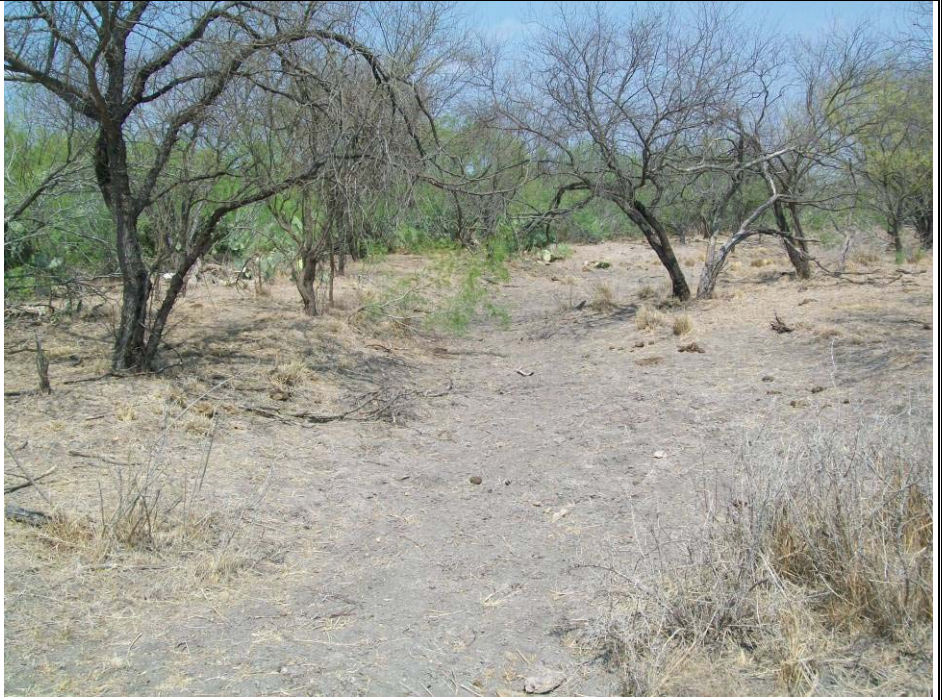
Client: Rancho Viejo Waste Management, LLC		Project Number: 182277
Project Name: Pescadito Environmental Resource Center		County, State: Webb County, Texas
Photograph ID: 25

Feature: Wetland W118		
Date: 4/20/2011		
Comments: Wetland W118, located within an abandoned drainage channel created by stock tank construction. Facing north.		
Photograph ID: 26	 	
Feature: Stream S116		
Date: 4/20/2011		
Comments: Ephemeral stream S116. Facing north (upstream).

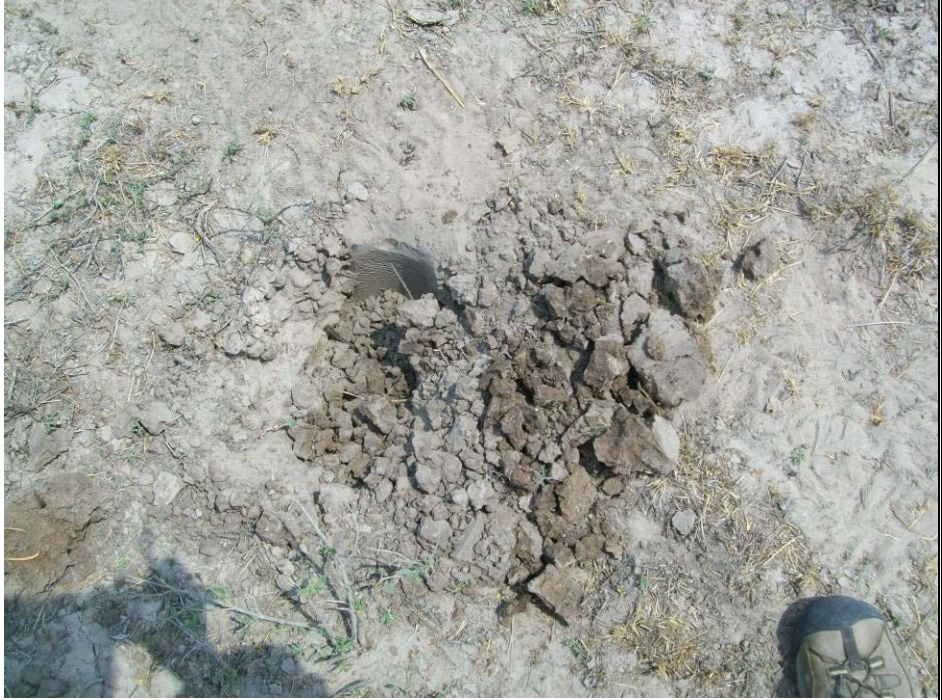
Client: Rancho Viejo Waste Management, LLC		Project Number: 182277
Project Name: Pescadito Environmental Resource Center		County, State: Webb County, Texas
Photograph ID: 35

Feature: Soil at W126-UDP		
Date: 4/21/2011		
Comments: Soil at W126-UDP upland data point.		
Photograph ID: 36	 	
Feature: Wetland W127 at W127-WDP1		
Date: 4/21/2011		
Comments: Wetland W127 at W127-WDP1. Facing south.

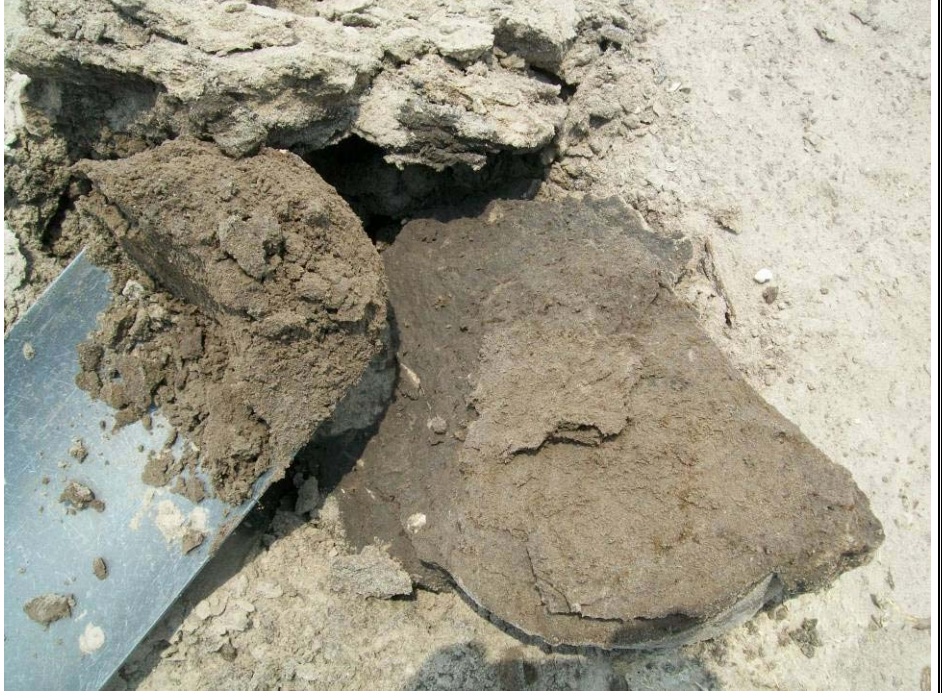
Feature: Soil at W127		
Date: 4/21/2011		
Comments: Hydric soil at sparsely vegetated area of W127.		
Photograph ID: 40	 	
Feature: Upland habitat at W127-UDP1		
Date: 4/21/2011		
Comments: Upland habitat at W127-UDP1 upland data point. Facing north.

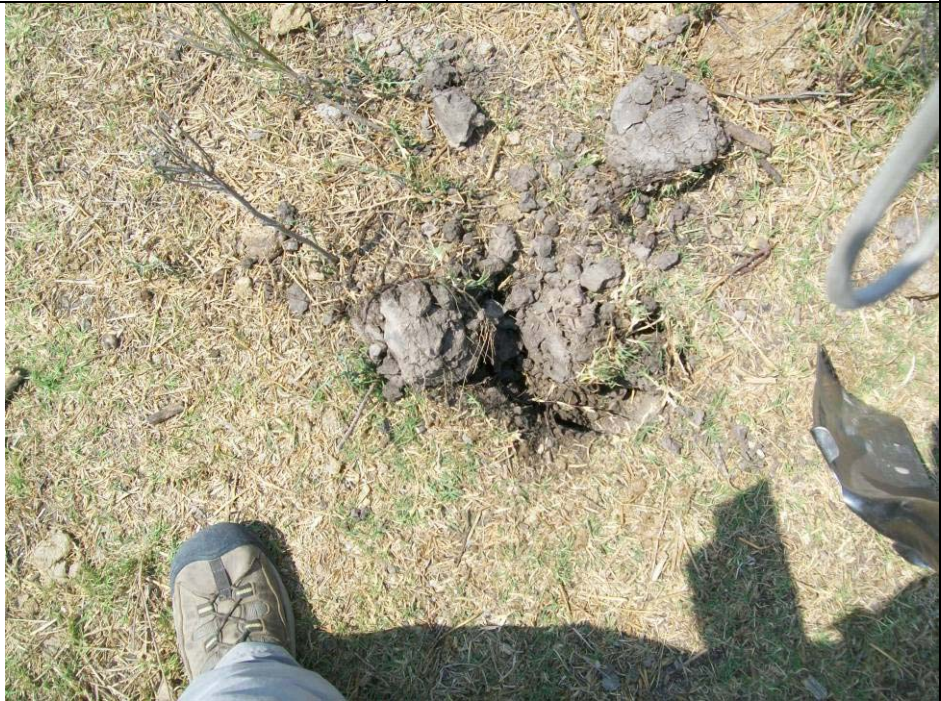
Feature: Soil at W127-WDP2			
Date: 4/21/2011			
Comments: Soil at W127-WDP2 wetland data point.			
Photograph ID: 44

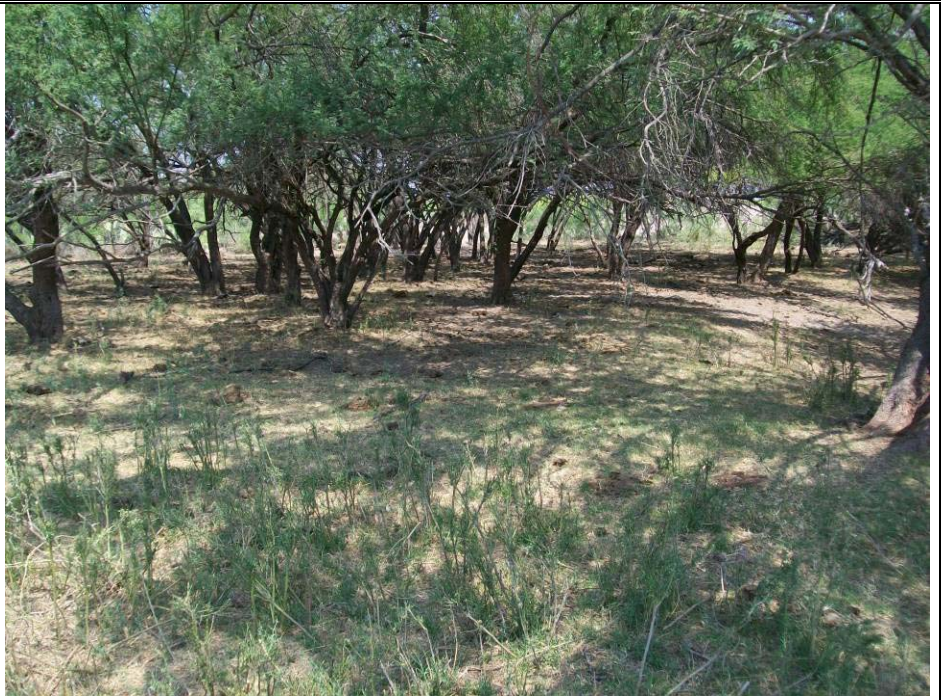
Feature: Upland habitat at W127-UDP2			
Date: 4/21/2011			
Comments: Upland habitat at W127-UDP2 upland data point. Facing southeast.

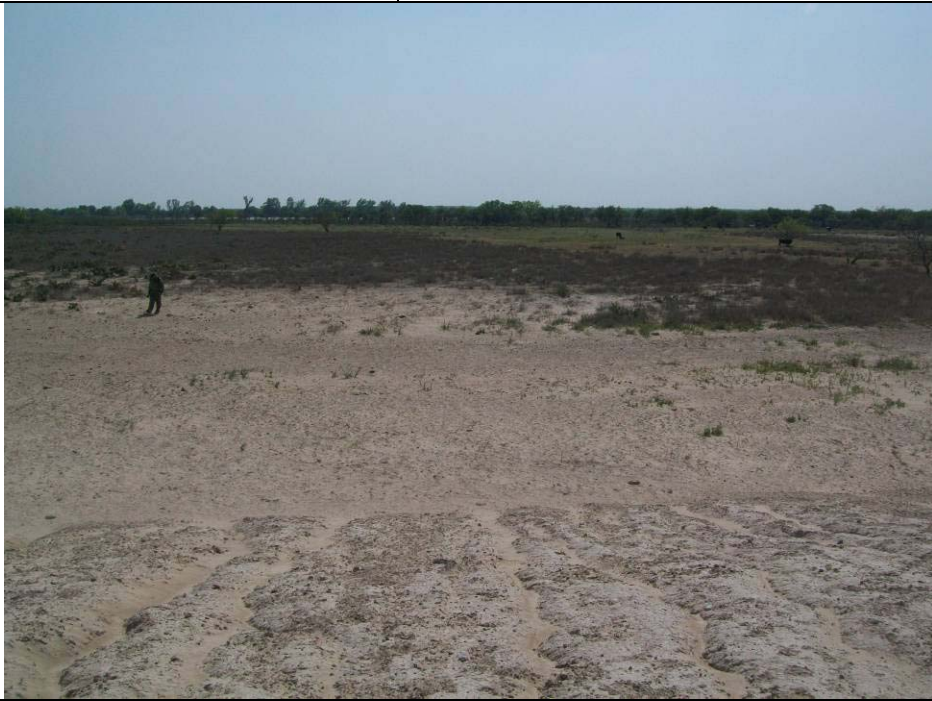
Feature: Wetland W127 at W104 Impoundment			
Date: 4/21/2011			
Comments: Wetland W127 (background) at W104 impoundment (foreground). Facing south.			
Photograph ID: 48

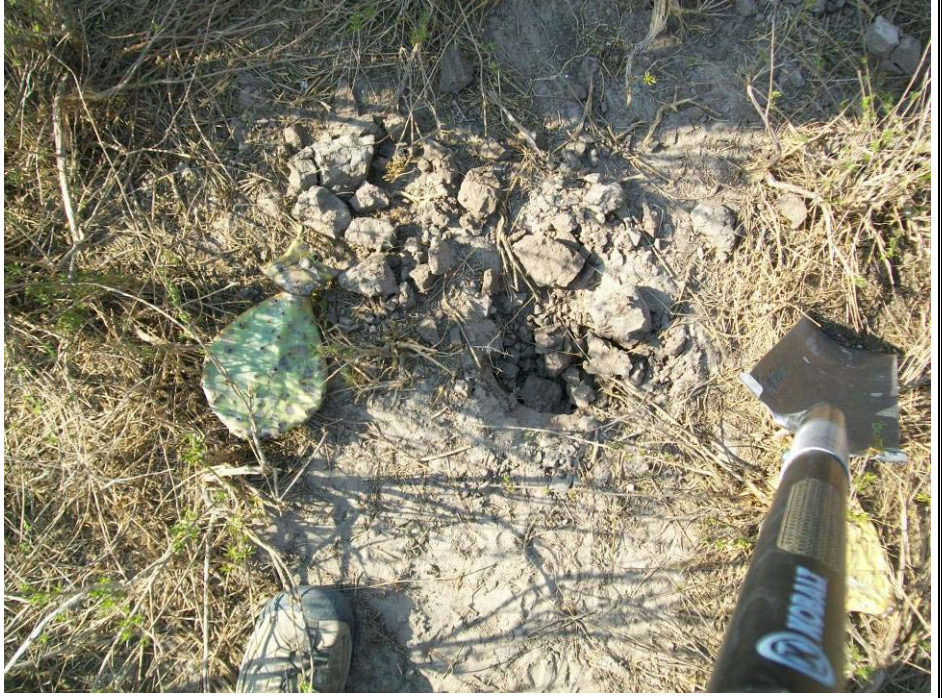
Feature: Soil at W12/W130-UDP		
Date: 4/21/2011		
Comments: Soil at W127/W130- UDP upland data point.		
Photograph ID: 52

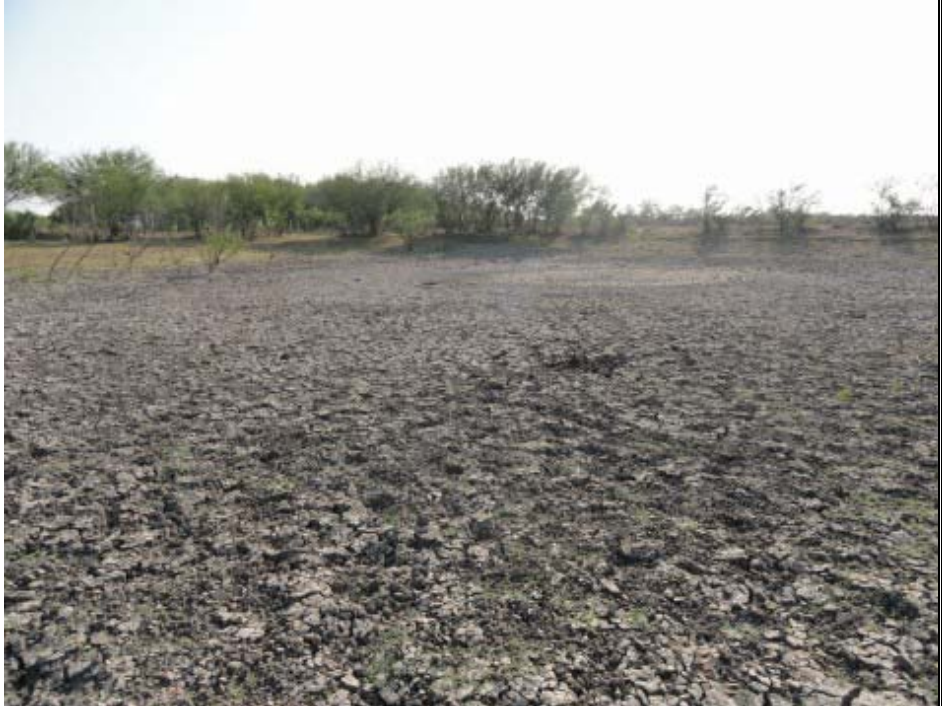
Feature: Stock Tank WB131		
Date: 4/21/2011		
Comments: Stock tank WB131. Facing west.

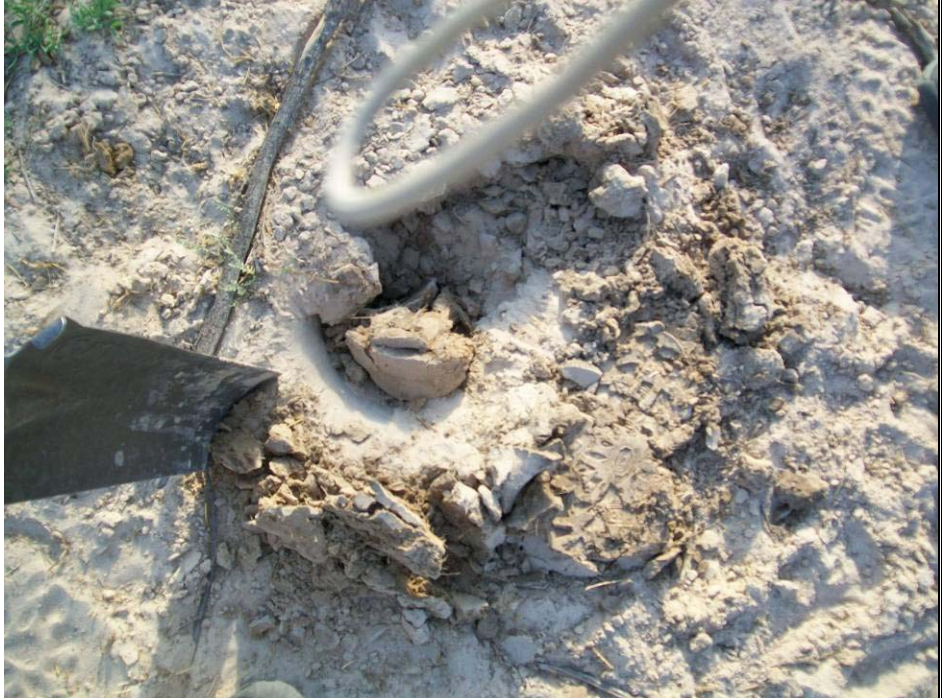
Feature: Soil at W132-WDP		
Date: 4/21/2011		
Comments: Soil at W132-WDP wetland data point.
