**Part III  
Attachment III-E  
Appendix III-E.5**

**SUPPLEMENTAL SUBSURFACE INVESTIGATION REPORT  
PHASE V**

**Pescadito Environmental Resource Center  
MSW No. 2374  
Webb County, Texas**

**Prepared by:  
CB&I Environmental and  
Infrastructure, Inc.**

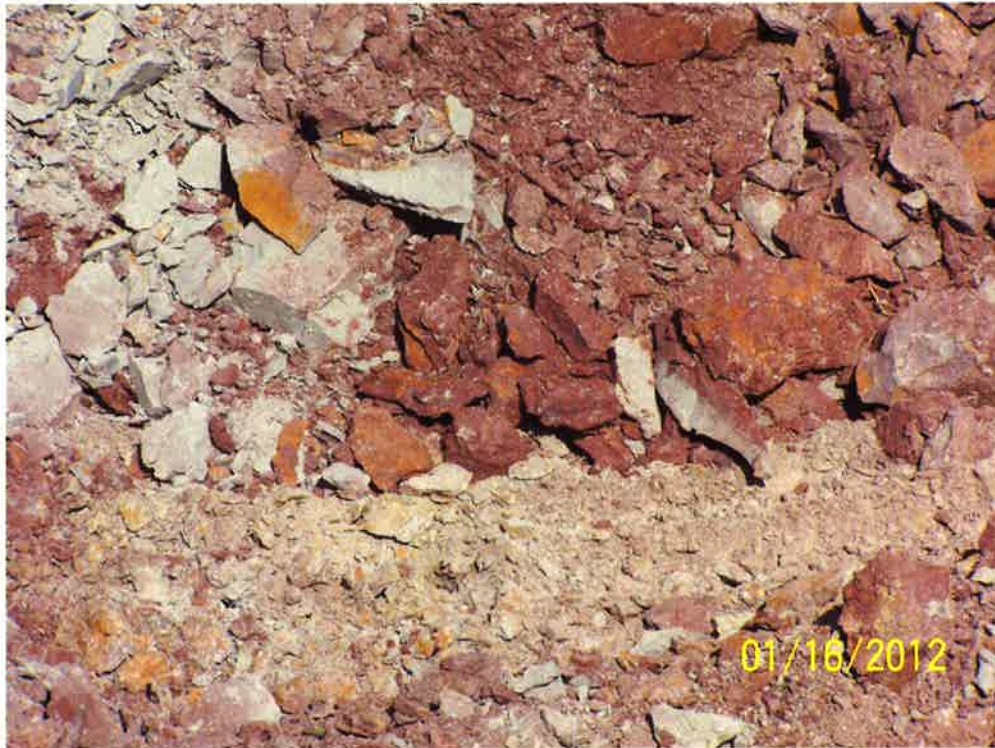
**Photo 1 - Test Pit 1 - January 2012**

The Y-J encountered at the site is predominantly (>90%) “claystone” with minor amounts of “sandstone” and “siltstone.” The encountered Y-J materials appear “rock-like” due to the fact that they have been heavily over-consolidated during their geologic history. In essence they are “compaction” claystones as opposed to cemented claystones. However, when exposed to the elements for a brief period or when processed, these rock-like materials quickly regain their soil identities. This rapid transformation is due to the fact that the “claystones” have a blocky, intensely-fissured structure (see Photo 1 - Test Pit - January 2012). A good example of the transformation is evident from the Phase IV test pits (See Photo 2 - Test Pit 1 January 2015 below). Other examples are the various dams constructed in the immediate area where only the Y-J colors remain, the rock-like materials have transformed back to soil.

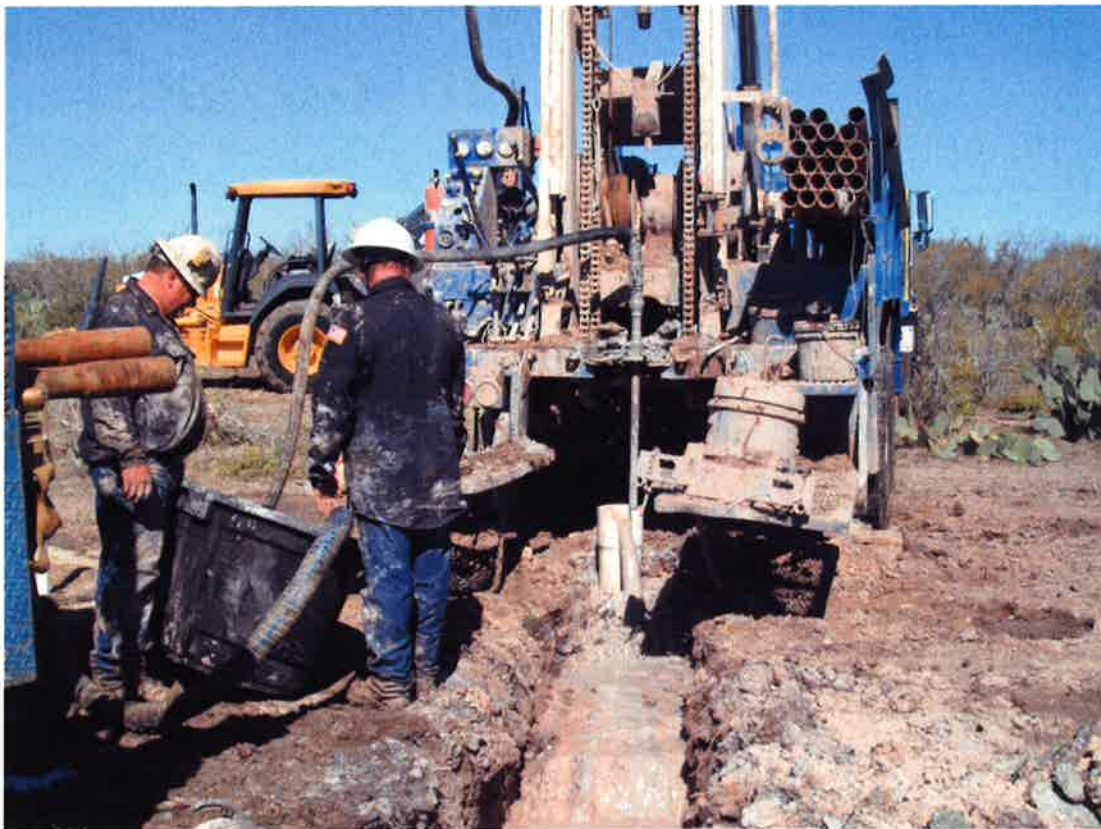
**Photo 3 - Grouting Boring B-52 – January 2015**

Sample drilling of the Y-J was conducted using a conventional Christensen 4-5/8 x 3-inch double tube core barrel employing a face-discharge ChrisDril bit and equipped with a split inner barrel. See photos 1 and 2 in Attachment C to this Appendix (III-E.5-C). Sample borings were cored continuously to the total depth with the recovered core being 3-inches in diameter. Both core recovery (as a percent) and Rock Quality Index or RQD (as a percent) are provided for each core run on the boring log. Recovered core was logged along with drilling observations, etc. Core samples were packaged and placed in waxed core boxes specifically manufactured for core storage. Visual reference samples were placed in glass jars. Boring B-58 was converted to a piezometer while borings B-55 and B-52 were pressure grouted from the bottom to top using a tremie and bentonite grout.

Two piezometers were set at the B-52 location – P-52S or shallow and P-52D or deep. Both piezometers were drilled with air rotary in separate holes for accurate subsurface water identification possibly unavailable from the original B-52 boring. Since the original B-52 was drilled using mud-rotary techniques, the process could have masked the identification of limited subsurface water and produced the results shown as moist on the log of borings. The "twin" holes were also used to avoid potential problems associated with plugging the original borehole back up to the desired screen interval.

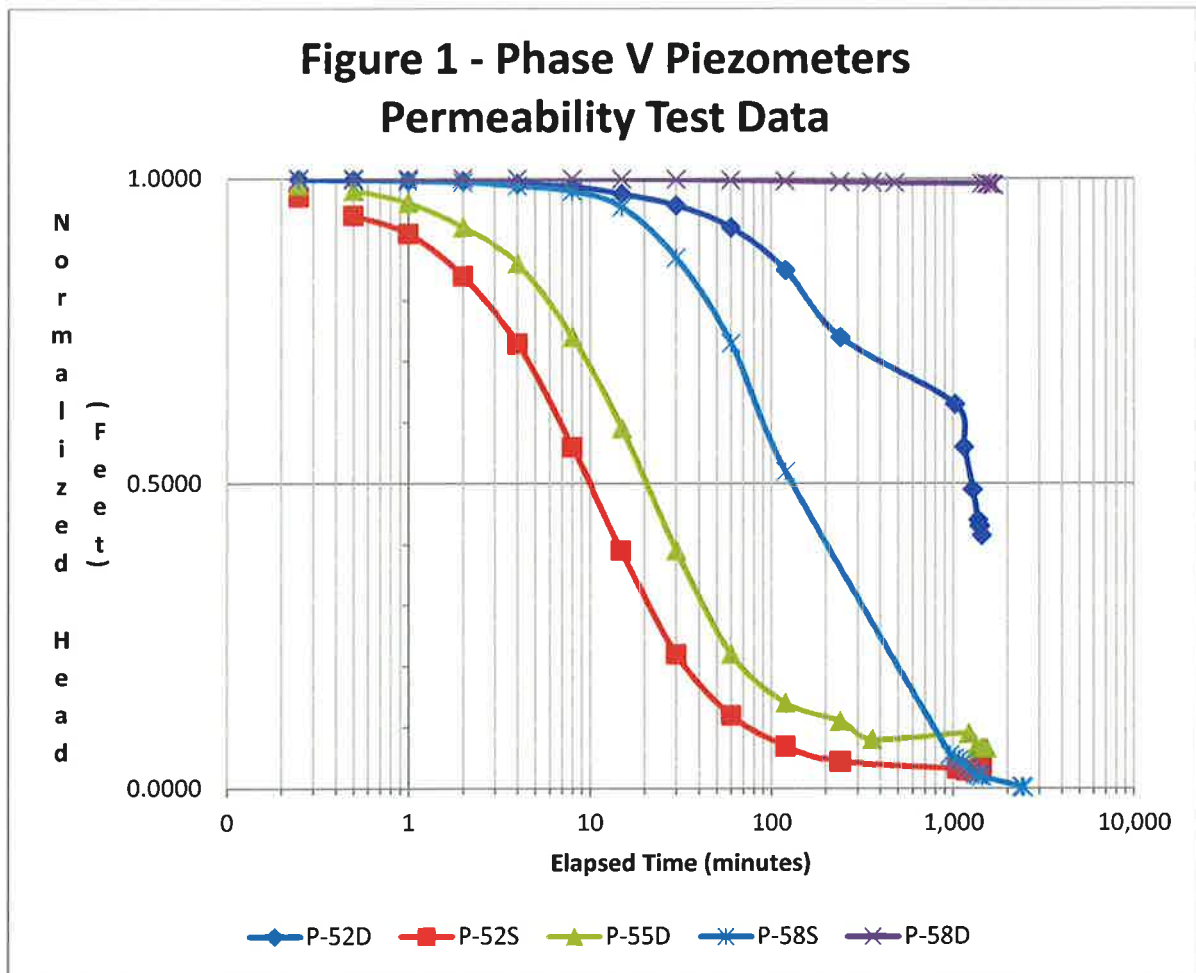
Figure 1 – Phase V Piezometers – Permeability Test Data .....	13
---	----

Piezometer recovery test data was obtained through February 14, 2015 for all five of the Phase V piezometers. Although recovery was not complete for all tests, the data for four piezometers was sufficiently complete for analysis. Semi-logarithmic plotting of the data indicated a classic or typical response with a good straight-line section in the middle of the signature. Points defining the ends of the straight lines on the graphs were picked from the tabular data. In addition, all data were tabulated and plotted in “normalized” form, i.e., the piezometer head reading at a given time was divided by the head reading at time zero. This procedure allows comparative

plotting of all piezometer tests to the same scale and is a useful tool to compare differences between geologic units, etc. See Figure 1.

Hvorslev's Variable Head Method "F" (Hvorslev, 1951) was selected for the preliminary analysis. Method F may provide a more realistic estimate for a "sand" unit between "confining layers." In addition, Method F provides a more conservative (higher) estimate of horizontal permeability than Method G. It should be noted that Method G is for a screen / filterpack in a uniform matrix without confining layers. Method G would also be potentially more applicable to the conditions at P-58S set in a shallow moist claystone interval. The Anisotropy ratio,  $m$ , was based on the typical assumption that horizontal permeability is at least 10 times the vertical permeability for bedded sedimentary materials. Note also that by assuming an anisotropy ratio

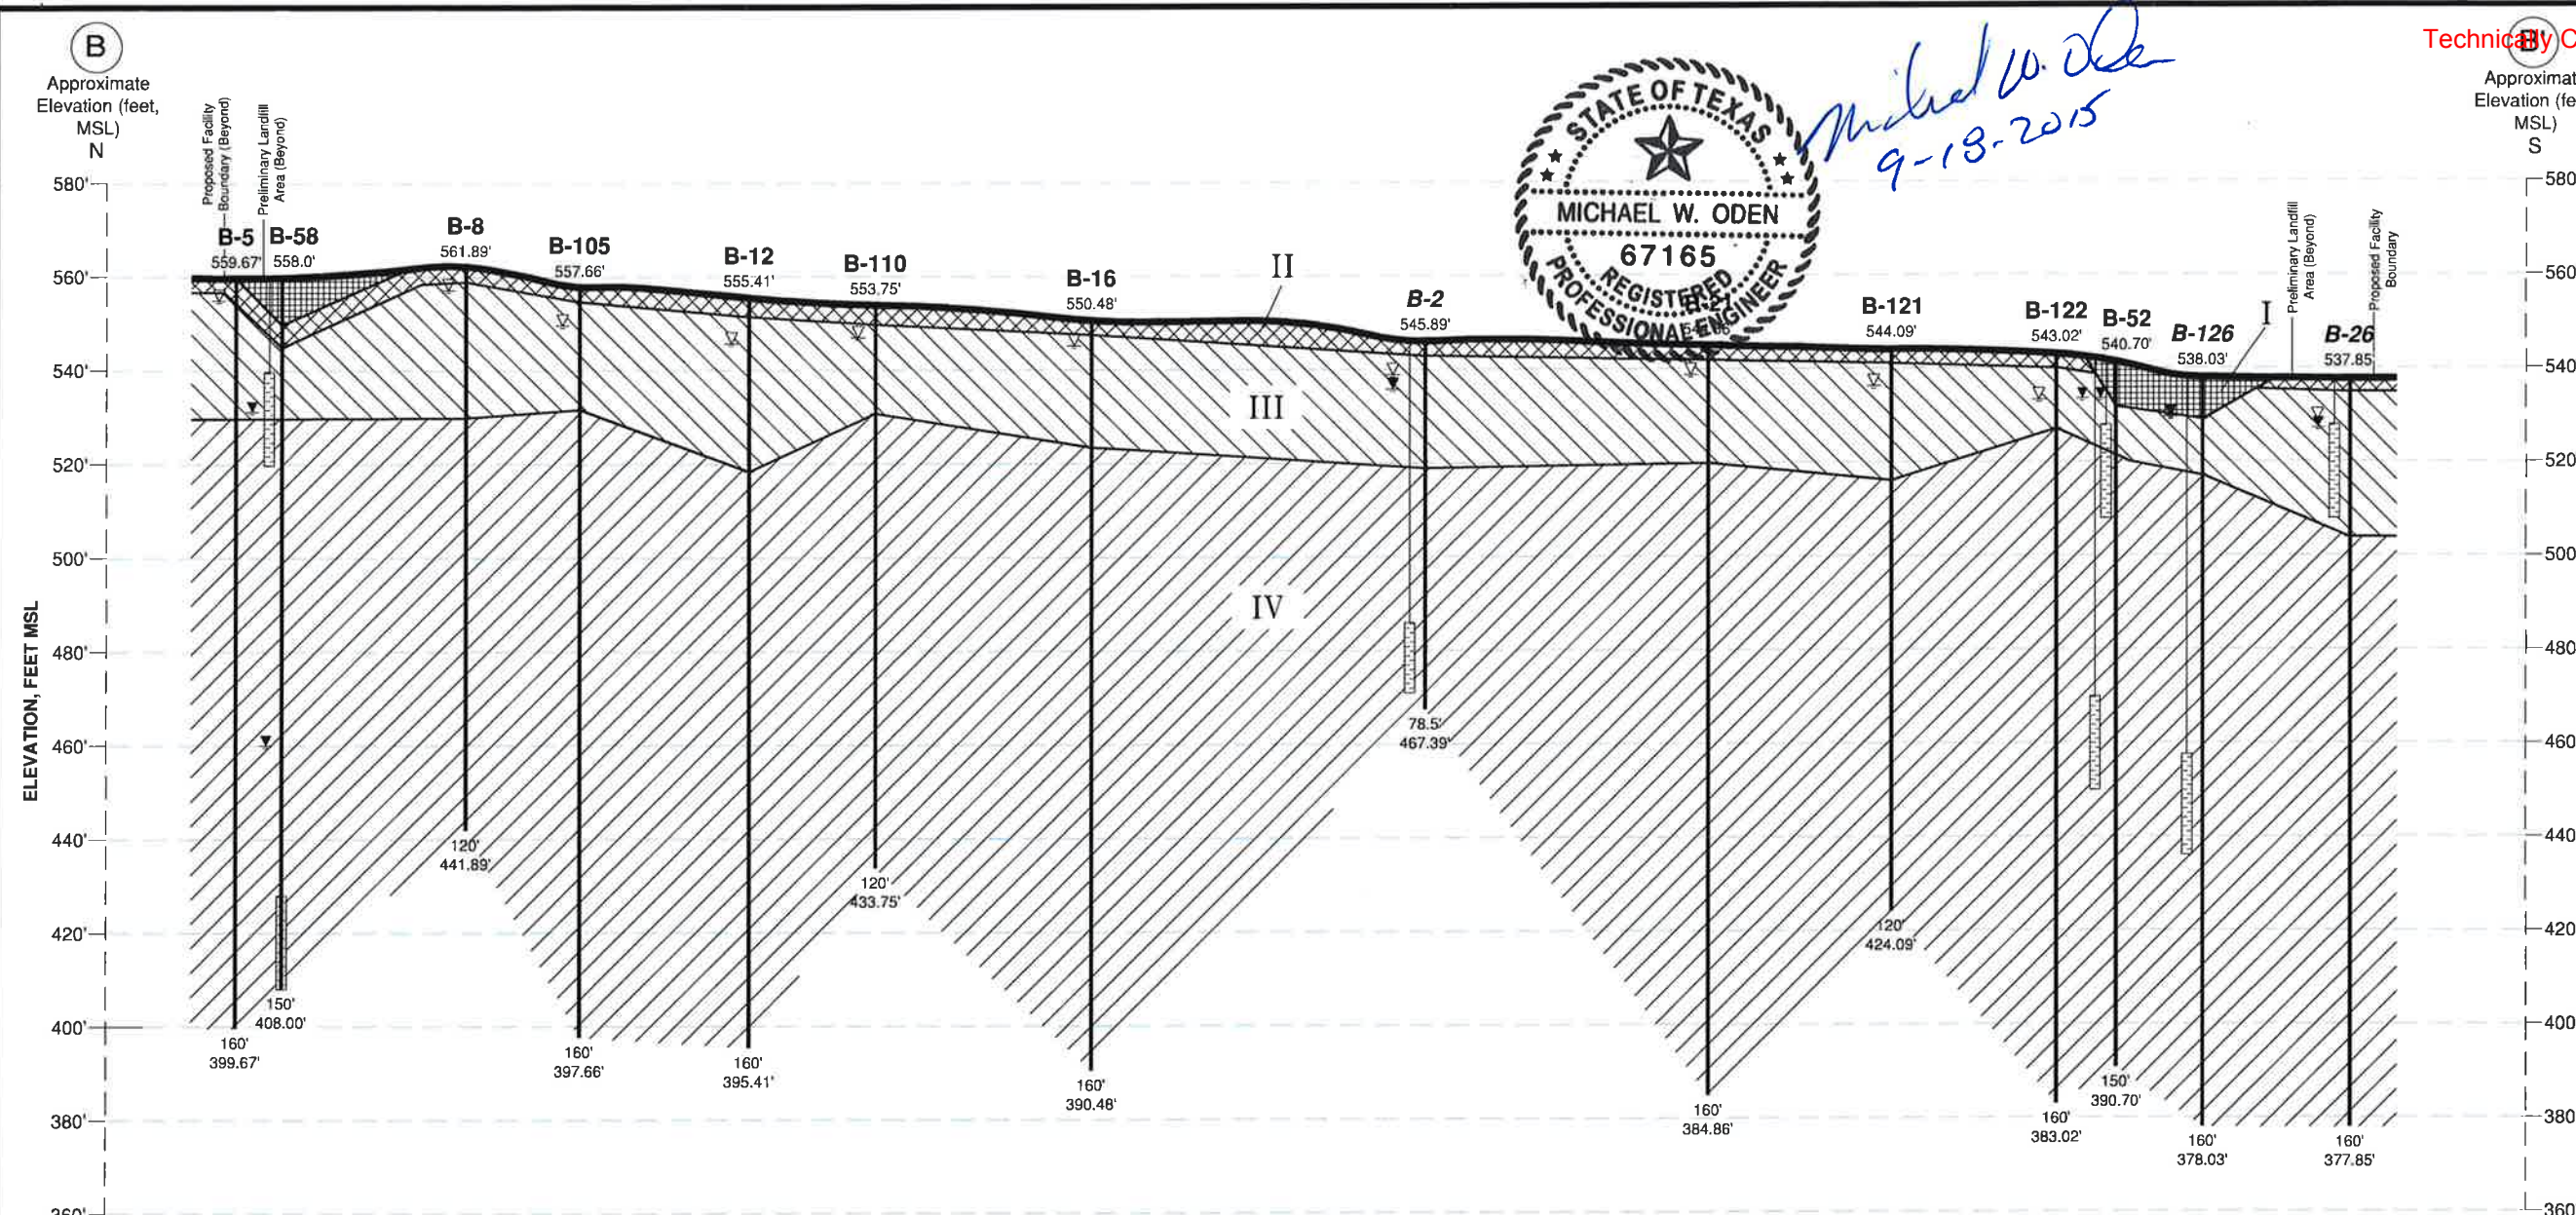
III-E.5-A.1

**STRATUM II - Highly Weathered Eocene Residuum:**  
This stratum corresponds to highly weathered surface and near-surface Eocene age soil strata logged throughout the majority of the site, both below the Qal, and in upland areas designated on the *Geologic Atlas of Texas Laredo Sheet (1976)* geologic map as the Yegua-Jackson Group formation (Y-J). This stratum is essentially a weathered-in-place (residual) soil horizon exhibiting similar structure and layering as underlying, less-weathered materials. This stratum consists of predominantly clay with minor sandy clay with ferrous staining, calcareous nodules, and organic (plant root) materials. The clays are fissured, stiff to hard, overconsolidated, and brown to light reddish brown with some brownish gray to greenish gray layers. At some locations, gypsum (selenite) and ironstone concretions were encountered. This stratum occurs from ground surface (where exposed) or below Stratum I soils to depths of up to 10 feet bgs, with a maximum thickness of 10 feet. Transmissive secondary soil structure (i.e., fissures, fractures, joints, and horizontal bedding) is present, but pursuant to criteria established by Terzaghi and Peck in *Soil Mechanics in Engineering Practice (1967)*, materials are classified as relatively or practically impermeable based on measured laboratory permeability values. As a result of post-Eocene geologic processes, Stratum II is not uniformly developed or laterally continuous throughout the site; and therefore was not always identified discretely in boring logs. In many instances, Stratum II was not logged as a separate unit, but simply described as the uppermost weathered portion of Stratum III as described below. Seasonally, the perched shallow subsurface water associated with Stratum I may also be encountered in this stratum. Based on observations during test pit excavation, an ephemeral fresh water lens appears to be present following rainfall events to depths on the order of 1 to 3 feet bgs, which controls the thickness of the plant root zone. Below this depth, scattered ephemeral saline water lenses occur throughout the remaining vertical extent of weathered Stratum II and/or Stratum III soils.

**STRATUM III - Weathered Eocene Sediments:**  
This near-surface stratum underlies Stratum I and Stratum II throughout the site and is considered to represent Eocene sediments associated with the upper weathered (e.g., ferrous stained) surface of the Yegua-Jackson Group formation (Y-J). This stratum consists of clay and sandy, silty clay with thinly to very thinly interbedded claystone, siltstone, and sandstone seams and lenses (i.e., bedding units typically 1 to 2 feet or less). The clays are fissured, hard, overconsolidated, light brown and brown to reddish brown with some olive to pale yellow layers, with scattered greenish gray to gray mottling and ferrous staining, and have a blocky structure. Stratum III is encountered at depths ranging from approximately 2 to 39 feet bgs, and ranges from approximately 8 to 33 feet in total thickness. This stratum is generally differentiated from Stratum IV as defined below by its consistently weathered appearance along partings (i.e., ferrous and carbonaceous staining), isolated presence of weathered zones containing groundwater, and the less frequent occurrence of interbedded sandstone, siltstone, or claystone layers. Transmissive secondary soil structure (i.e., fissures, fractures, joints, and horizontal bedding) is present, but pursuant to criteria established by Terzaghi and Peck (1967), materials are classified as relatively or practically impermeable based on measured laboratory permeability values.

**STRATUM IV - Relatively Unweathered Eocene Soils:**  
This stratum underlies Strata III throughout the site, was encountered to total exploration depth for the landfill project on the order of 160 to 500 feet (based on single deep boring, DB-1), and is considered to represent relatively unweathered Eocene soils of the Yegua-Jackson Group formation (Y-J). This stratum consists predominantly of clay and sandy, silty clay, with thinly to very thinly interbedded claystone, siltstone and sandstone seams and lenses (i.e., bedding units 1 to 2 feet or less). The clays are hard and fractured, overconsolidated, light green to green and greenish gray (with some dark gray to gray and brown to reddish brown layer with scattered greenish gray mottling) with some ferrous staining, and have a blocky (intensely fissured) structure. Stratum IV is encountered throughout the site at depths ranging from approximately 16 feet to greater than 160 feet bgs, and has a thickness exceeding 144 feet. As indicated on boring logs, this stratum is complexly interbedded and does exhibit significant variation in the nature and occurrence of indurated materials, although very thinly interbedded claystone units are most frequently encountered throughout. Although relatively unweathered relative to Stratum III, zones of localized weathering indicated by ferrous staining and weathered surfaces of clay partings are present likely in association with shallow groundwater movement. Transmissive secondary soil structure (i.e., fissures, fractures, joints, and horizontal bedding) is present, but pursuant to criteria established by Terzaghi and Peck (1967), materials are classified as relatively or practically impermeable based on measured laboratory permeability values.

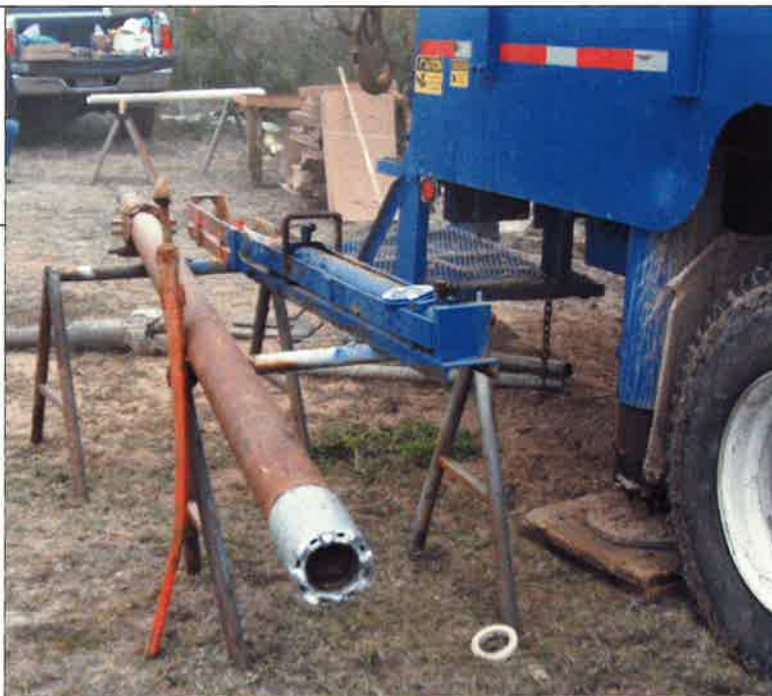
Double Tube Core Barrel

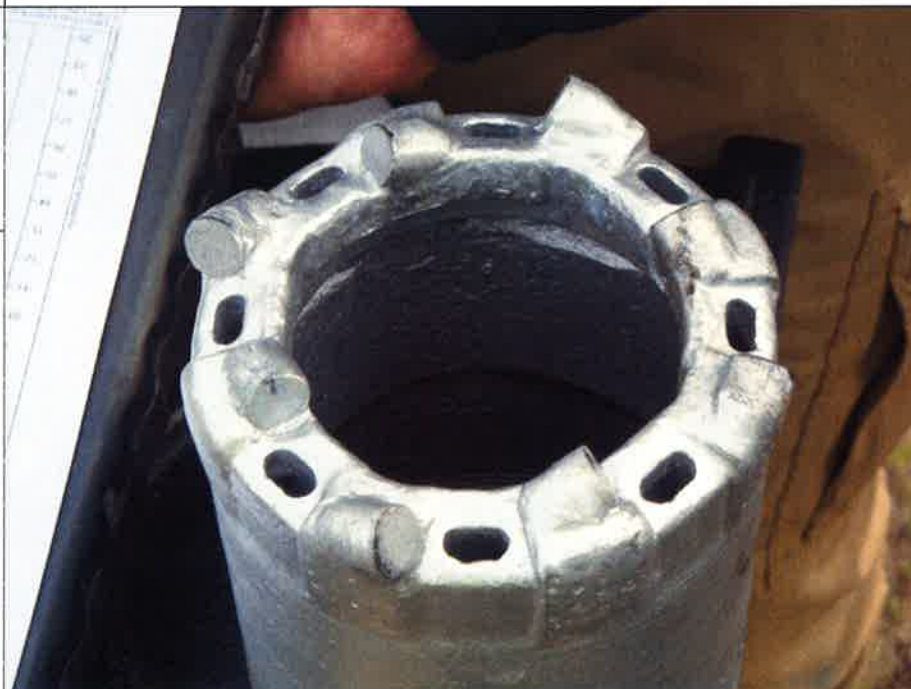
### Photograph No. 2

Drill Bit

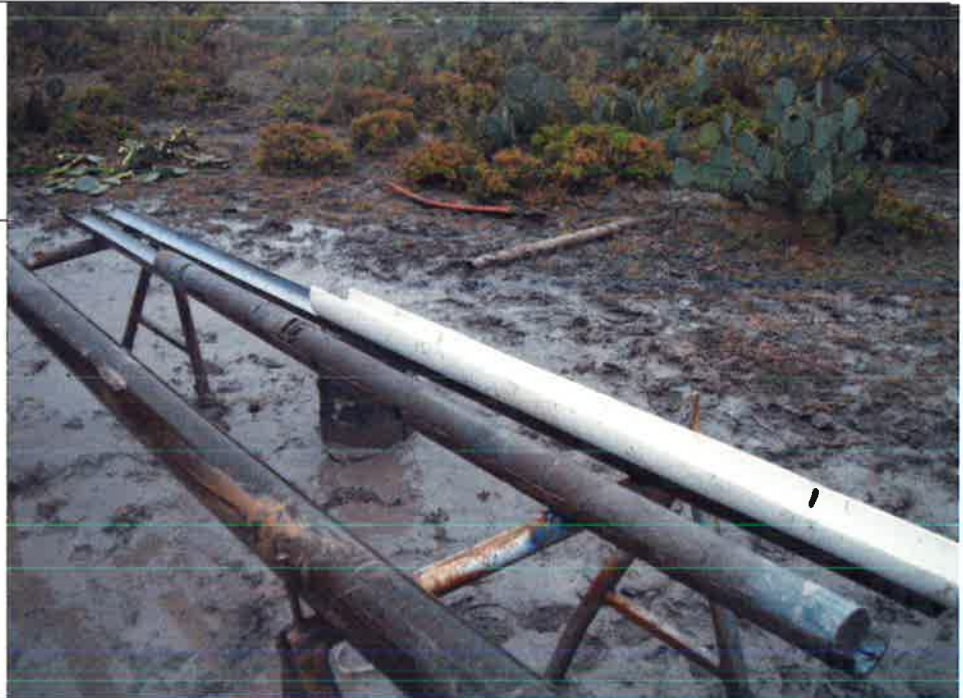
B-52

53' to 60'

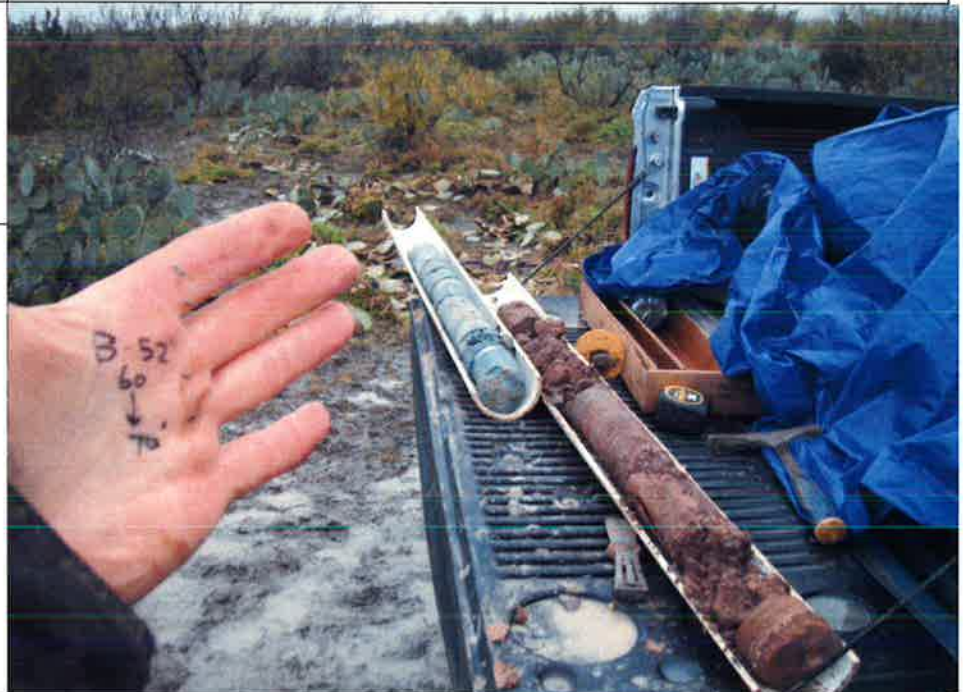
### Photograph No. 4

B-52

60' to 70'

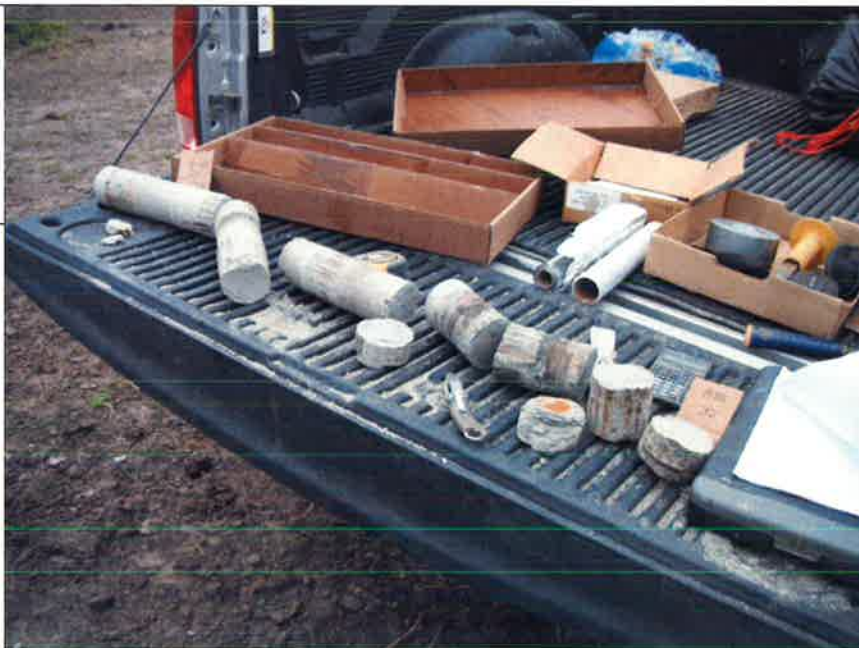
B-55

27' to 32'

- Boring B-55 used air-rotary drilling to core all the way down to the completion depth of 153 feet. Moist soil materials were encountered in Shelby Tube samples down to the R-P and Y-J contact zone (approximately 11 to 12 feet in depth); however, no shallow subsurface water was encountered. While reaming out the borehole for the surface casing, moisture was indicated in the cuttings from approximately the 10-foot depth. Surface casing was set to 17

feet. Moisture was noted in some of the recovered core samples and small amounts of water were observed at several intervals during drilling; notably 32 to 36 feet and 95.5 to 101 feet.

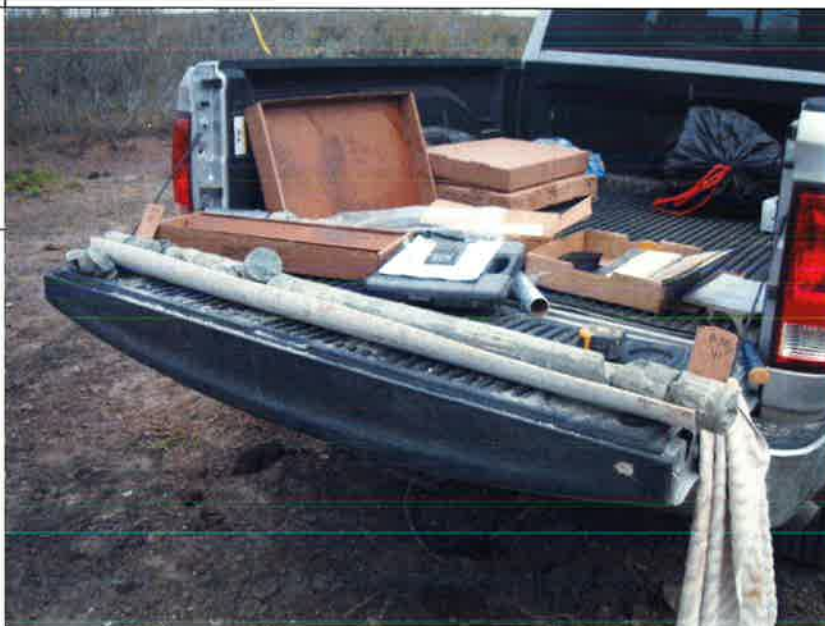
### Photograph No. 8

B-55

36' to 41'

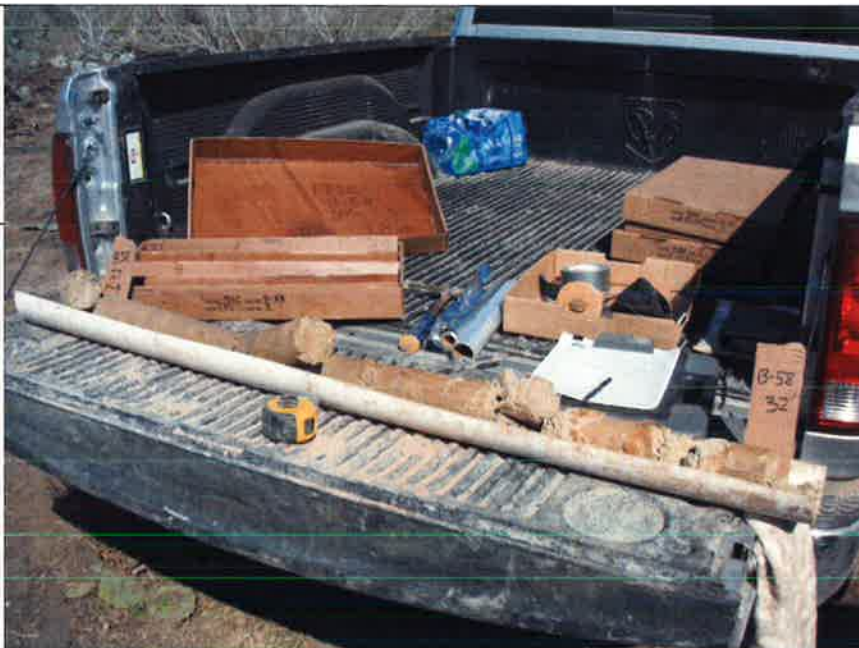
B-58

27' to 32'

- Boring B-58 used air-rotary drilling to core all the way down to the completion depth of 150 feet. Moist soil materials were encountered in Shelby Tube samples down to the R-P and Y-J contact zone (approximately 11 to 12 feet in depth); however, no shallow subsurface water was encountered. Moisture was noted in some of the recovered core samples and small amounts of water were observed at several intervals during drilling; notably 12 to 17 feet, 22.5 to 30.5 and 32 to 32.3 feet.

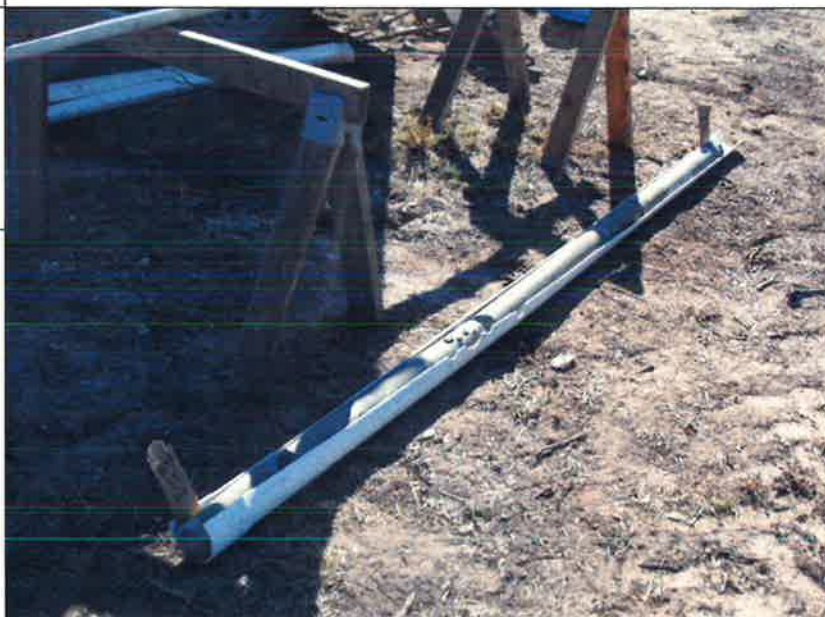
### Photograph No. 12

B-58

53' to 63'

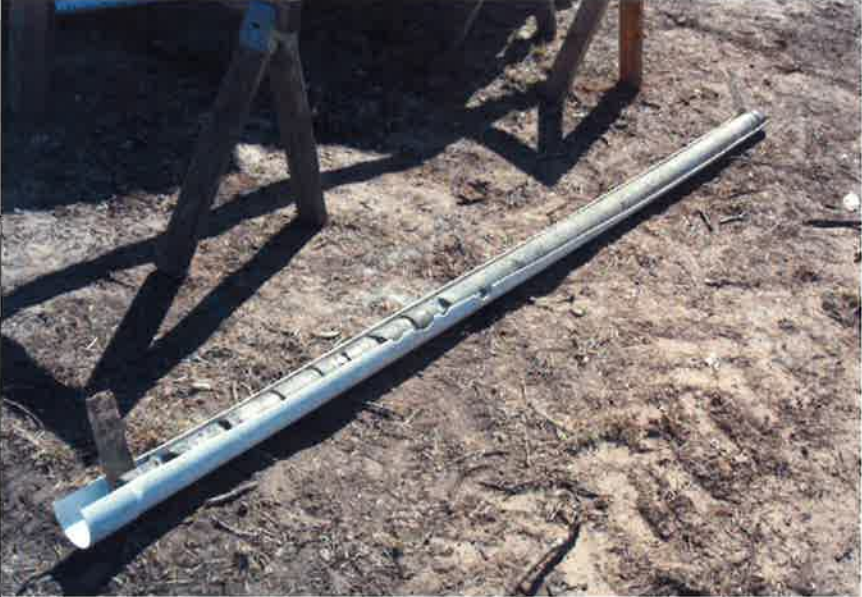
<p><b>Photograph No. 13</b></p>

<p><b>Description:</b> B-58  63' to 73'</p>	
<p><b>Photograph No. 14</b></p>

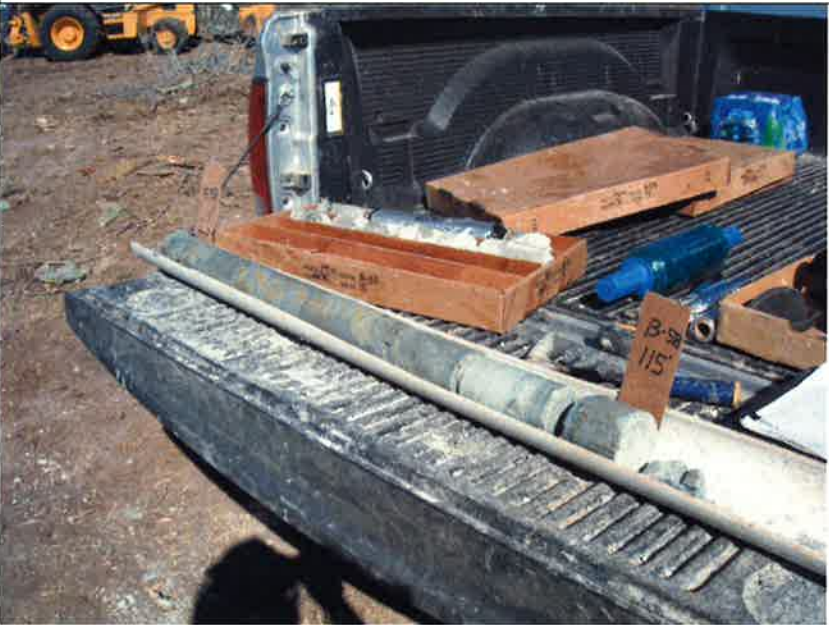
<p><b>Description:</b> B-58  111' to 115'</p>

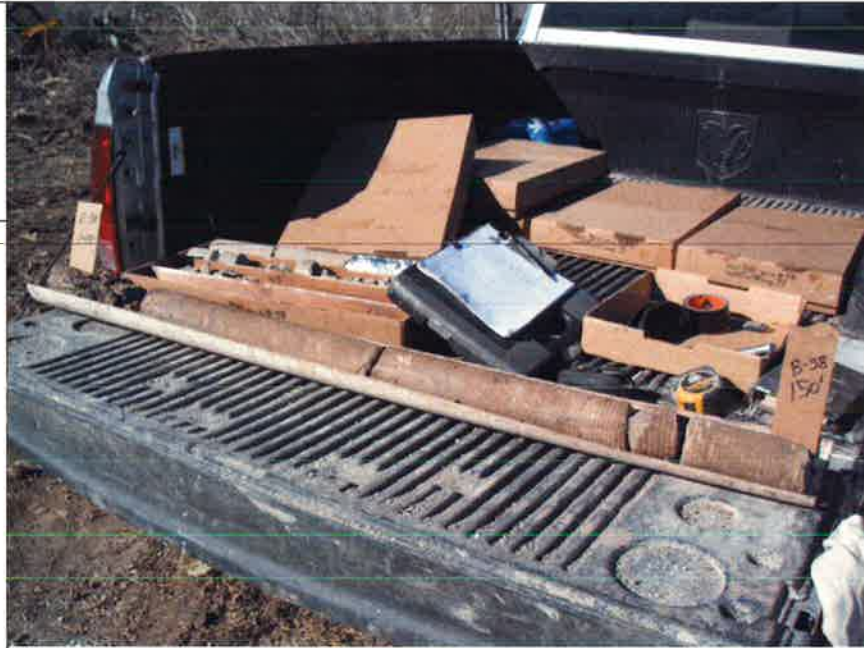
B-58

145' to 150'

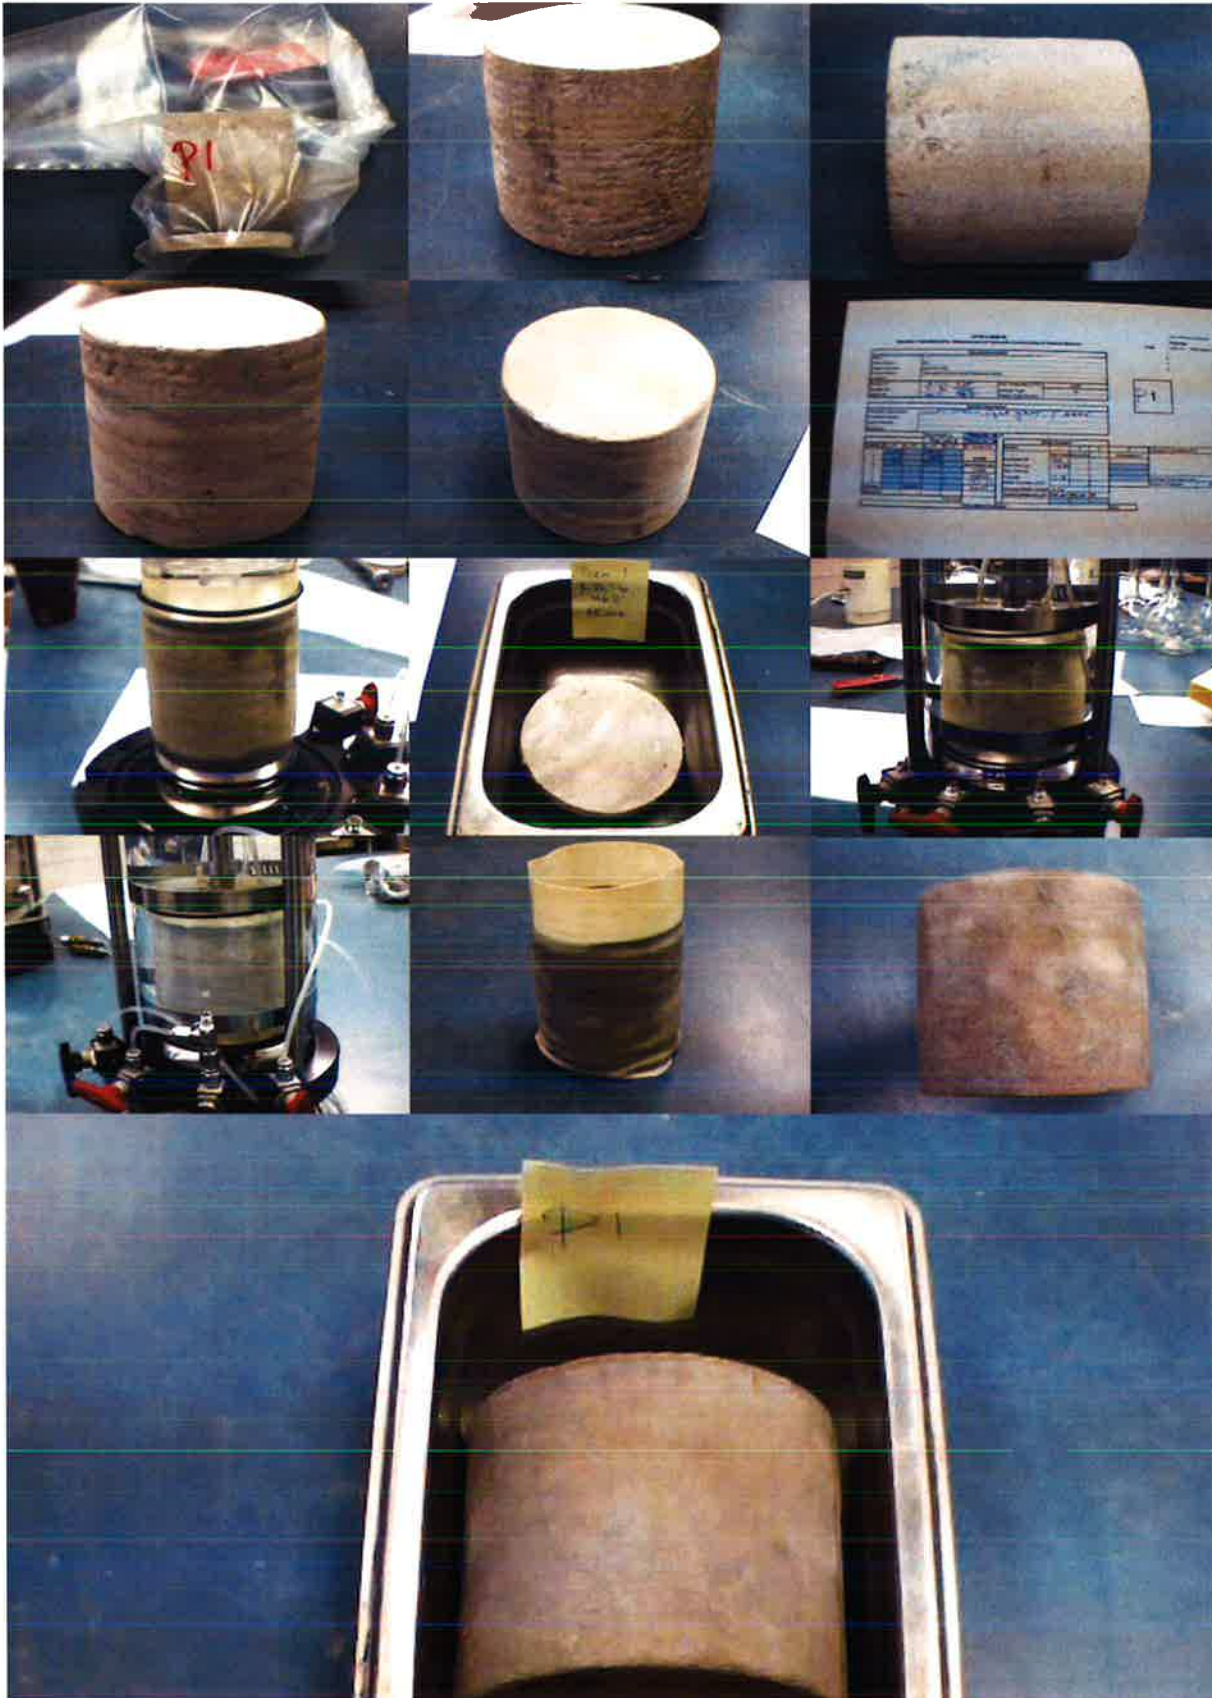
B-52 at 146.5'

Hydraulic Conductivity, k	Hydraulic Conductivity at 20°C, $k_{20}$
Weighted Averages:	2.141E-09	1.942E-09
	(cm/sec)

- Permeability tests (ASTM D5084-10) – Four tests were conducted on undisturbed samples to determine their vertical-axis permeability. Three test results indicated permeability (hydraulic conductivity) in the  $10^{-9}$  to  $10^{-11}$  cm/sec range. A fourth test result was in the  $10^{-7}$  range; however, testing of that sample was delayed in the laboratory and micro-cracking was observed in the test specimen that could have affected the test result.
