**Part III
Attachment III-C
Appendix III-C.2**

FACILITY SURFACE WATER DRAINAGE DRAWINGS

**Pescadito Environmental Resource Center
MSW No. 2374
Webb County, Texas**

**FACILITY SURFACE WATER DRAINAGE REPORT
TERRACE BERM, DOWNCHUTE, AND PERIMETER CHANNEL DETAILS**

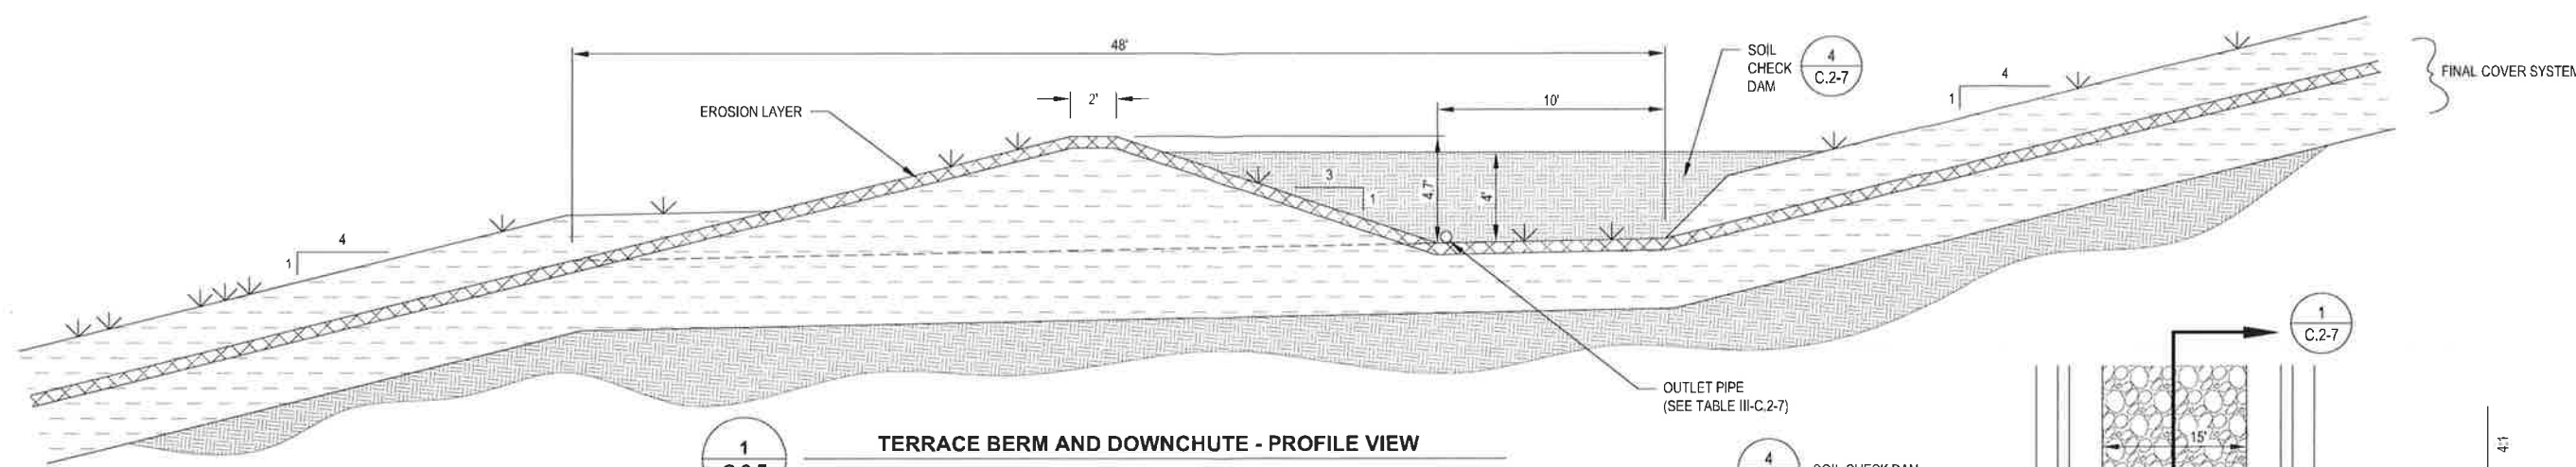
1 C.2-7 TERRACE BERM AND DOWNCHUTE - PROFILE VIEW
NOT TO SCALE

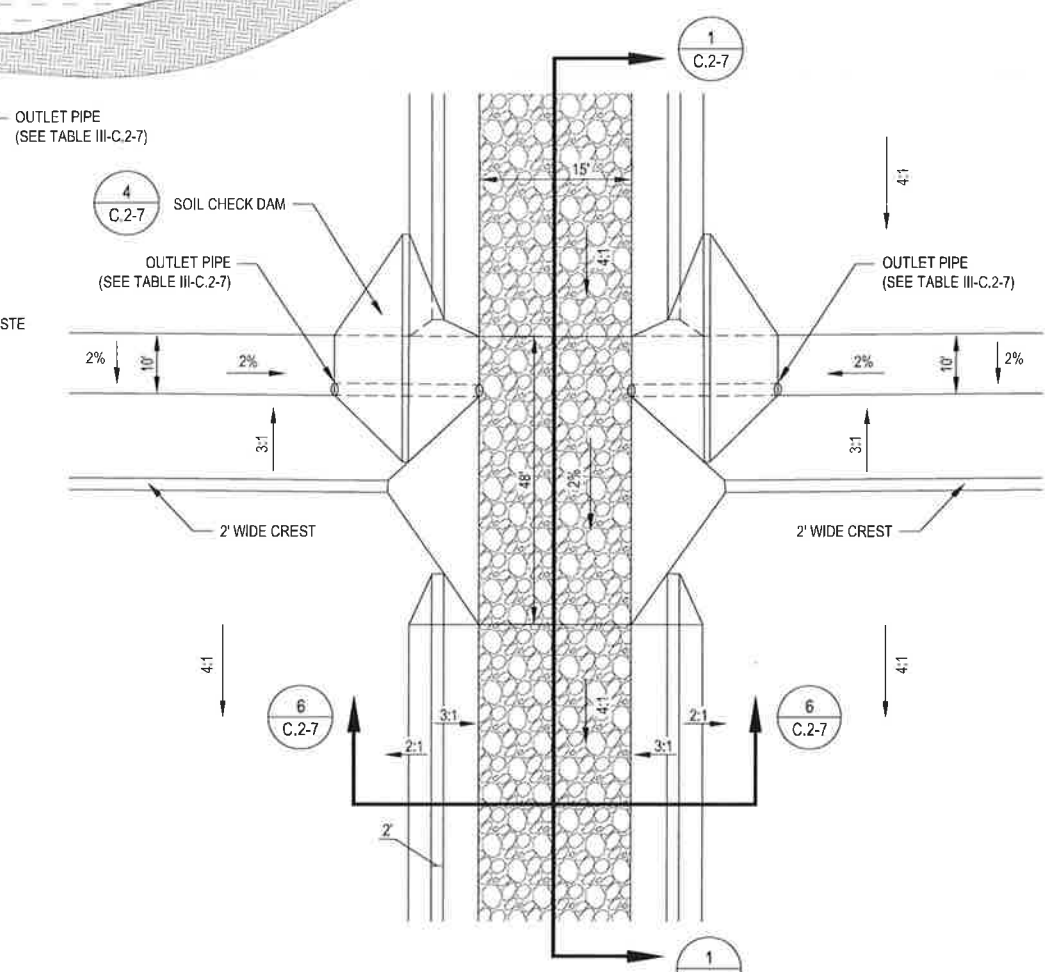
3 C.2-7 TERRACE BERM AND DOWNCHUTE - PLAN VIEW
NOT TO SCALE

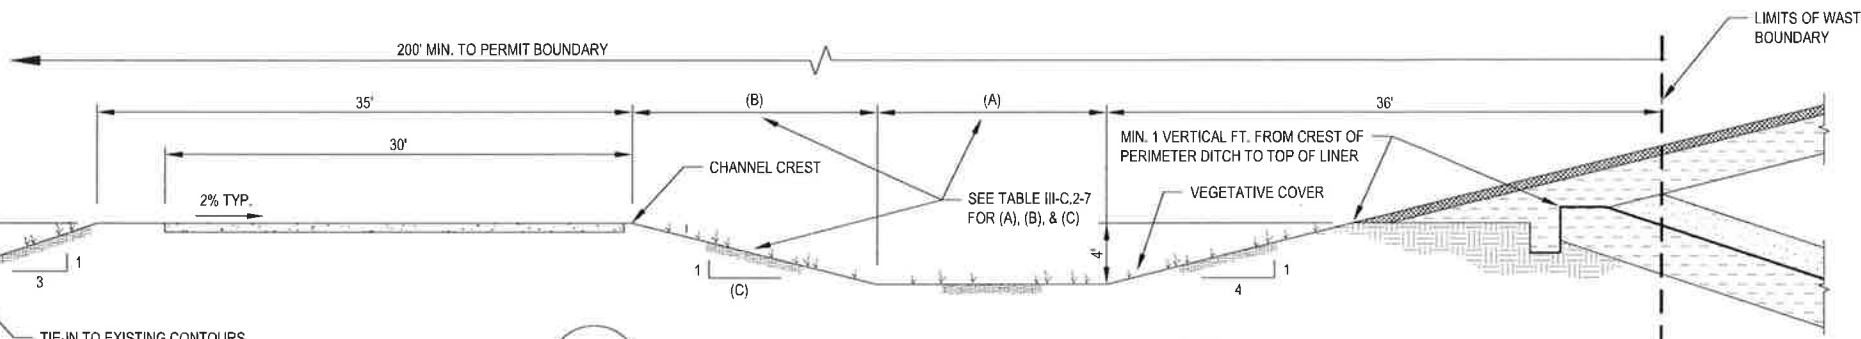
2 C.2-7 PERIMETER DITCH AND ROAD SECTION
NOT TO SCALE

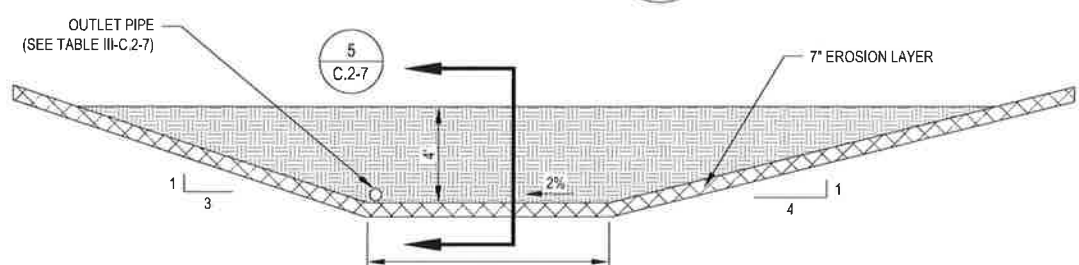
4 C.2-7 TYPICAL SOIL CHECK DAM PROFILE
NOT TO SCALE

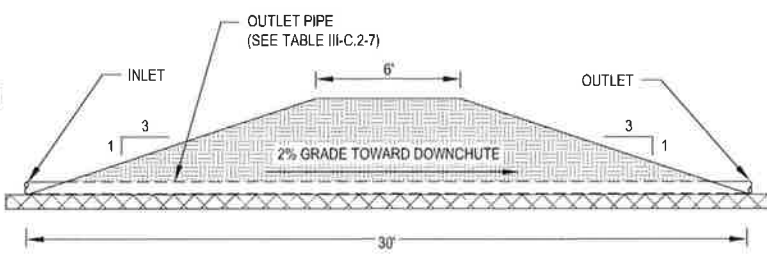
5 C.2-7 TYPICAL SOIL CHECK DAM SECTION
NOT TO SCALE

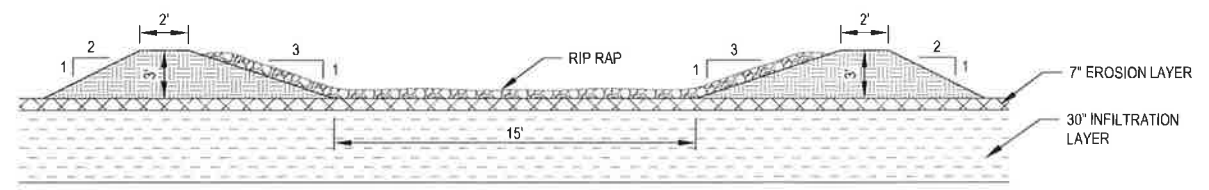
6 C.2-7 TYPICAL DOWNCHUTE SECTION
NOT TO SCALE
